Occupant Protection from Cargo in Armored Vehicles

John Yannaccone, Alan Cantor, Don Eisentraut, Wayne Denham, Larry Sicher
ARCCA, Inc.

Copyright © 2005 SAE International

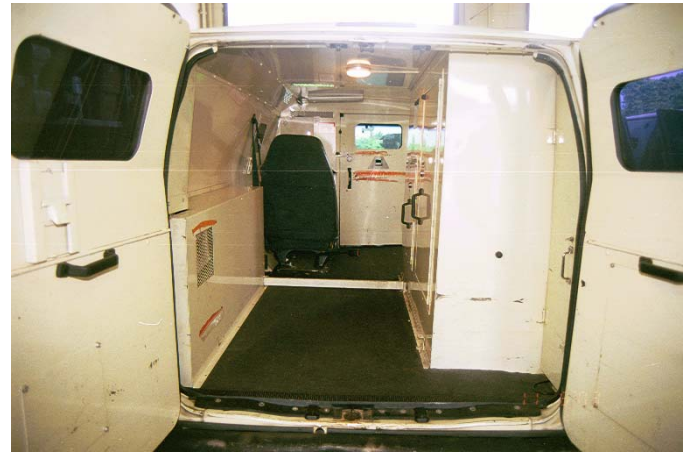
Figure 1. Armored Van Cargo Compartment Looking Forward with the Messenger Seat Shown

Armored vehicles used on transport routes vary widely in design and size from heavy trucks to cargo vans similar in size to a standard 12-passenger van. The analysis in the paper will focus on the smaller, more common vehicles in this group used for making deliveries and pickups at banks and stores. In many of these vehicles there is an occupant, or messenger, seat in the rear cargo compartment of the vehicle as seen in Figure 1.

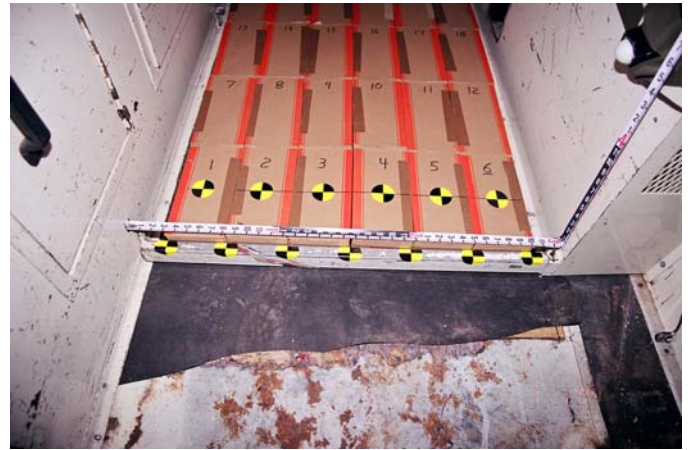
Figure 2. Armored Van Cargo Bar
View Looking Aft From Messenger's Seat

At the beginning of this program, a used 1995 armored route van was acquired and the provided cargo securing method was analyzed. In the van analyzed, the only means provided to prevent the motion of the cargo was a 25.4 by 50.8 millimeter (one-inch by two-inch) hollow rectangular tube, with a 1.6 mm (0.0625 inch) wall thickness, across the cargo area on the floor as shown in figure 2. According to the van's converter, the maximum payload this van is intended to carry was 363 kilogram (800 pounds), in a maximum of 30 boxes placed against the cargo bar all the way across the cargo area as seen in figure 3. This placement of the cargo is an important factor in the design of the barrier. [1] With the cargo against the barrier, there is no opportunity for the cargo to develop relative velocity to the barrier in a crash. This relative velocity would increase the forces the cargo places on the barrier in a crash and generally increases as the initial distance between the barrier and the cargo increases. Using the specifications of the vehicle's converter and the mass of the common coin boxes, these limits would allow the van to carry a maximum of 30 boxes of quarters with a total mass of 347 kilograms (765 pounds).

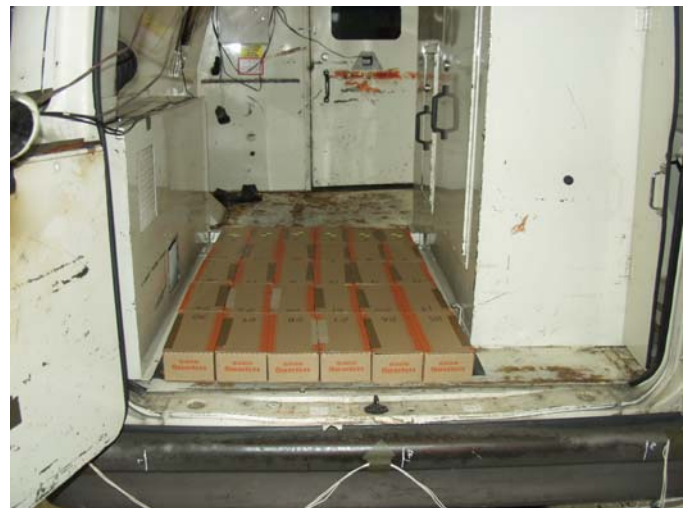
Figure 3. Armored Van Payload
View Looking Forward

To confirm the calculation and further investigate the performance of the provided system a 48 KPH (30 mph) frontal barrier impact test was conducted with the armored route van. For this test the vehicle was loaded with 15,000 dollars or 347 kilograms (765 pounds) of quarters in 30 boxes as seen in Figure 3. The messenger seat was removed from the van for this test so as to be conserved for the full cargo barrier design test to be conducted later.

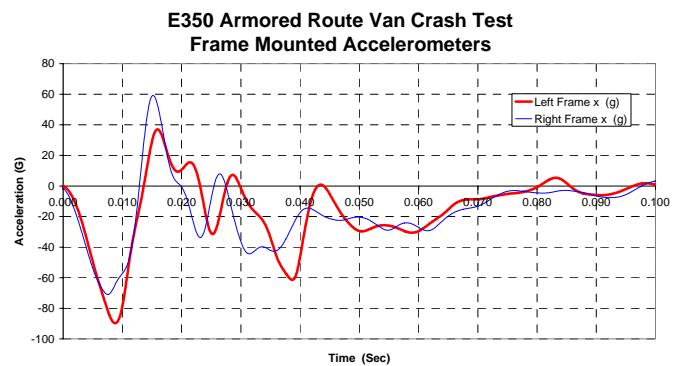
The crash pulse shape from this test was somewhat unusual in that at a point approximately 13 milliseconds into the crash, the frame accelerometers show that the vehicle is actually being accelerated into the barrier and the vehicle's speed is increasing. This is a rather unusual result until one considers the sizeable movable mass of the cargo. Review of the video demonstrated that this acceleration of the vehicle into the barrier is likely the result of the cargo impacting the interior of the van, driving the van forward into the barrier. This unusual pulse shape is seen in figure 4. The authors have conducted other crash test in which there was a large shifting mass where similar acceleration-time characteristics have been seen.

Figure 4. Longitudinal Van Frame Crash Pulse

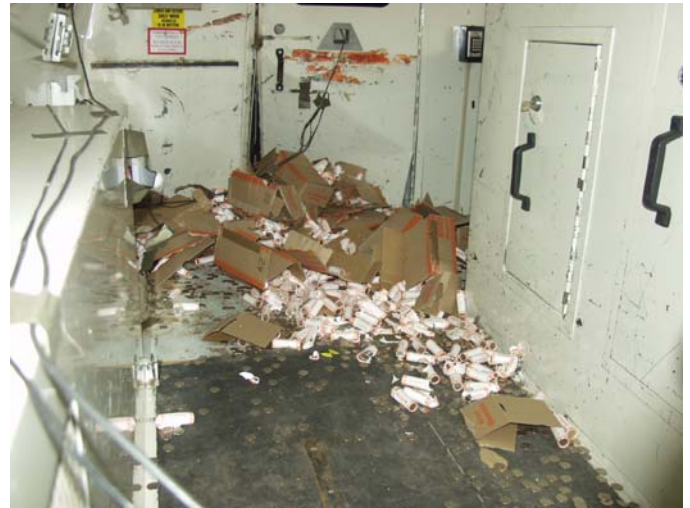
During this crash the coin boxes loaded the cargo bar causing it to bend and separate from the attachment on the left side prior to releasing on the right side. This allowed the coin boxes to move forward, through the area normally occupied by the messenger's seat and messenger and impact the forward bulkhead that separates the cargo area from the driver's compartment. The motion of the cargo during the impact is shown in figure 6 with the post-test cargo position shown in Figure 7.

Figure 7. Post-Crash Cargo Position with Cargo Shifted Forward in Van

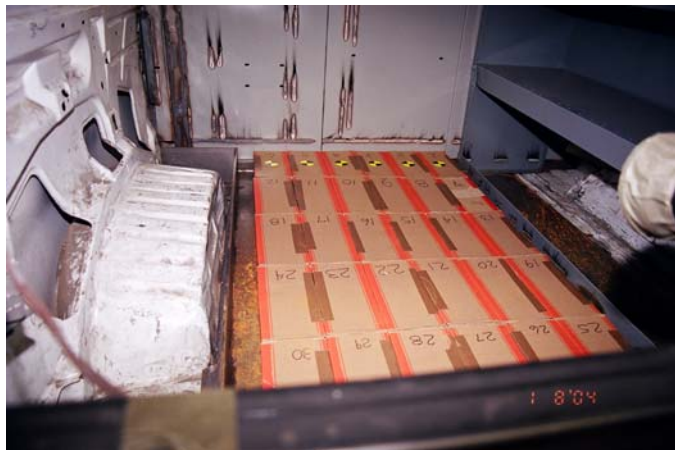
The cargo for this sled test was exactly the same as what was used in the prior crash test and was loaded in the same fashion for both tests. The pre-test cargo and barrier are shown in figure 8.

Figure 8. Pre-Sled Test Cargo Position Looking Forward

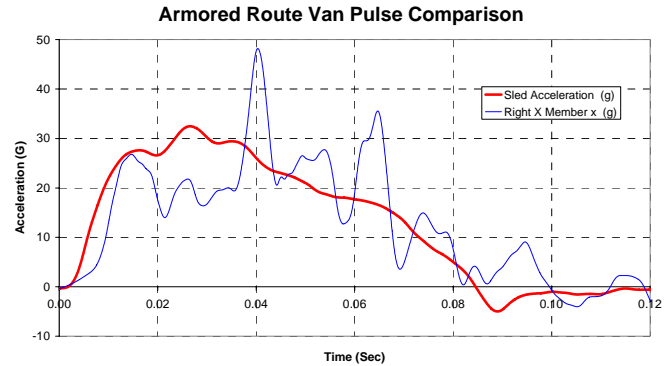
The acceleration-time profiles for the crash and sled tests are shown in Figure 9. While the crash test has a higher peak acceleration, the sled test had a slightly

higher velocity and thus a higher energy. Additionally the effective sustained acceleration in the sled test was slightly greater than in the crash test. While there were some differences between the sled and the crash tests, they are comparable for looking at the performance of the subject cargo barrier. While it is desirable to more closely control parameters, in a test, such as this one, with a large amount of moving, shifting mass, such control is difficult to achieve.

Figure 9 Sled and Crash Test Pulses

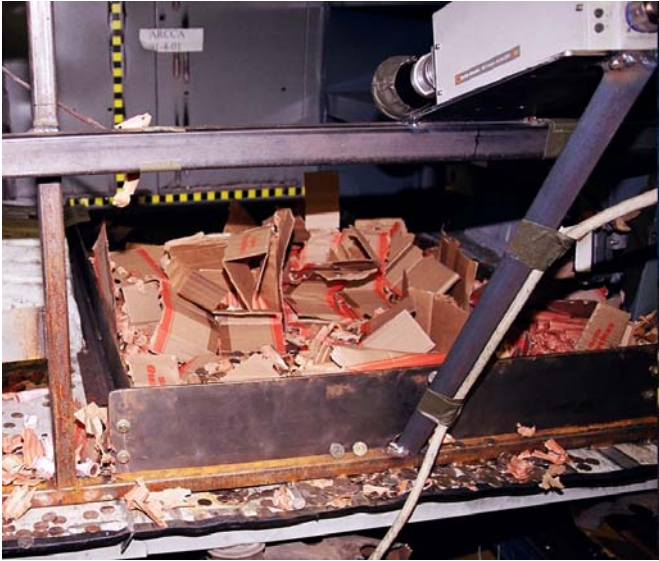
Following the test, the cargo barrier was still completely intact and the cargo was retained in the area behind the barrier with no cargo entering the space where the messenger's seat is located. The post-test cargo and cargo barrier is shown in figure 11 with the cargo barrier in the forward area. Figure 12 shows the area forward of the cargo barrier is free of damage and cargo did not enter this area.

Figure 11. Post-Sled Test Cargo Barrier Looking Forward

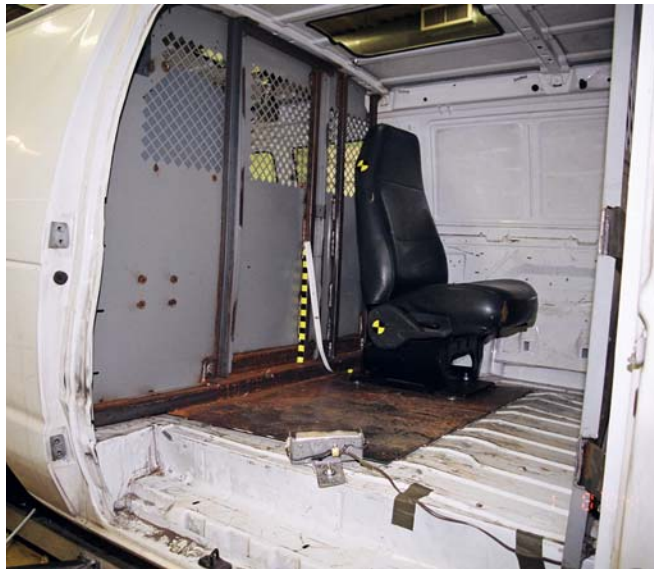
Figure 12. Post-Sled Test Cargo Barrier
