BUILDING ENVELOPE TECHNOLOGY SYMPOSIUM

**EVERYONE LOVES A POOL,
BUT WHAT'S LURKING BENEATH THE SURFACE?**

ROBERT HOLMER, PE, GE

MICHAEL PHIFER

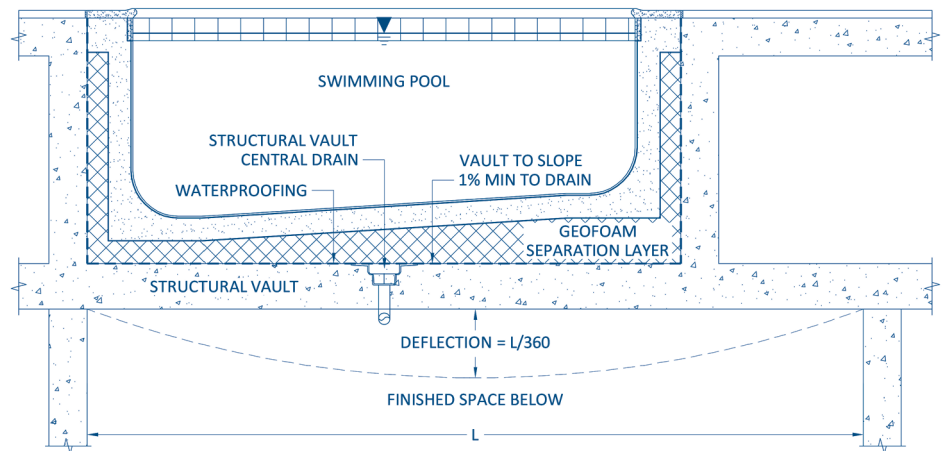
Figure 2 – Illustration of pool slab with eccentrically spaced structural support. This condition shows differential deflection of a vault, causing racking and twisting of pool shell.

exists in both directions, the pool can rack or twist—a far more serious structural condition. This deformation not only increases the risk of structural cracking, but also results in a pool that is not level. Rim flow pools with deck-level gutters can be very problematic, as they require the rim to be perfectly level for proper operation.

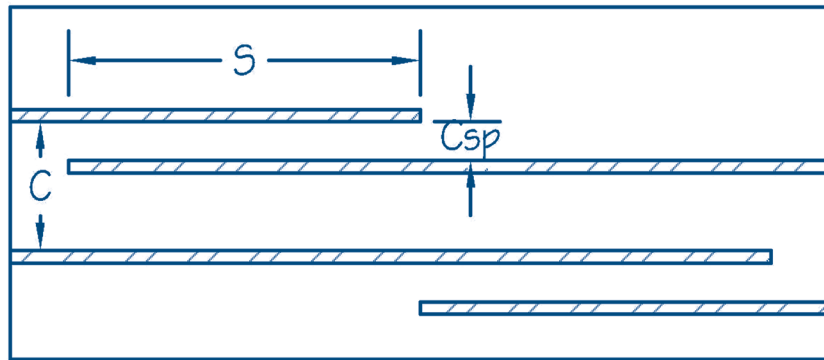
SHOTCRETE REINFORCEMENT: NON-CONTACT LAP SPLICE

S: LAP SPLICE LENGTH - VARIES, SEE PLANS

C: CLEARANCE - 2½" MIN FOR #5 BARS AND SMALLER
6 bd FOR #6 BARS AND LARGER

C_{sp}: SPLICE CLEARANCE - 2" MIN

Figure 3 – Non-contact lap splice method.

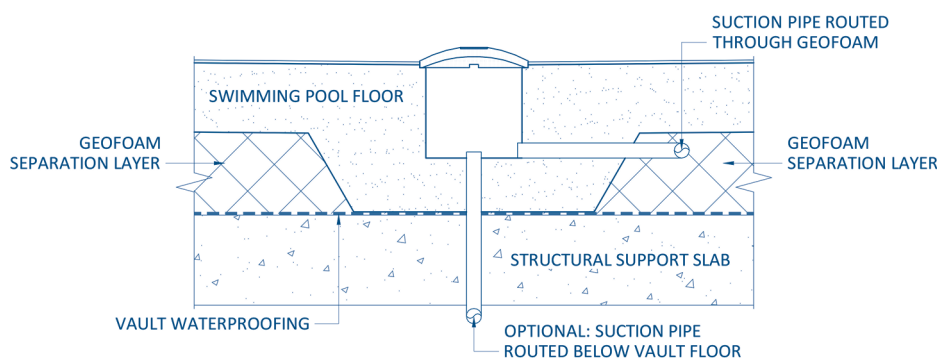
Figure 4 – Piping penetrations should be routed either through the geofoam or beneath the slab. Never embed piping through the pool structure.

A rebar schedule consisting of #5 bars at 5 in. on-center is the maximum reinforcement schedule the building code allows in shotcrete/gunite construction without building and testing preconstruction test panels. Many rooftop pools are specified with this reinforcement schedule. In order to reduce shadowing behind the rebar and maintain the utmost structural integrity, it is important to use the non-contact lap splice method to tie all reinforcement (Figure 3). Furthermore, all plumbing pipes should be routed either through the geofoam separation layer or beneath the structural slab (Figure 4). Plumbing pipes should never be embedded in the gunite/shotcrete swimming pool shell because the pipe creates a thin structural section at the pipe location where cracking can develop.

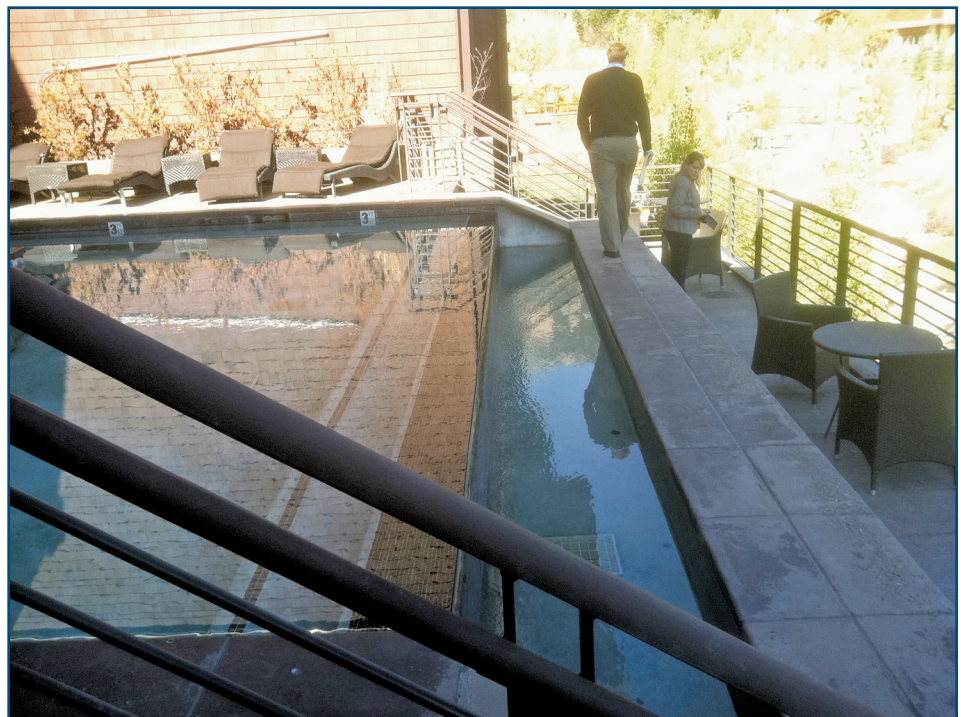
A new Wyoming ski lodge that incorporated a rooftop spa was constructed in 2009. The 300-sq.-ft. spa was 3 ft. deep and included a 26-ft.-long vanishing edge (Figure 6). The spa was located on the third-floor balcony and was built over a ballroom/banquet room. The spa was constructed inside a concrete vault, and the vault received a comprehensive waterproofing and drainage system similar to the recommendations herein. The interior surface of the vault was waterproofed with an approved water sealant product, and the entire vault

Figure 6 – Spa with vanishing edge built on third-floor balcony.

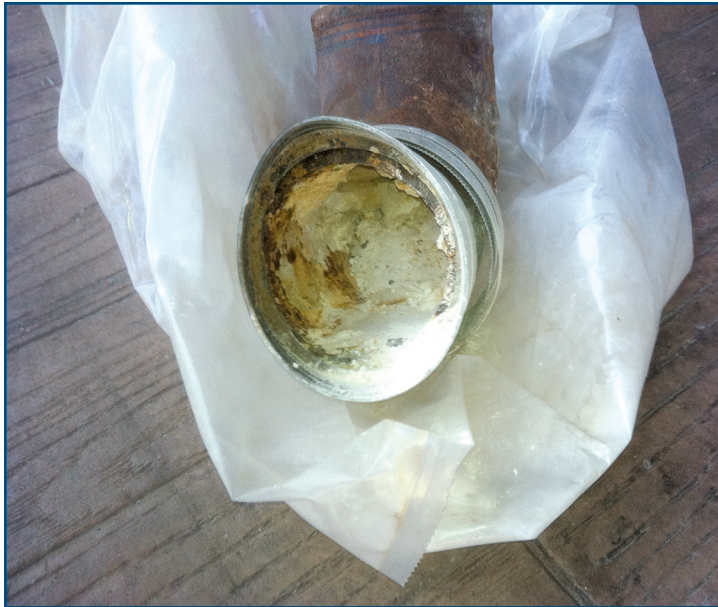
Figure 7 – Drain line plugged with fireproofing.

applied fireproofing. At the time the fireproofing was applied, only the drain inlet was installed in the vault. The drainpipe connection to the landscaping discharge had not yet been installed. When the fireproofing was applied, the inlet was plugged and remained plugged when the pipe connection was later completed.

Leaking water from the spa should have collected within the drainage composite and discharged through the drainpipe to the landscape area as designed. However, the drainpipe was found to be plugged with spray-applied fireproofing material (Figure 7). The structural framing above the ballroom was protected with a coat of spray-

struction had proper protection, quality control, and quality assurance been performed. A small piece of plastic with a rubber band to cover the drainpipe would have prevented the blockage. Furthermore, the plumber who later plumbed the line should have inspected the drainpipe and cleared it of the obvious blockage.

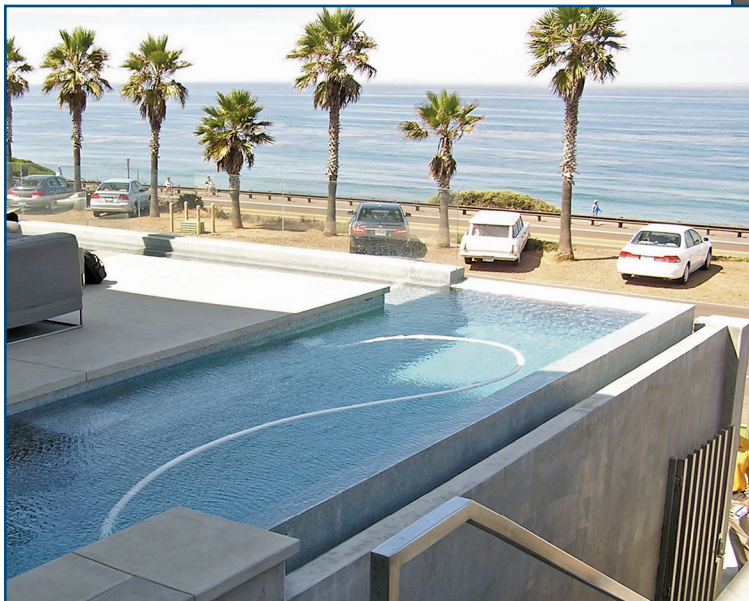
Figure 8 – Vanishing-edge rooftop swimming pool.

This vanishing-edge rooftop swimming pool (Figure 8) was constructed at a beachfront residential home in San Diego, California. The pool was constructed over a pool equipment room, garage, and finished living space. The pool was underlain by a geotextile drainage composite and included foam insulation as a separation layer. However, waterproofing of the structural slab was insufficient, and the geotextile drainage composite was laid flat (Figure 9) so that accumulated water would not drain to the inlet. The pool structure was also under-reinforced.

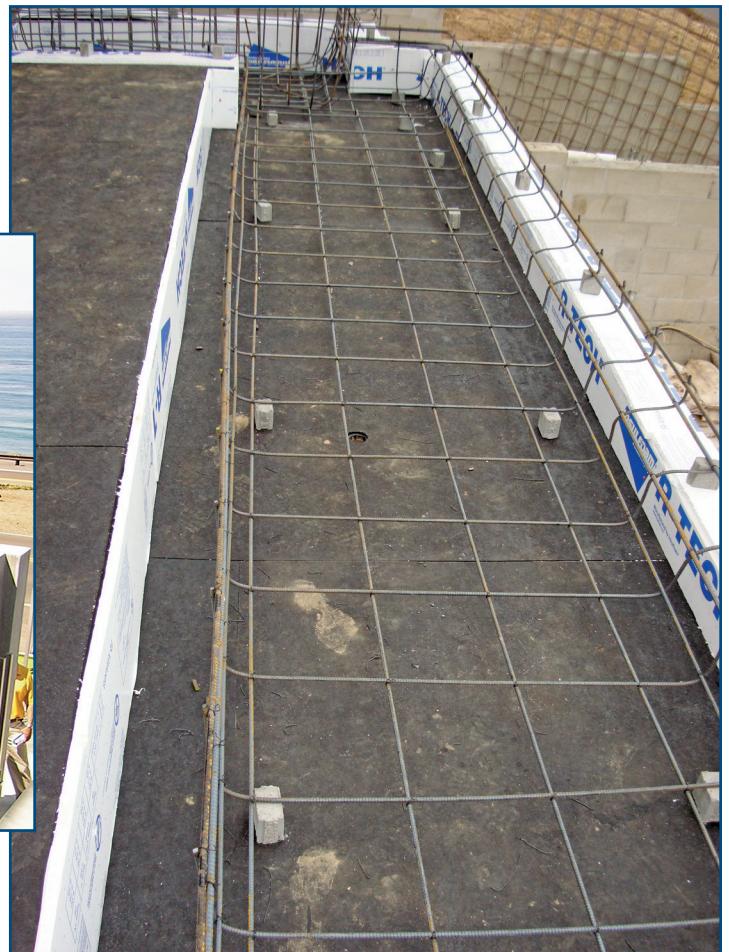
Figure 9 – Geotextile drainage composite laid flat.

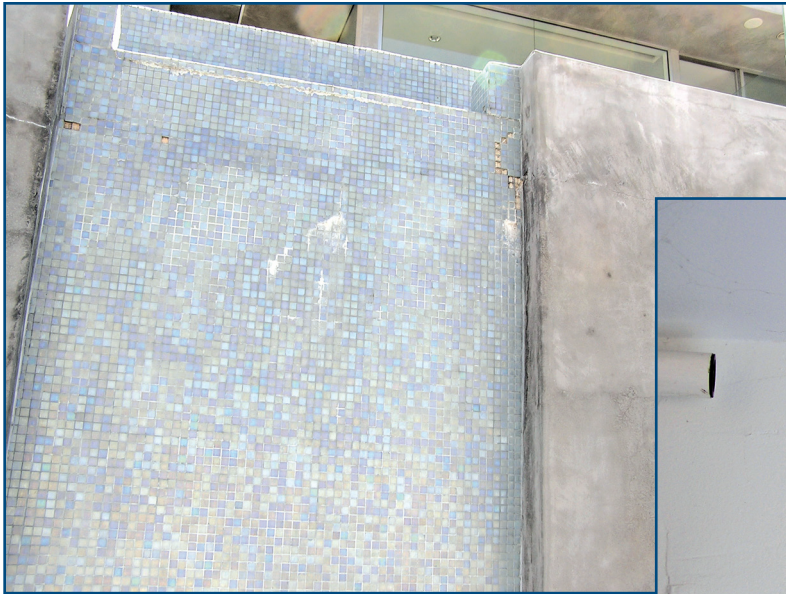
Figure 10 - Efflorescence and tile delamination due to water intrusion.

When the pool ultimately developed a leak, the water collected in the drainage layer had no ready means of egress. What resulted was a multitude of water penetrations into both interior and exterior spaces. Significant water intrusion with efflorescence developed in the exterior foundation walls, mosaic tile delaminated due to the water pressure, and water intrusion entered interior spaces, causing flooding, mold, and damage (Figures 10 through 13).

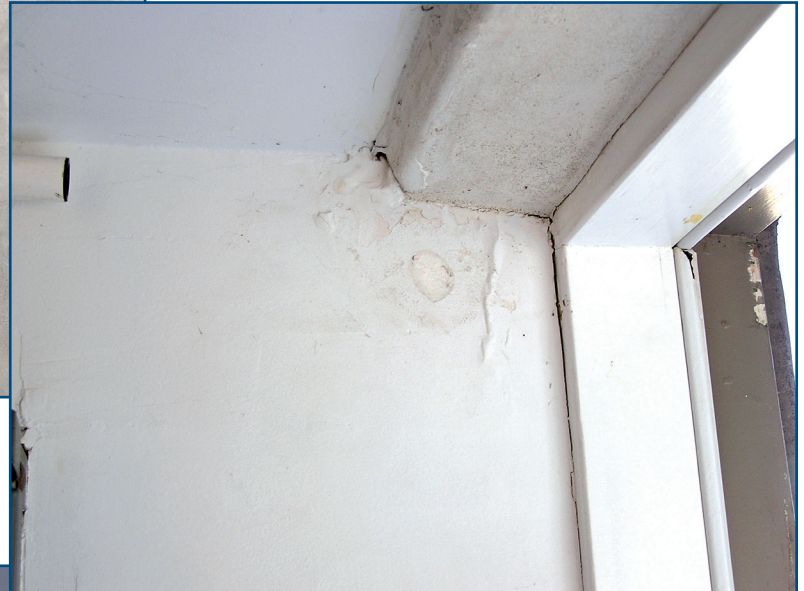
Figure 12 - Water leaking through residence utilities. Note the formation of stalactites from chronic leakage. The swimming pool is directly above this finished living space.

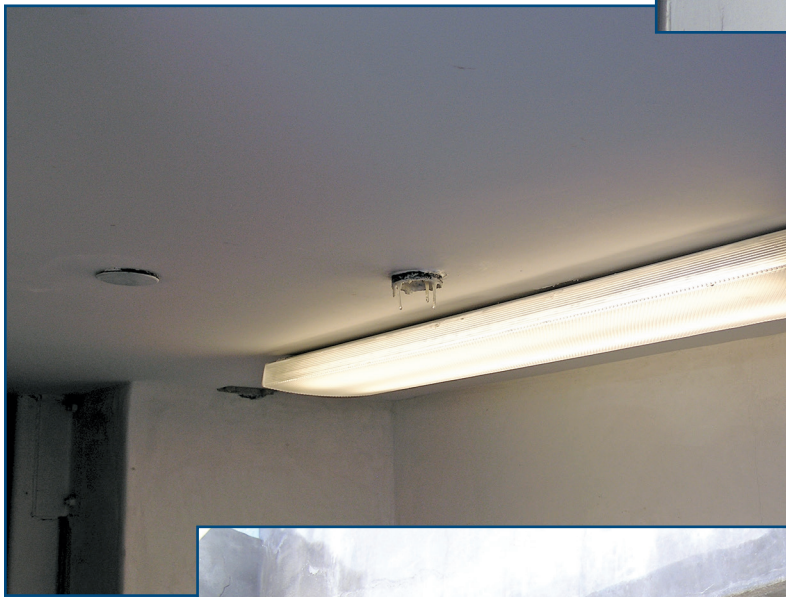
Figure 11 - Damaged finishes inside the residence.

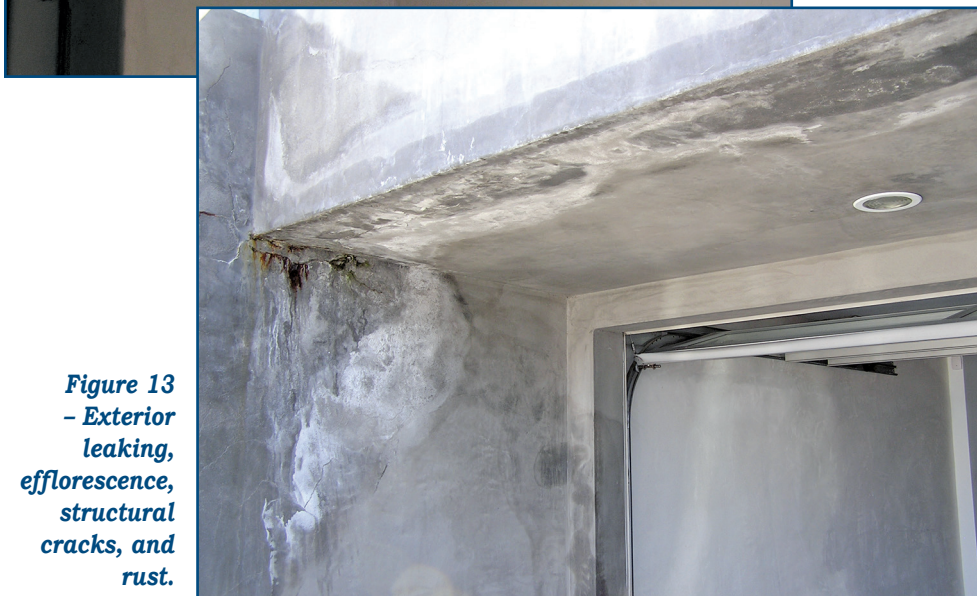
Figure 13 - Exterior leaking, efflorescence, structural cracks, and rust.

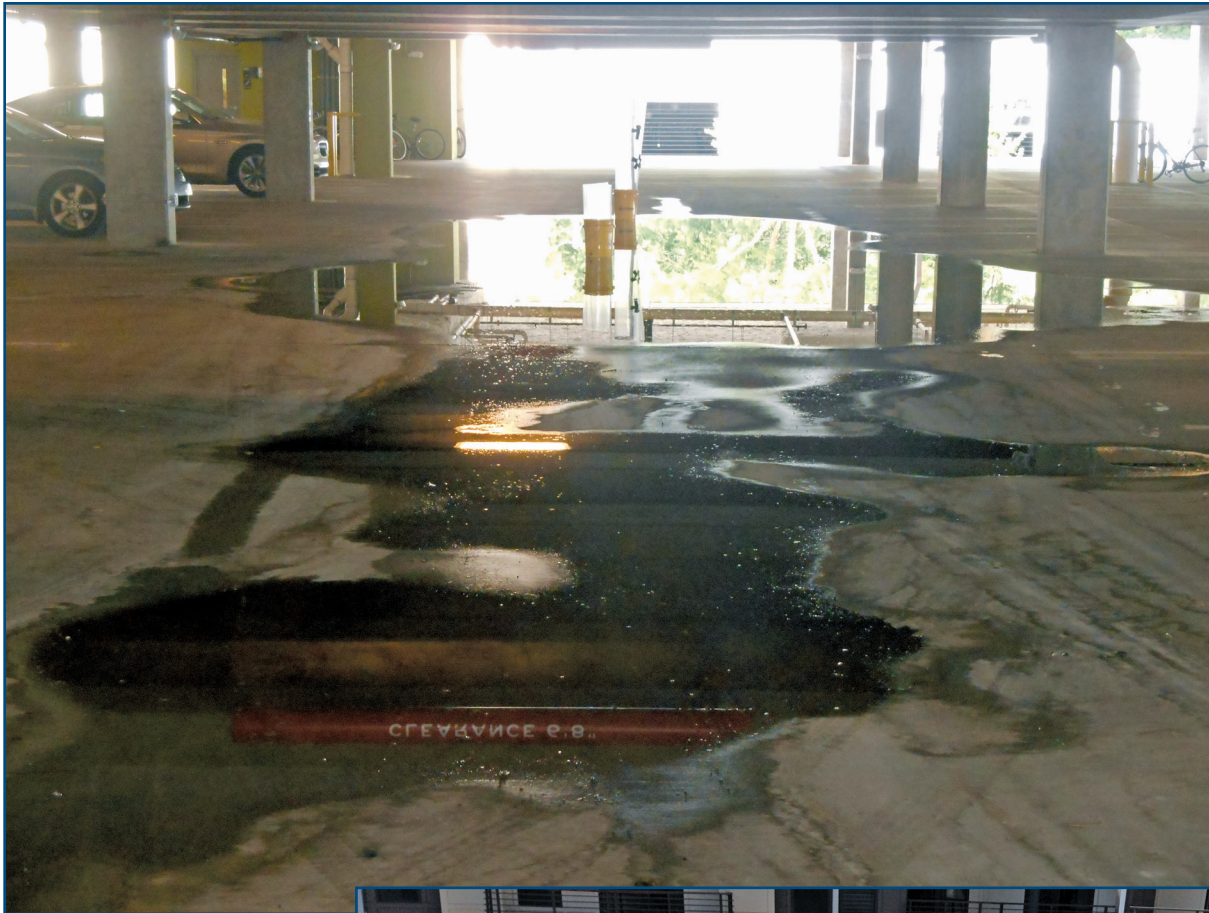
Figure 14 –
Water intrusion
into parking
structure.

The saltwater rooftop swimming pool was constructed above a parking deck at a high-end apartment complex located in Greenville, South Carolina. Water intrusion was occurring into the parking deck (Figure 14). Based upon existing construction photos and drawings received by the client, the surfaces of the vault were waterproofed with a fluid-applied waterproofing system (Figure 15). Within the vault, expanded polystyrene and wooden pour forms were used to create the shape of the pool. Shotcrete was installed into the vault over the expanded polystyrene shapes and prepared for the pool surface coating. The vertical wall for the vault slab extended slightly higher than the top surface of the vertical wall for the pool shape. It was observed that waterproofing did not continue across the

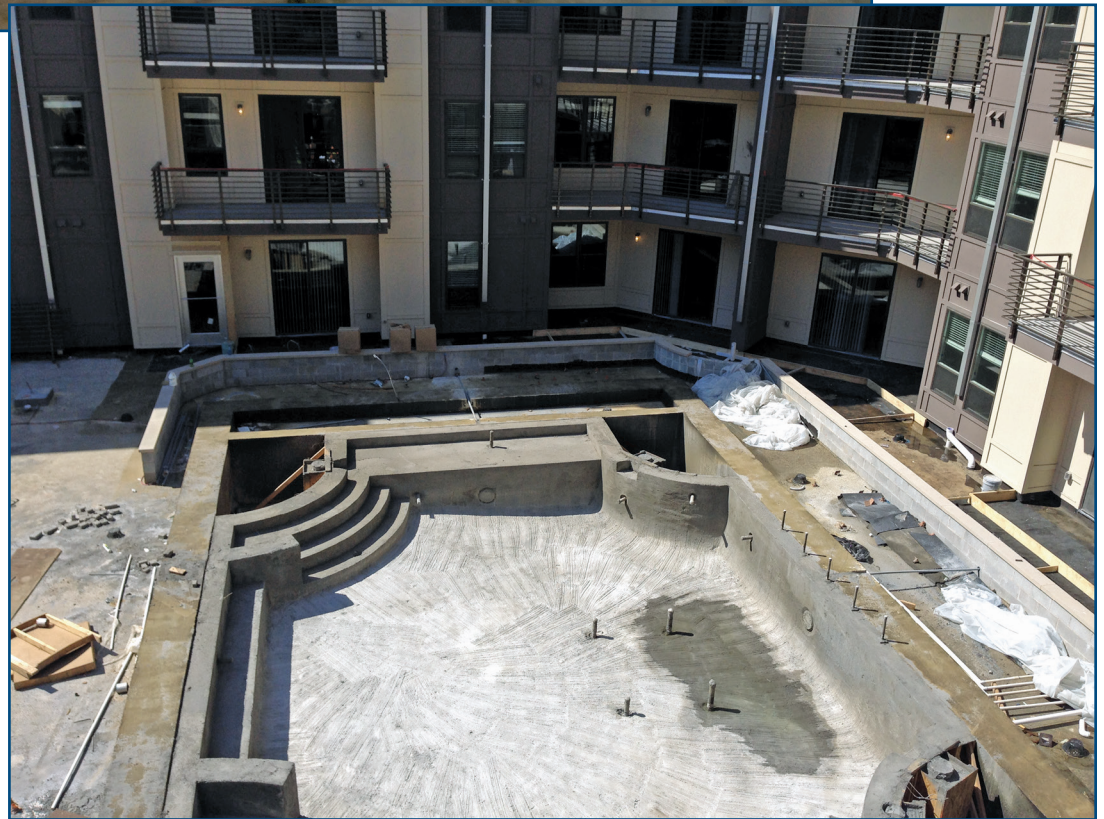
Figure 15 –
Overview of
pool during
construction.

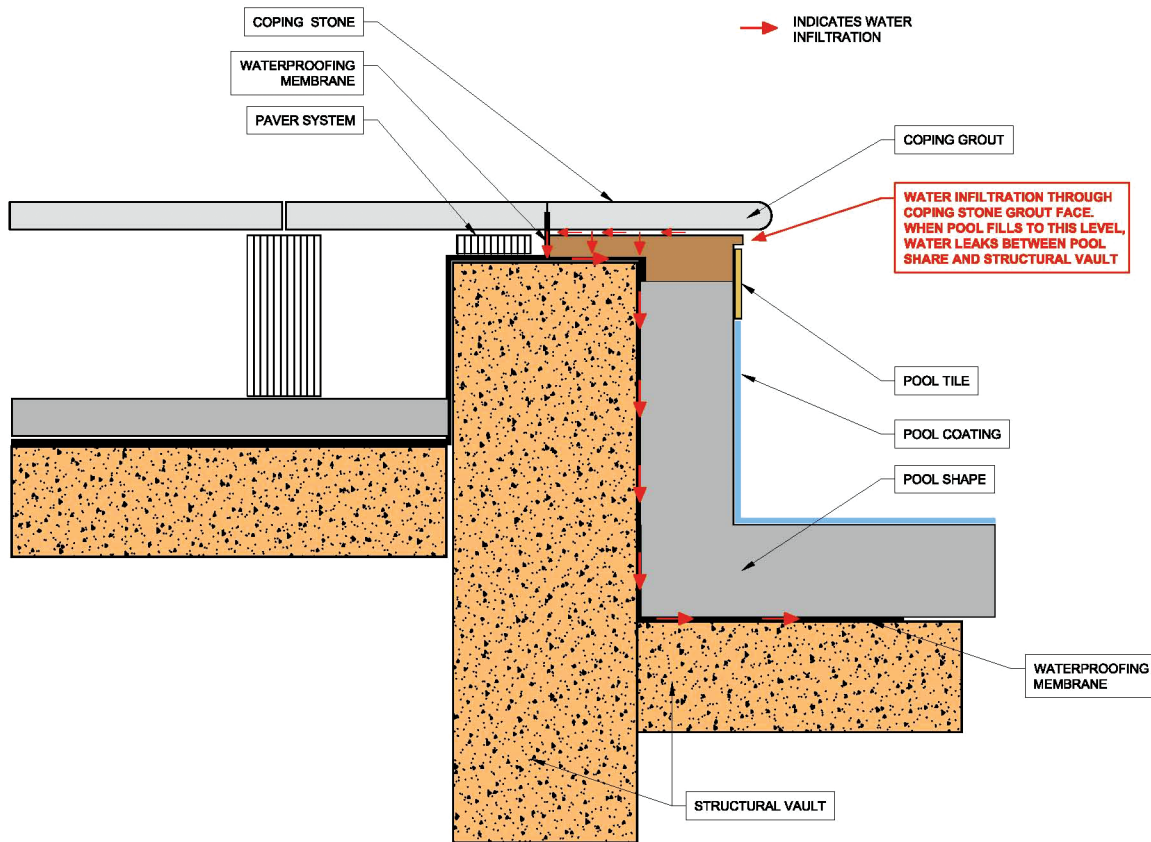
Figure 16 – Pool construction showing water infiltration.

The coping stone was removed, and it was discovered that the waterproofing was not continuous, resulting in water infiltration at the intersection of the pool wall and the

vault wall beneath the coping cap. Following the discovery, a continuous waterproofing system was applied beneath the coping stone, resulting in a significant reduction in the moisture intrusion experienced in the parking garage.
