Criteria for Restoration of Longitudinal Barriers, Phase II (2021)

Criteria for Restoration of Longitudinal Barriers, Phase II

Contractor's Final Report for NCHRP Project 22-28
Submitted June 2015

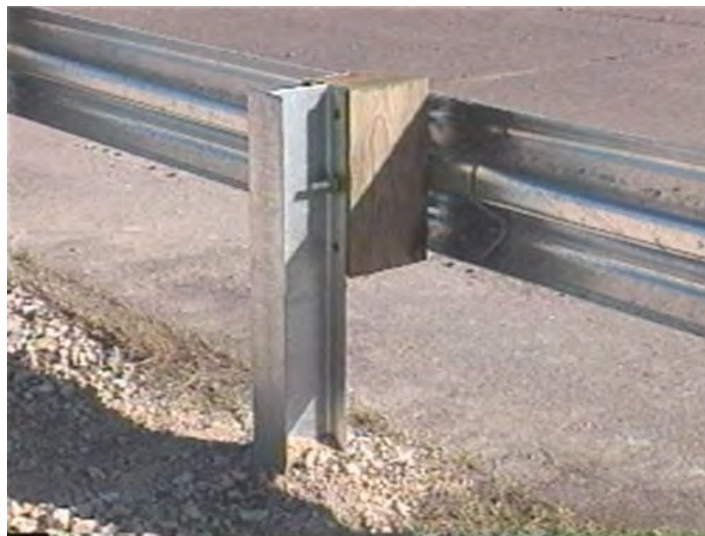
Figure 1. Modified G4(1S) with wood blockouts.[Bullard96]

A photo of the modified G4(1S) with routed wood blockouts is shown in Figure 1. This guardrail system was successfully crash tested at Texas Transportation Institute (TTI Test 405421-1) on November 16, 1995 under *NCHRP Report 350* Test 3-11 impact conditions.[*Bullard96*] A sequence of snapshots from the crash test video is shown in Figure 2.

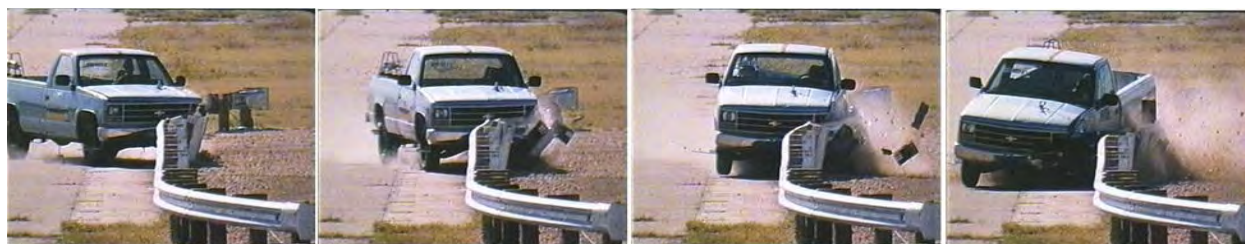
Figure 2. Sequential views of Crash Test 405421-1.[Bullard96]

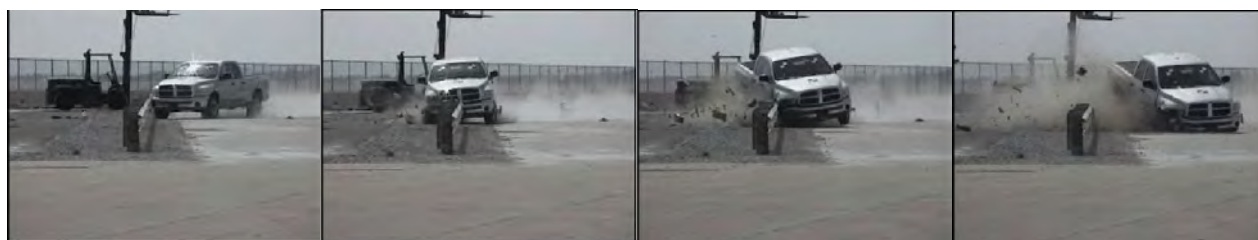
Figure 3. Sequential views of Crash Test 2214-WB2.[Polivka06b]

The modified G4(1S) with wood blockouts was also successfully tested under *MASH* Test 3-11 impact conditions on April 8, 2005 at the Midwest Roadside Safety Facility (MwRSF). A sequence of snapshots from the test video from Test 2214-WB2 is shown in Figure 3. In an earlier test, 2214-WB1, which was conducted under test conditions very similar to the *MASH* Test 3-11 requirements, the system failed to safely contain and redirect the vehicle.[*Polivka06a*] The standard test vehicle for *MASH* Test 3-11 is the 2270P, which is a 5,000-lb ½-ton quad-cab pickup. The test vehicle used in Test 2214-WB1 was a 5,000-lb ¾-ton standard cab pickup. During Test 2214-WB1, the rail ruptured at a w-beam splice connection allowing the vehicle to penetrate behind the system. A sequence of snapshots from the test video for Test 2214-WB1 is shown in Figure 4. The failed test caused many in the roadside safety community to wonder if the modified G4(1S) was being tested very close to its performance limit if a slightly different (but still common) vehicle type resulted in a failed test. This led to the development of the Midwest Guardrail System (MGS) and other 31-inch w-beam guardrails.

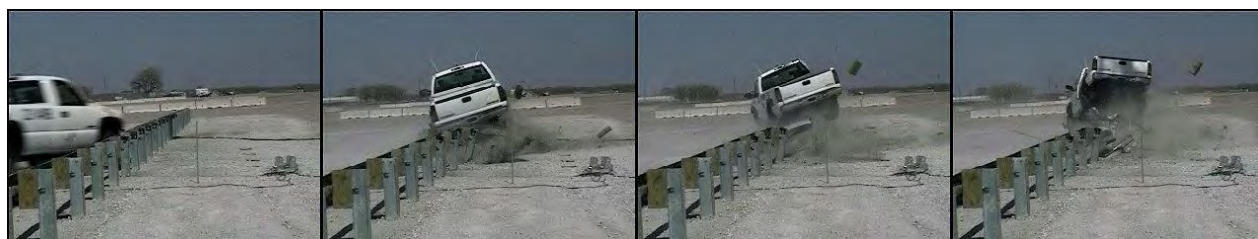
Figure 4. Sequential views of Crash Test 2214-WB1.[Polivka06b]

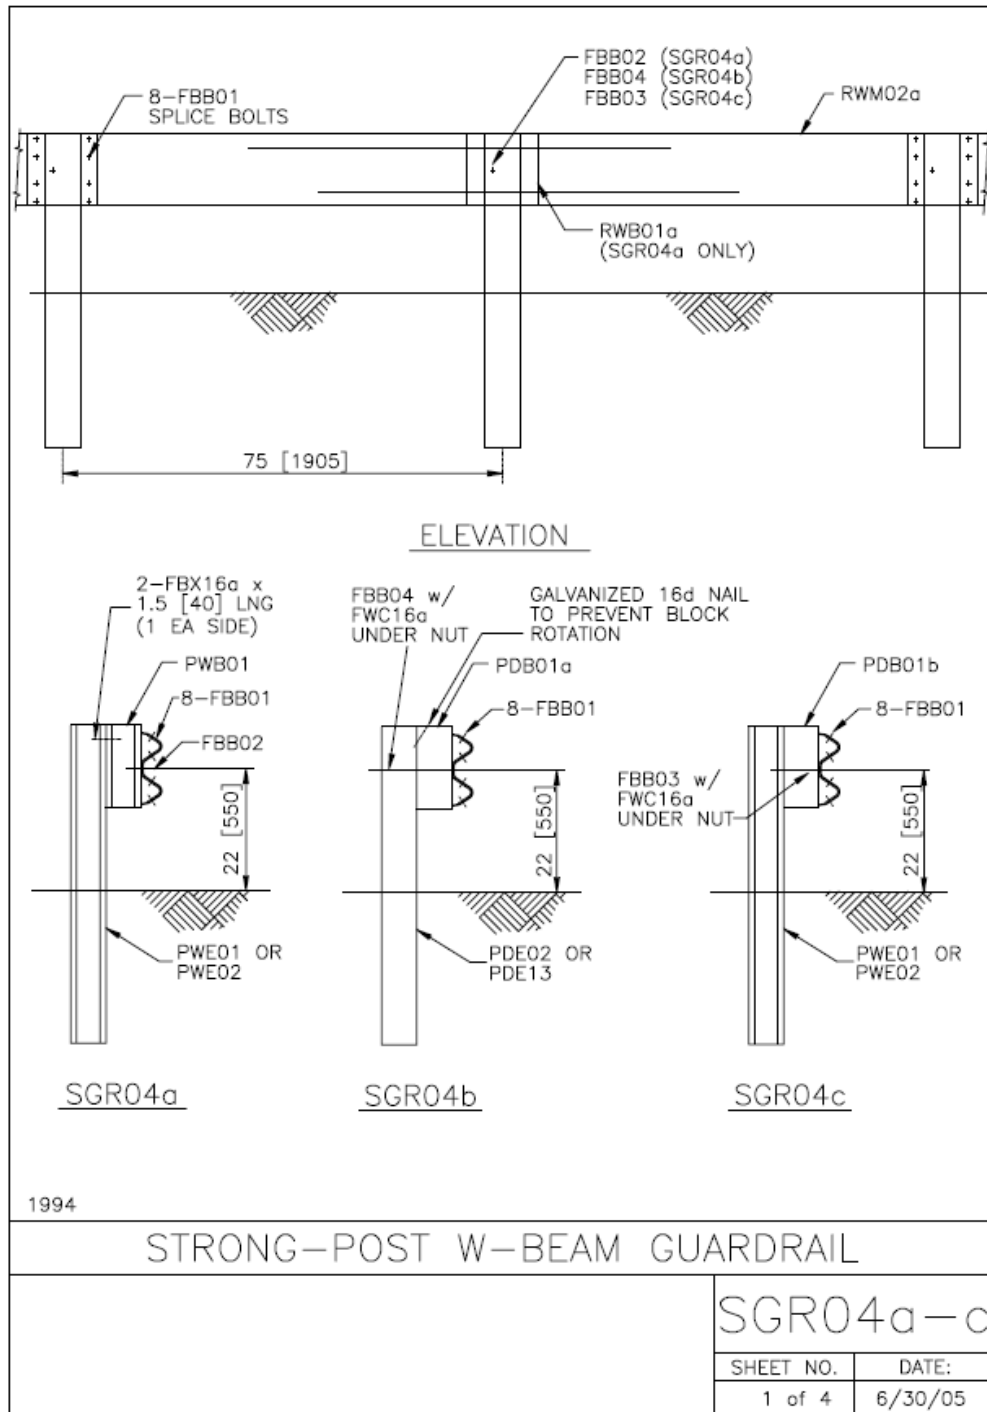
Figure 5. Drawing of the strong-post w-beam guardrail (SGR04a-c).

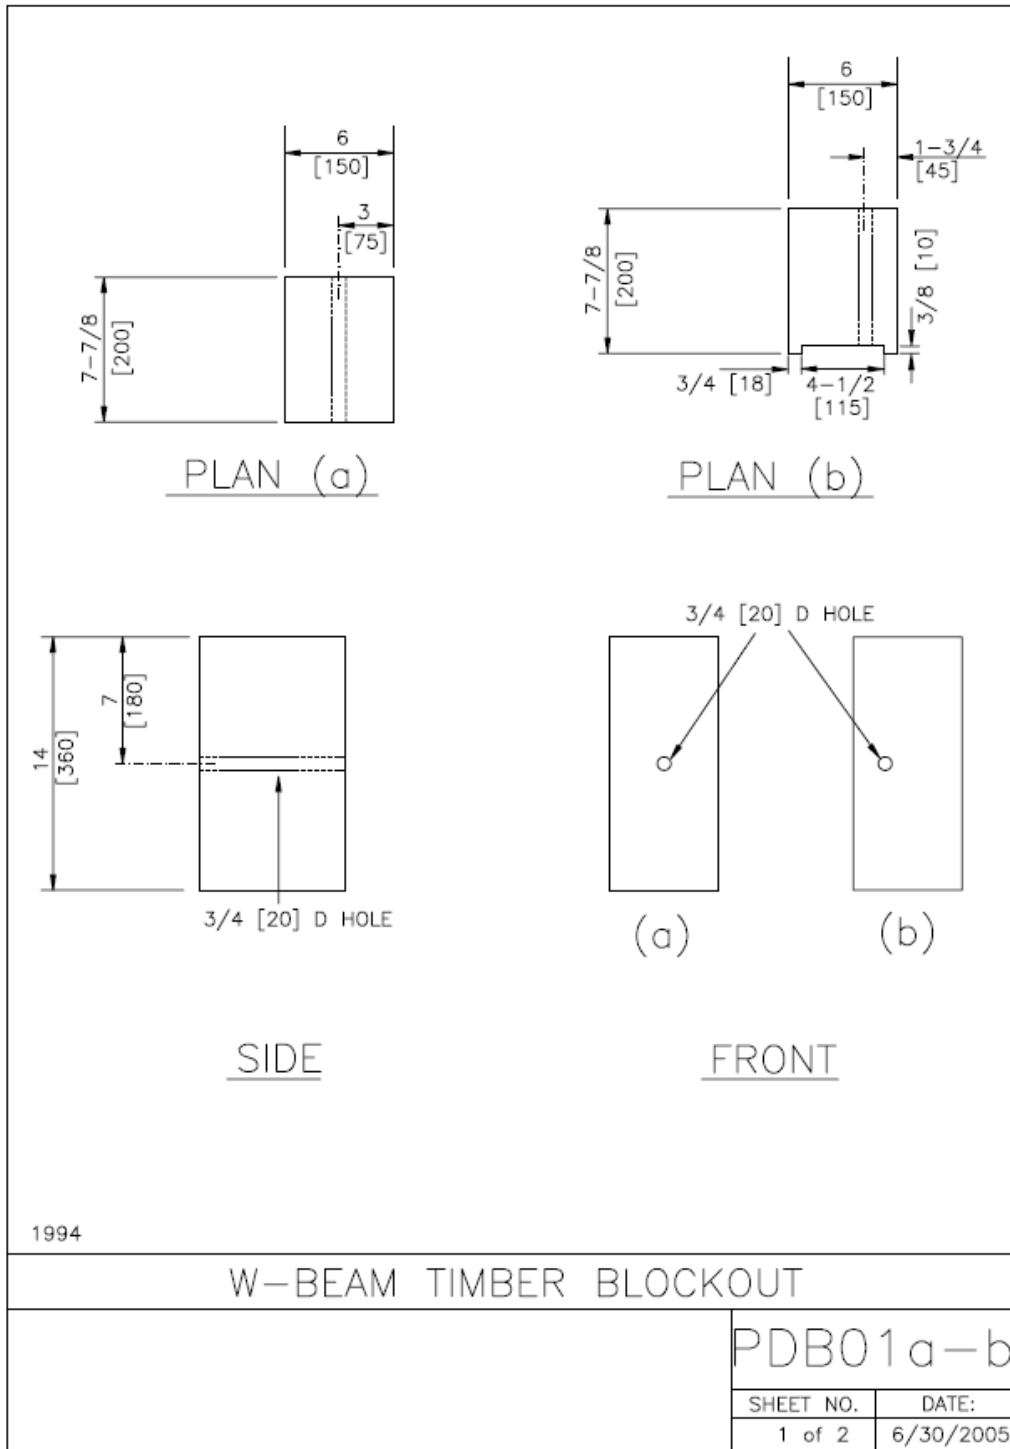
Figure 6. Drawing of the 8-inch wood blockout for the modified G4(1S) with wood blockout guardrail (PDB01b).

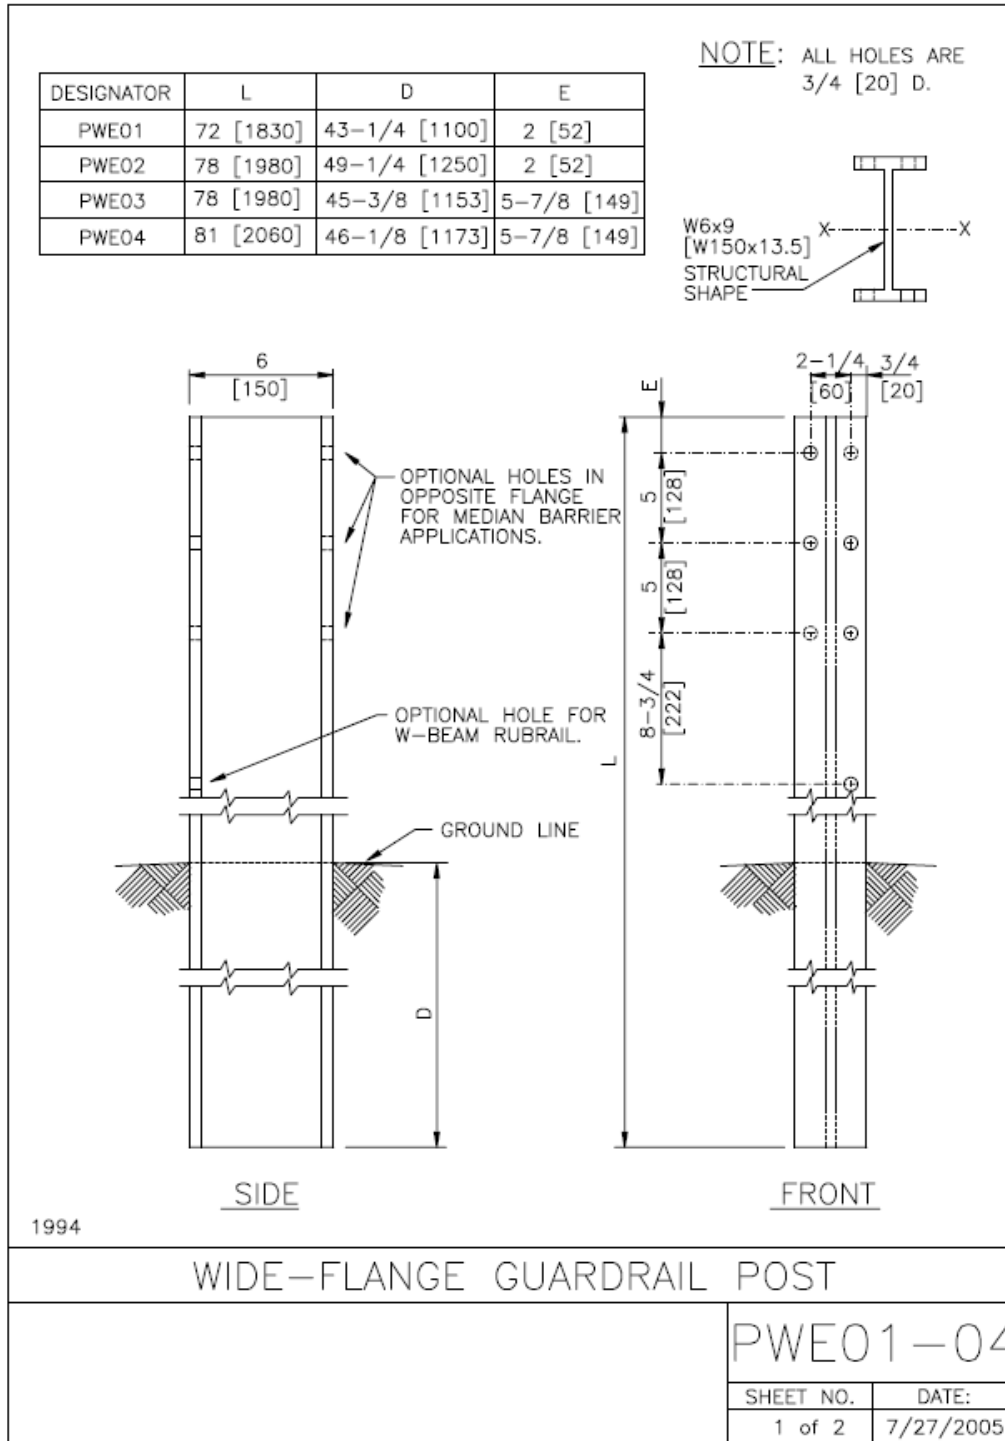
Figure 7. Drawing of the W6x9 guardrail post (PWE01).

The Modified G4(1S) with routed wood blockouts is constructed with 6-ft long W6x9 steel guardrail posts spaced at 6 feet- 3 inches center-to-center; the 12-gauge w-beam rail is offset 8 inches from the posts using routed wood blockouts with dimensions 6 x 8 x 14 inches. The w-beam and blockout are fastened to the post using a 5/8-inch diameter bolt 10 inches long. Drawings for the system (i.e., AASHTO-AGC-ARTBA designator SGR04c) are shown in Figure 5. (AASHTO-AGC-ARTBA designator SGR04c), drawings of the blockout are shown in Figure 6 (PDB01b), drawings of the post are shown in Figure 7 (PWE01), and drawings of the rail-to-post fastener are shown in Figure 8 (FBB03).

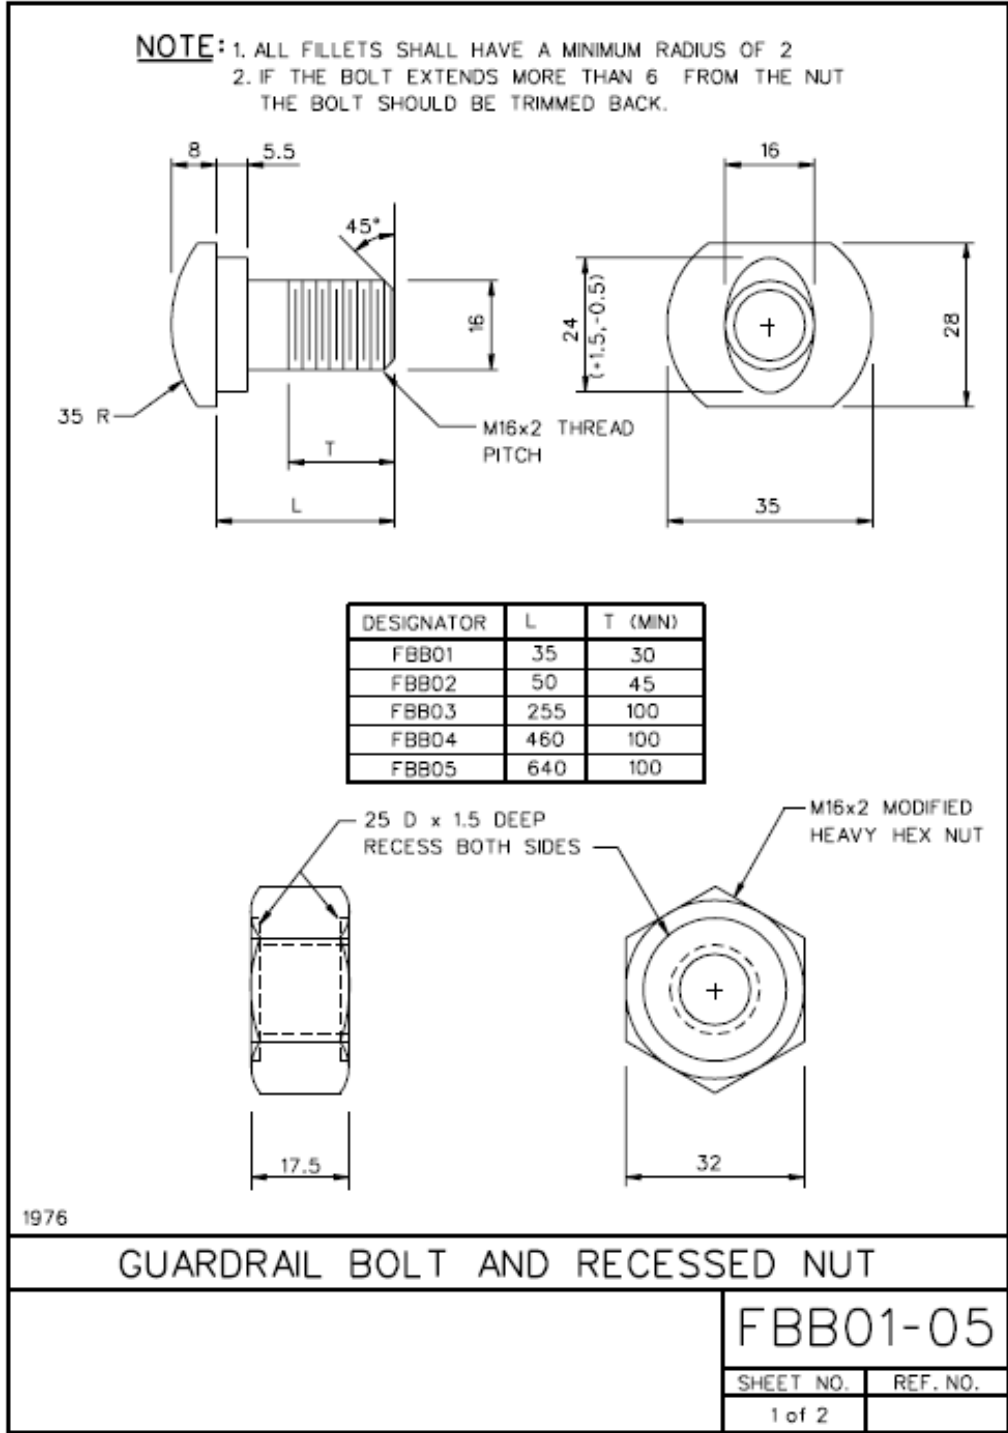
Figure 8. Drawing of the bolt used to fasten the rail element to guardrail posts.

The G4(2W) guardrail is constructed with 6x8-inch rectangular timber posts spaced at 6 feet- 3 inches center-to-center; the 12-gauge w-beam rail is offset 8 inches from the posts using wood blockouts with dimensions 6 x 8 x 14 inches. The w-beam and blockout are fastened to the post using a 5/8-inch diameter bolt 18 inches long. A photo of the G4(2W) guardrail is shown in Figure 9. Drawings for the system are shown in Figure 5 (SGR04b), drawings of the blockout are shown in Figure 6 (PDB01a), drawings of the post are shown in Figure 12 (PDE01 and PDE02), and drawings of the rail-to-post fastener are shown in Figure 8 (FBB04).

The G4(1W) guardrail is constructed with 6-ft long, 8x8-inch rectangular timber spaced at 6 feet- 3 inches center-to-center; the 12-gauge w-beam rail is offset 8 inches from the posts using wood blockouts with dimensions 8 x 8 x 14 inches. The w-beam and blockout are fastened to the post using a 5/8-inch diameter bolt 18 inches long. Drawings of the G4(1W) guardrail system are shown in Figure 5(SGR04b), drawings of the blockout are shown in Figure 6 (PDB01a), drawings of the post are shown in Figure 12 (PDE05), and drawings of the rail-to-post fastener are shown in Figure 8 (FBB04).

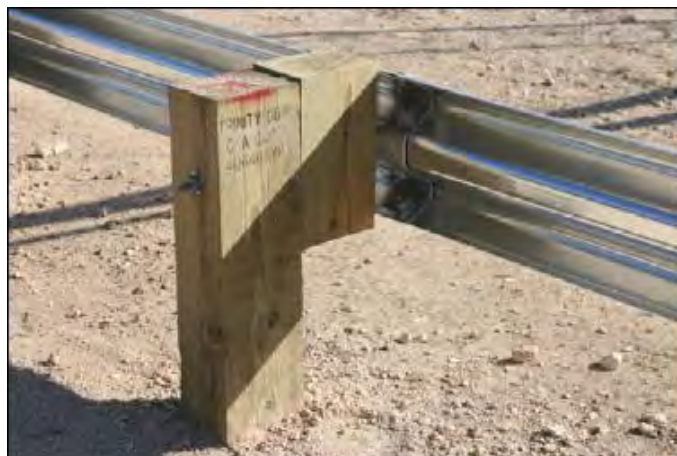
Figure 9. Photo of the G4(2W) guardrail Test 476460-1-5 test installation.[*Bullard10*]

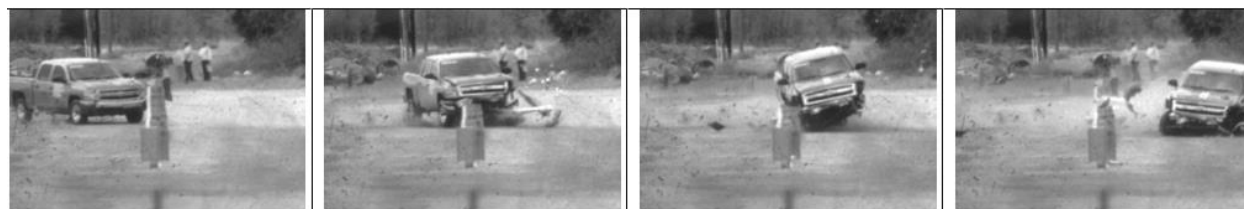
Figure 11. Sequential views of full-scale crash Test RF476460-1-5.[*Bullard10*]

The G4(2W) was also tested (Test RF476460-1-5) under MASH test conditions, in which the guardrail ruptured at a splice connection allowing the vehicle to penetrate behind the guardrail.[Bullard10] Test RF476460-1-5 was conducted at the Transportation Research Institute on March 4, 2009. In this case, the posts were 72 inches long with an embedment depth of 44 inches. A sequence of snapshots from the test video is shown in Figure 11.

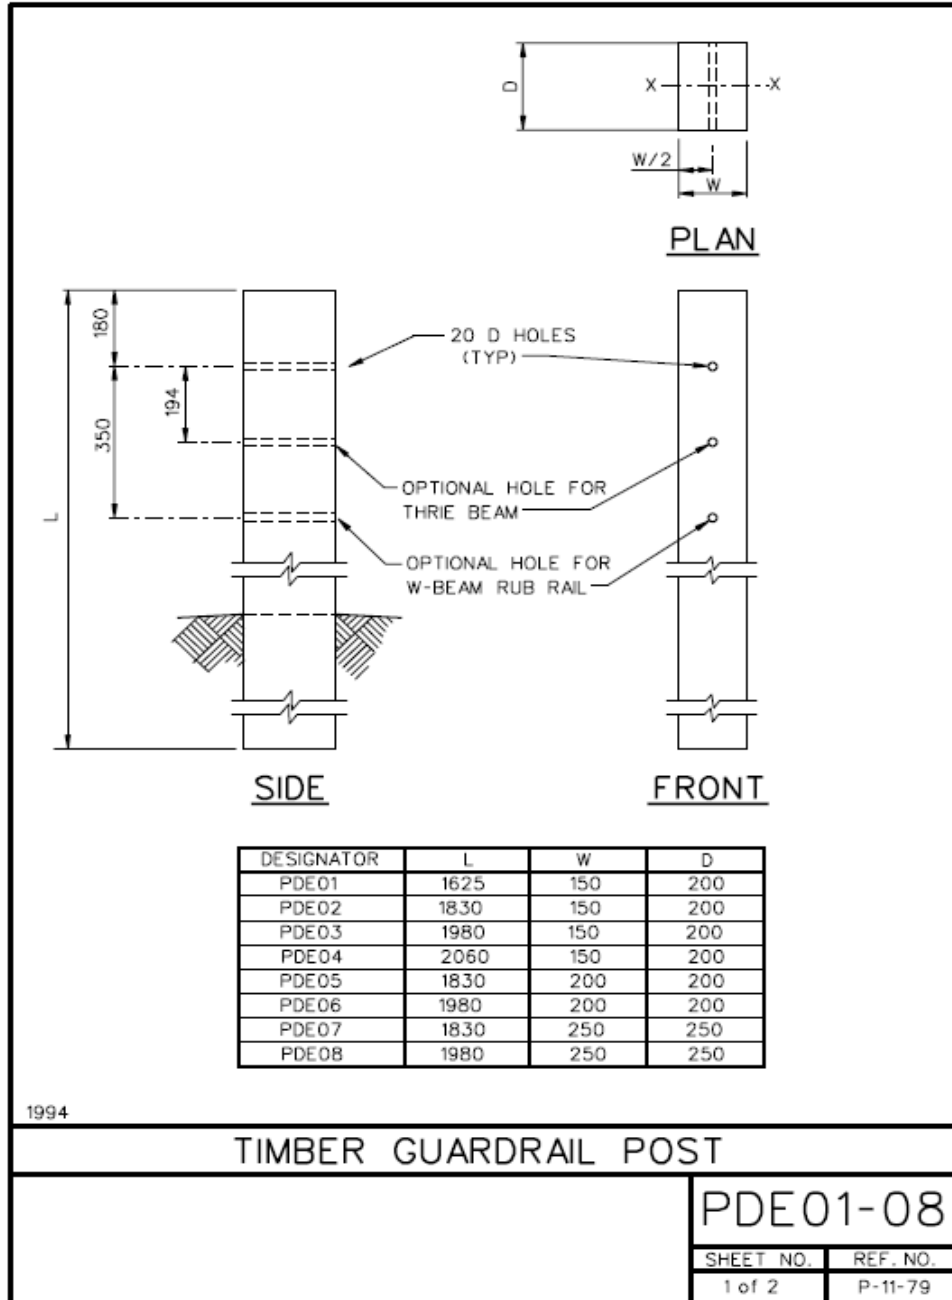
Figure 12. Drawing of the rectangular wood post used in the G4(2W) and G4(1W) guardrail systems (i.e., AASHTO designator SGR04b).

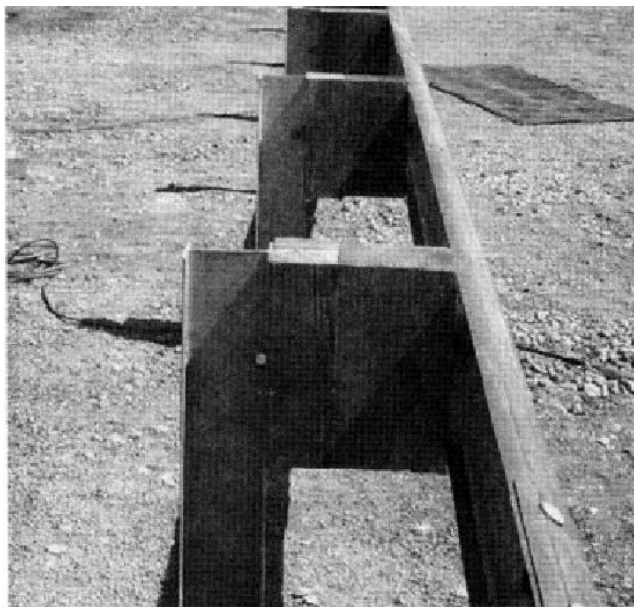
Figure 13. Photo of the MGS guardrail system. [Sicking02]

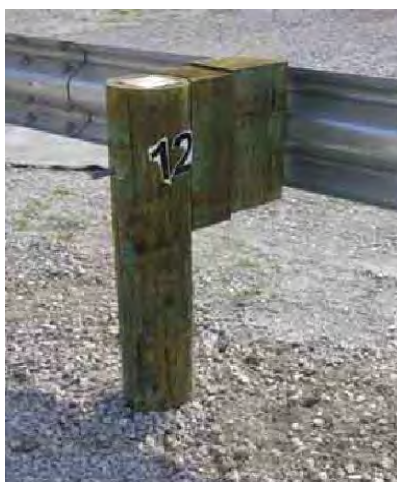
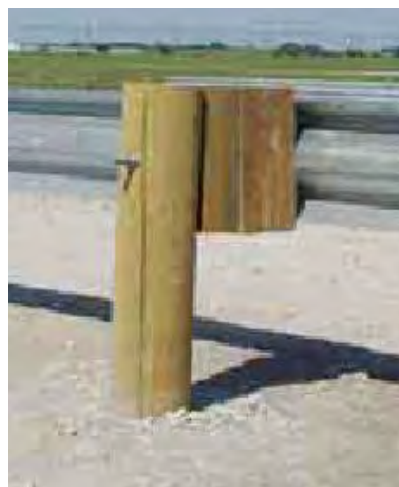
(a) 7.25-in. dia. Douglas Fir

(b) 8-in. dia. Ponderosa Pine

Figure 14. MGS with (a) 7.25-inch diameter round Douglas Fir posts and (b) 8-inch diameter round Ponderosa Pine posts.

The MGS with round wood posts has also been successfully crash tested at the Midwest Roadside Safety Facility. [Hascal07] Two full-scale crash tests were performed to evaluate system performance according to the testing and evaluation requirements of *NCHRP Report 350* Test 3-11. Test MGSDF-1 used guardrail posts made from 7.25-inch diameter Douglas Fir, and Test MGSDF-2 used guardrail posts made from 8-inch diameter Ponderosa Pine. The test results showed that the MGS functioned adequately with posts made from either species. Photographs of the guardrail system with Douglas Fir and Ponderosa Pine are shown in Figure 14. A sequence of snapshots from the test videos are shown in Figure 15 and Figure 16.

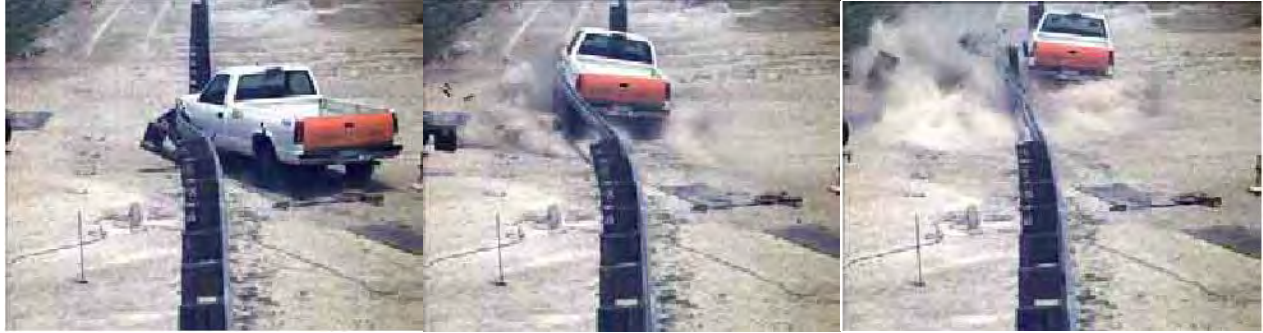
Figure 15. Test MGSDF-1 of the MGS guardrail with 7.25-inch diameter Douglas Fir posts. [Hascal07]

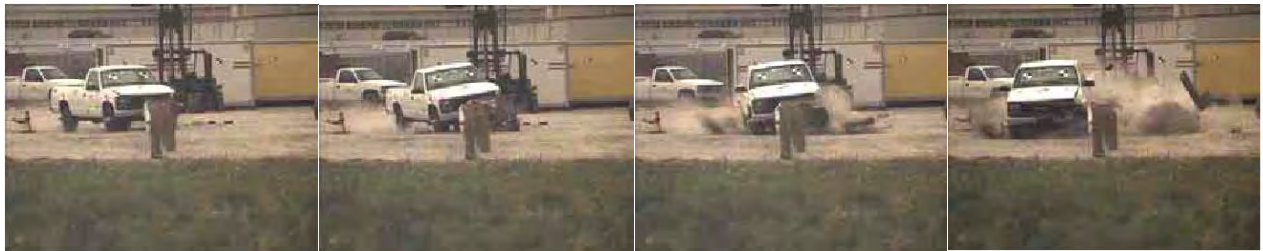
Figure 16. Test MGSPP-1 of MGS with 8-inch diameter Ponderosa Pine posts. [Hascal07]

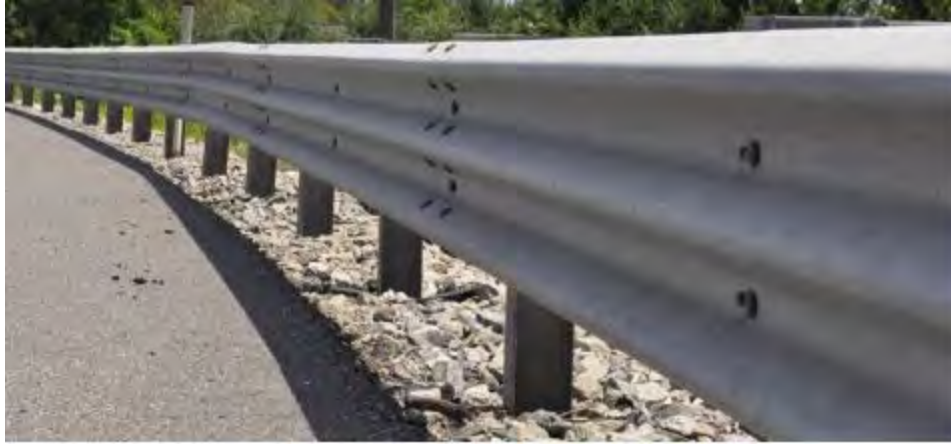
Figure 17. Photo of the standard three-beam guardrail (G9; SGR09a)

A photo of the G9 guardrail is shown in Figure 17. The G9 system was crash tested at Texas Transportation Institute (TTI Test 471470-31) on April 14, 1995 under *NCHRP Report 350* Test 3-11 impact conditions.[Mak99] The system failed to meet the safety requirements of Report 350. A sequence of snapshots from the crash test video is shown in Figure 18. “After the vehicle exited the installation, it rolled two and a quarter revolutions and came to rest on its left side 138 feet downstream of the impact point.”

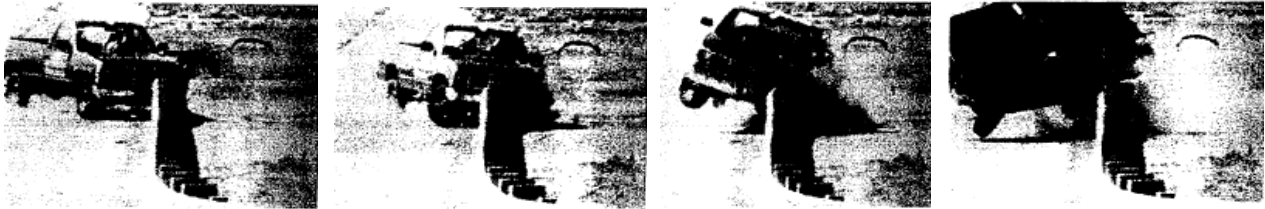
Figure 18. Sequential photos of Test 471470-31 on the G9 three-beam guardrail. [Mak99]

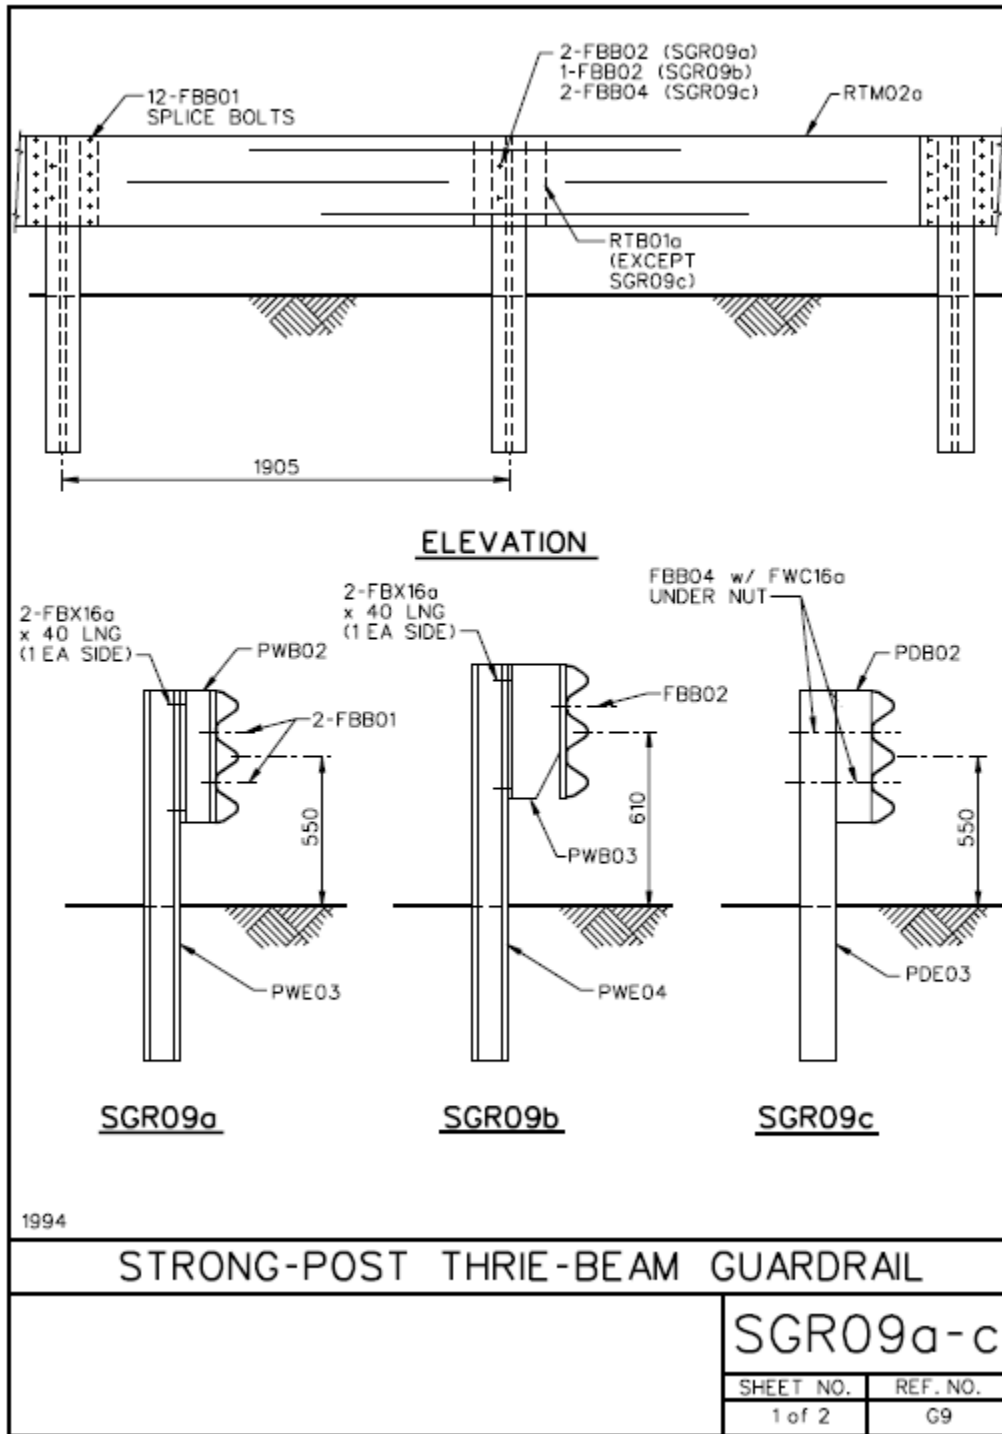
Figure 19. AASHTO-AGC-ARTBA drawings for the SGR09 guardrail systems. [AASHTO04]

inch diameter button-head guardrail bolts (FBB02). The blackout is fastened to the posts using two 5/8-inch diameter hex bolts (FBX16a). Drawings for the system (i.e., AASHTO-AGC-ARTBA designator SGR09b) are shown in Figure 19, drawings of the blackout are shown in Figure 26, drawings of the post are shown in Figure 7 (PWE04), and drawings of the rail-to-blackout fastener are shown in Figure 8 (FBB02)¹.

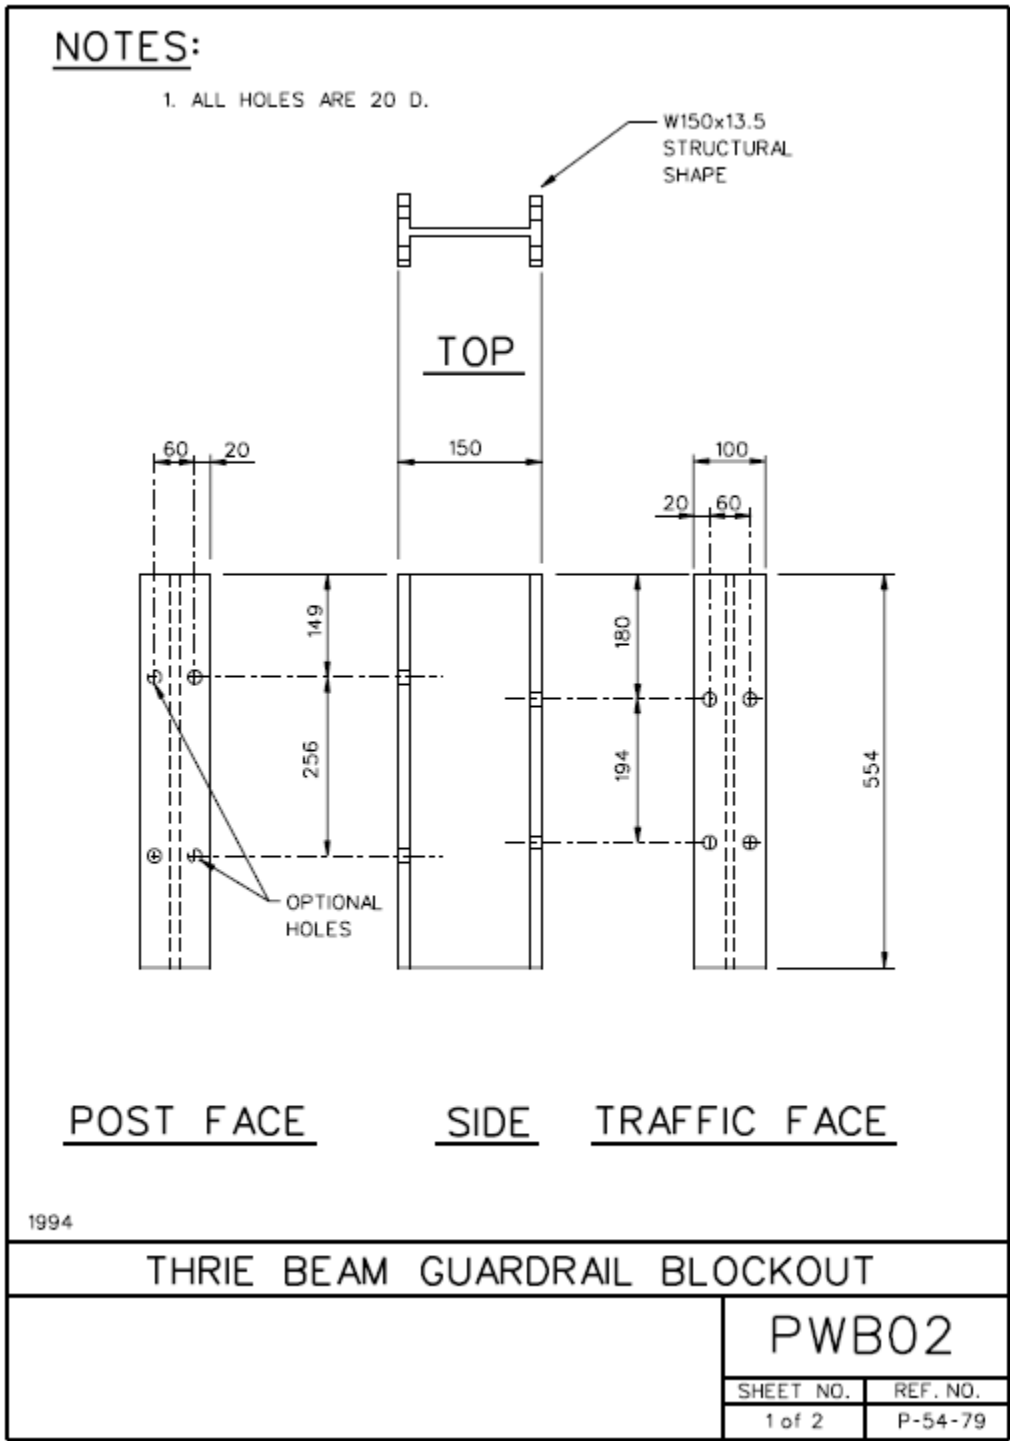
Figure 20. AASHTO-AGC-ARTBA drawings for the W6x9 steel blockout for the G9 thrie-beam guardrail.[AASHTO04]

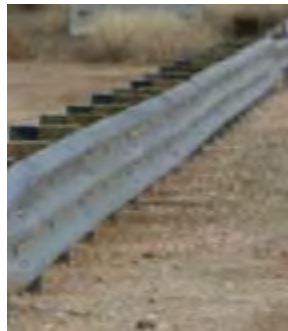
Figure 21. Photo of the thrie-beam guardrail with routed wood blockouts. [*Bullard10*]

A photo of the guardrail system is shown in Figure 21. The system was successfully crash tested at Texas Transportation Institute (TTI Test 476460-1-8) on February 26, 2009 under MASH Test 3-11 impact conditions.[*Bullard10*] However, the vehicle appeared to be very unstable upon exiting the guardrail, as shown in the sequential photos of the full-scale test in Figure 22.

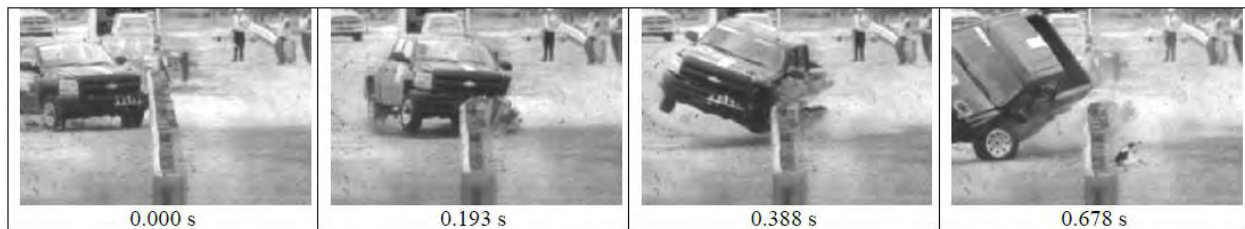
Figure 22. Sequential photos for Test 476460-1-8 on the thrie-beam guardrail with routed wood blockouts (MASH Test 3-11).[*Bullard10*]

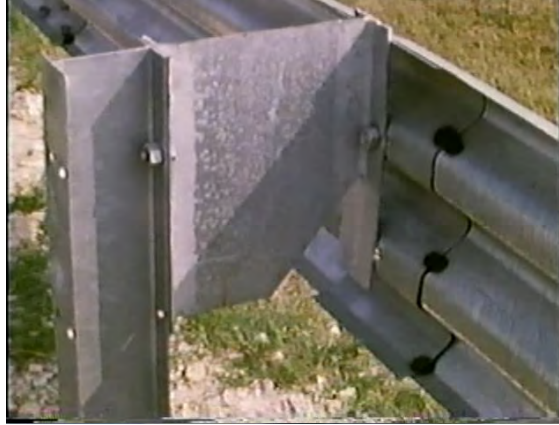
Figure 23. Photo of the modified three-beam guardrail (SGR09b).

A photo of the modified three-beam guardrail is shown in Figure 23. The guardrail system was successfully crash tested at Texas Transportation Institute (TTI Test 471470-30) on January 1, 1995 under NCHRP Report 350 Test 3-11 impact conditions. [Mak99] A sequence of

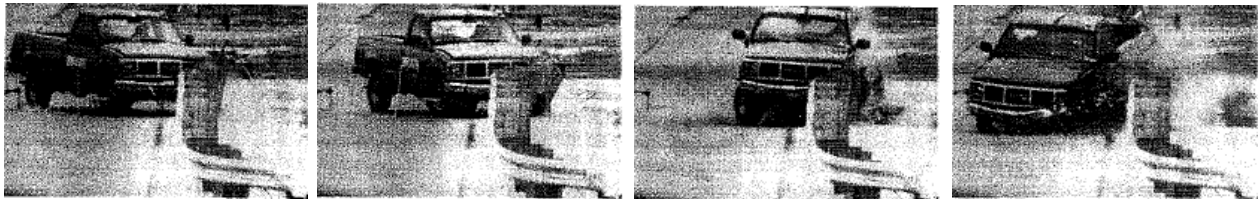
Figure 24. Sequential photos for Test 471470-30 on the modified three-beam guardrail (SGR09b) under NCHRP Report 350 Test 3-11 conditions. [Mak99]

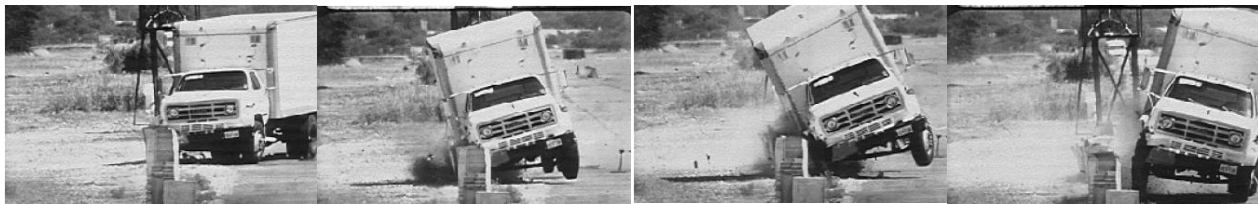
Figure 25. Sequential photos for Test 404211-5a on the modified three-beam guardrail under NCHRP Report 350 Test 4-12 conditions. [Buth99c]

snapshots from the crash test video is shown in Figure 13. The system was also successfully crash tested on June 12, 1998 at the Texas Transportation Institute with the 18,000-lb single unit truck according to *NCHRP Report 350* Test 4-12 test conditions.[*Buth99c*] A sequence of snapshots from the crash test video is shown in Figure 25.

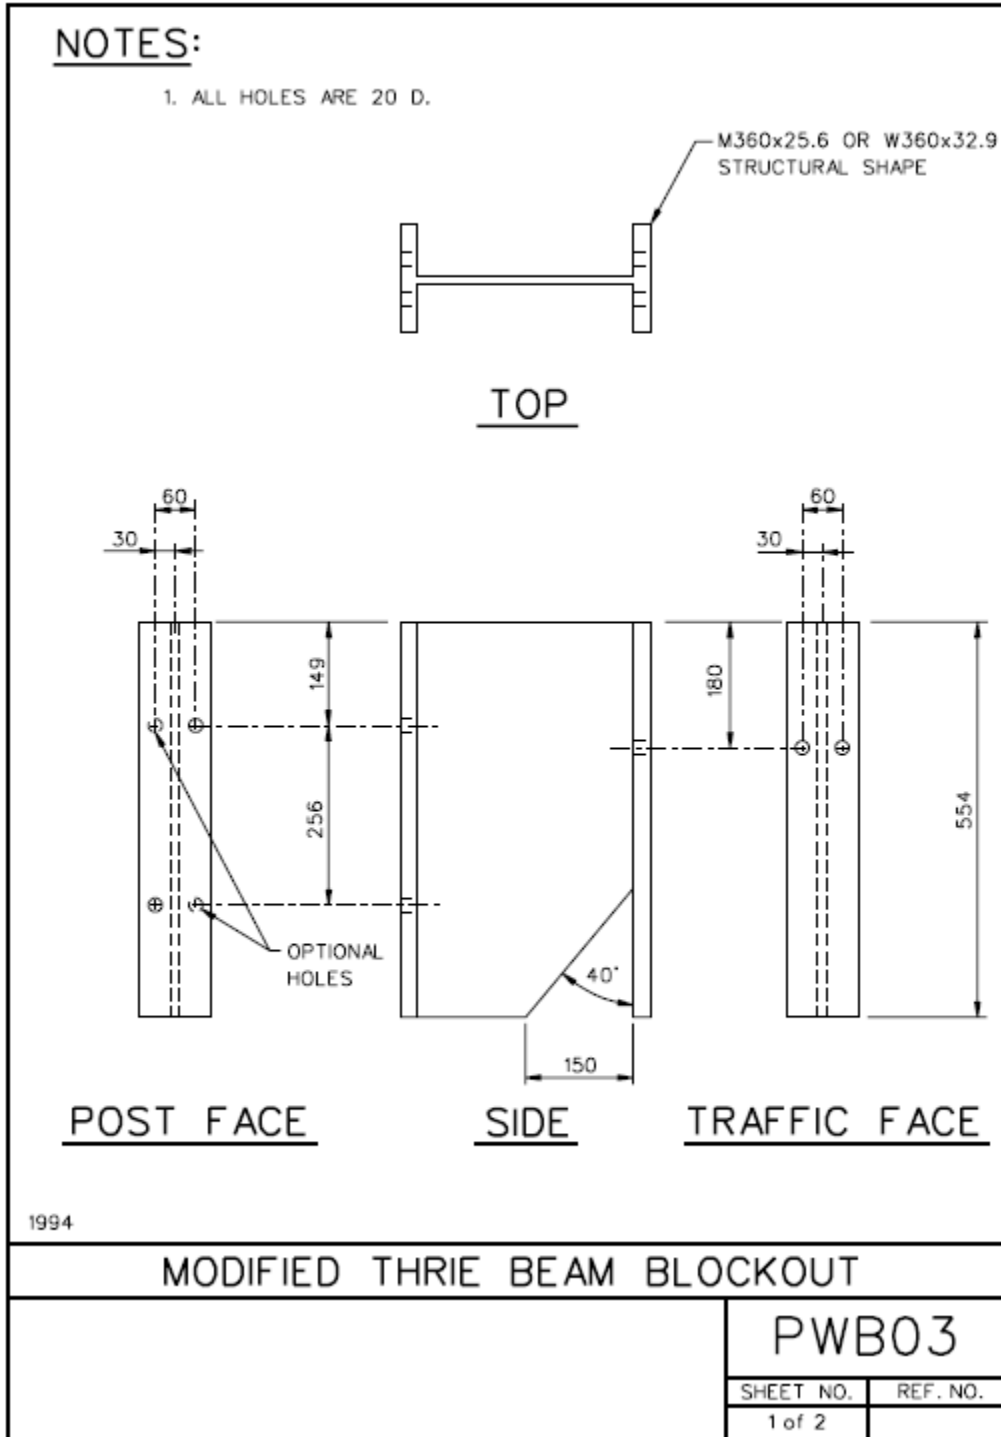
Figure 26. AASHTO-AGC-ARTBA drawings for the M14x17.2 steel blockout for the modified thrie-beam guardrail.[AASHTO04]

The 14-inch depth of the M14x17.2 creates a greater separation between the rail and post (e.g., 8 inches deeper than the SGR09a); while the cutout at the bottom of the web allows the lower section of the rail to deflect inward during impact and helps to keep the face of the rail vertical as the posts rotate back in collisions.

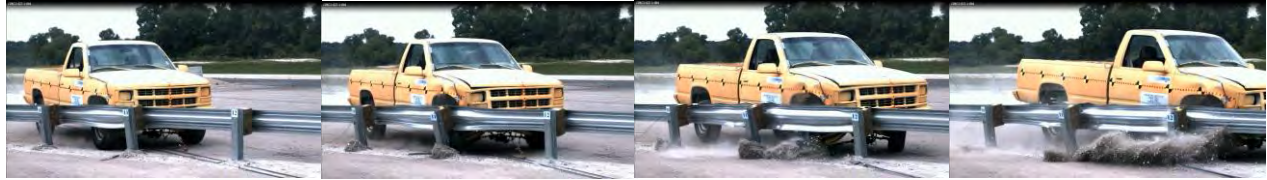
Figure 27. Low-speed Test C08C3-027.1 on the modified G4(1S) with routed wood blockouts. [Fleck08]

The low speed test (i.e., Test C08C3-027.1) was conducted by MGA Research Corporation on August 6, 2008.[*Fleck08*] The test involved a 4,632-lb $\frac{3}{4}$ -ton pickup impacting the undamaged guardrail at 30 mph and 26 degrees. The impact point was 23.27 inches upstream of post 11. The test installation, including end-terminals, was 162.4 ft. long. A sequence of photographs from the crash event is shown in Figure 27. The results of the low-speed test provide information regarding the types and magnitude of damage that can commonly be expected in low-speed collisions with this and similar guardrail types.

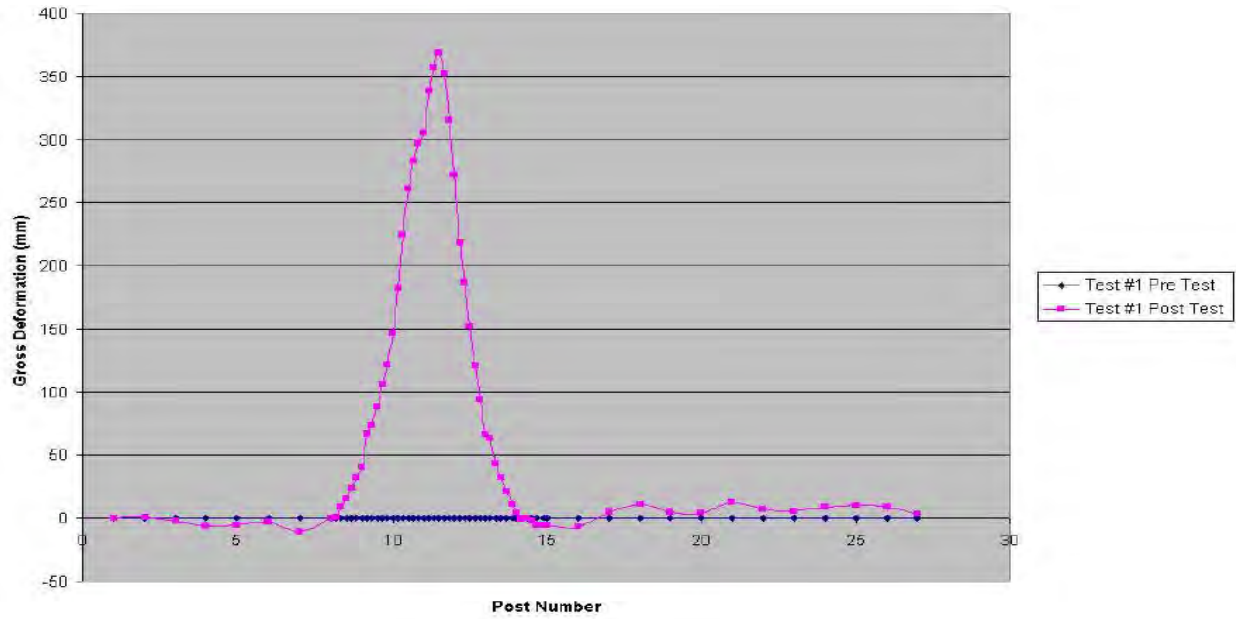
Figure 28. Barrier deflections recorded after Test C08C3-027.1. [Fleck08]

The deflection of the guardrail was recorded and is shown in Figure 28. Rail and post deflections were the primary damage modes resulting from the impact. There were no torsional deformations of any of the posts, no twisted blocks, nor rail tears, and no significant damage to the splice connection (other than rail bending), as shown in Figure 29.

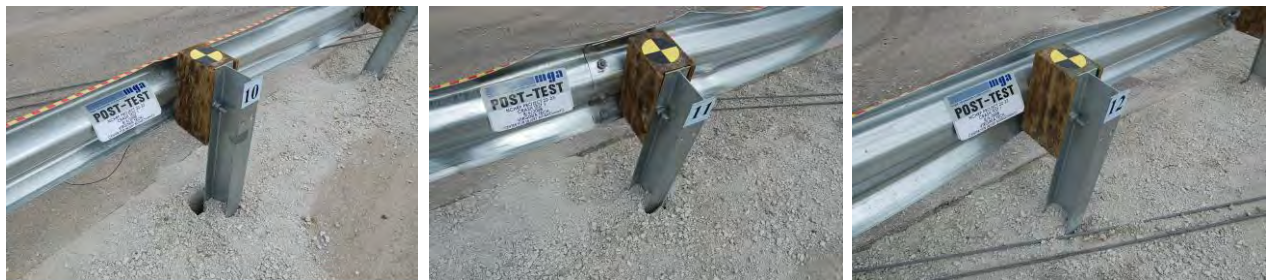
Figure 29. Guardrail damage in Test C08C3-027.1. [Fleck08]

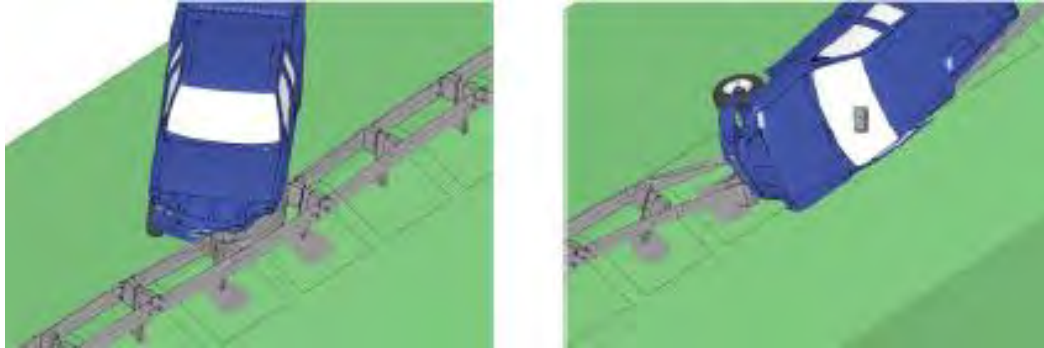
Figure 30. Example of pocketing during a simulated impact with a w-beam median barrier. [Fang10]

Pocketing is the crash event in which the impacting vehicle causes a large deflection in a relatively low-stiffness section of a guardrail upstream and adjacent to a relatively high-stiffness section of the guardrail, which forms a “pocket” shape in the rail. For strong-post w-beam guardrails, this phenomenon occurs when the w-beam rail experiences relatively high lateral deflections in the span between guardrail posts, as shown in Figure 30. As the vehicle approaches the downstream end of the pocket, the rail element tends to bend around the post. This generally causes high stress concentrations in the rail element at the post location, particularly when a splice connection exists at that post, and often results in rupture of the rail element.

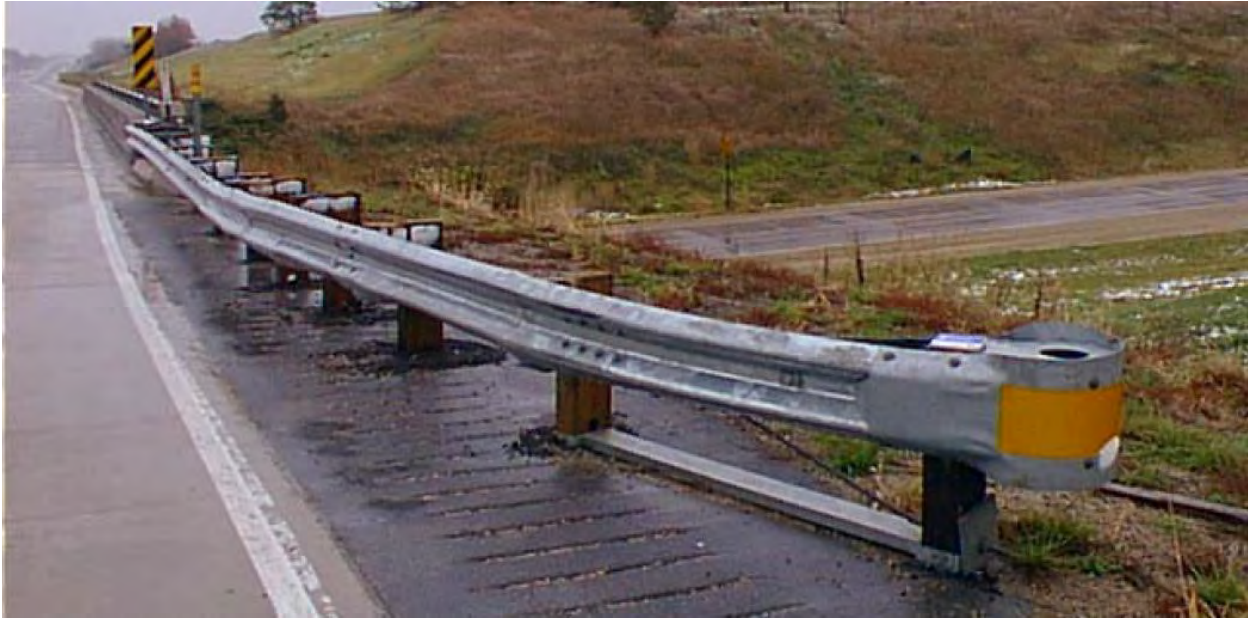
Figure 31. Modified Eccentric Loader Breakaway Cable Terminal. [Patzner99]

Patzner, Plaxico and Ray while at the University of Iowa conducted a study for the Federal Highway Administration to investigate the effects of post and soil strengths on the performance of a common generic guardrail terminal called the Modified Eccentric Loader Breakaway Cable Terminal (MELT), shown in Figure 31.[Patzner97; Patzner99] The MELT was tested at the Southwest Research Institute in San Antonio, Texas in 1997 and it was found that the system would meet performance criteria for *NCHRP Report 350* Test 3-35 only after optimizing the post and soil conditions (i.e., “Grade 1 structural grade lumber for the posts and dry compacted strong soil”).[Mayer99]

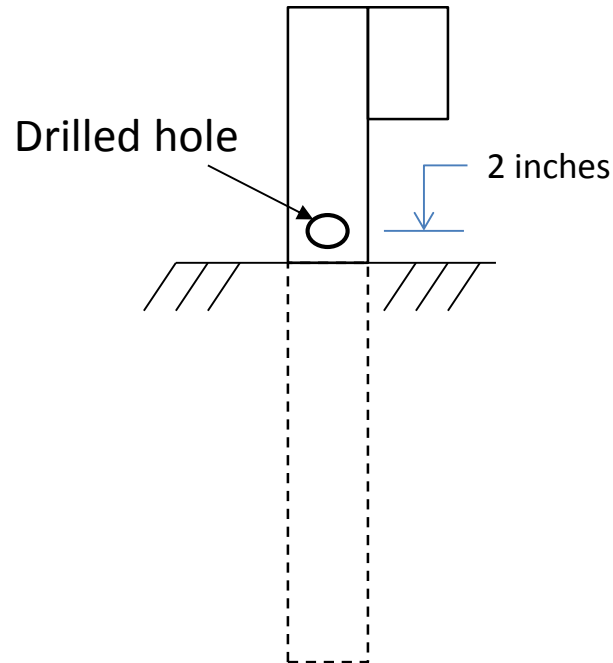
Karlsson investigated the use of failure fuses on timber guardrail posts to reduce the impact forces when vehicles directly impact against the side of the posts during collisions with strong-post guardrail systems.[Karlsson00] Karlsson's study included evaluation of a 6x8-inch wood post that was modified by drilling a 3.5-inch diameter hole through the side of the post at approximately two-inches above the groundline, as illustrated in Figure 32. The study was carried out using finite element analysis, where it was shown that the post provided

approximately the same stiffness and load carrying ability as the standard 6x8-inch wood post when loaded in the strong direction (i.e., impacts on front of post), but would fail at 60% of the impulse required to fail the standard post in the weak direction (i.e., impacts on the side of the posts). The same basic technique has been widely used in the design of the breakaway mechanism in guardrail terminals for decades.

Figure 32. Illustration of wood post with failure fuse.
