Criteria for Restoration of Longitudinal Barriers, Phase II (2021)

Criteria for Restoration of Longitudinal Barriers, Phase II

Contractor's Final Report for NCHRP Project 22-28
Submitted June 2015

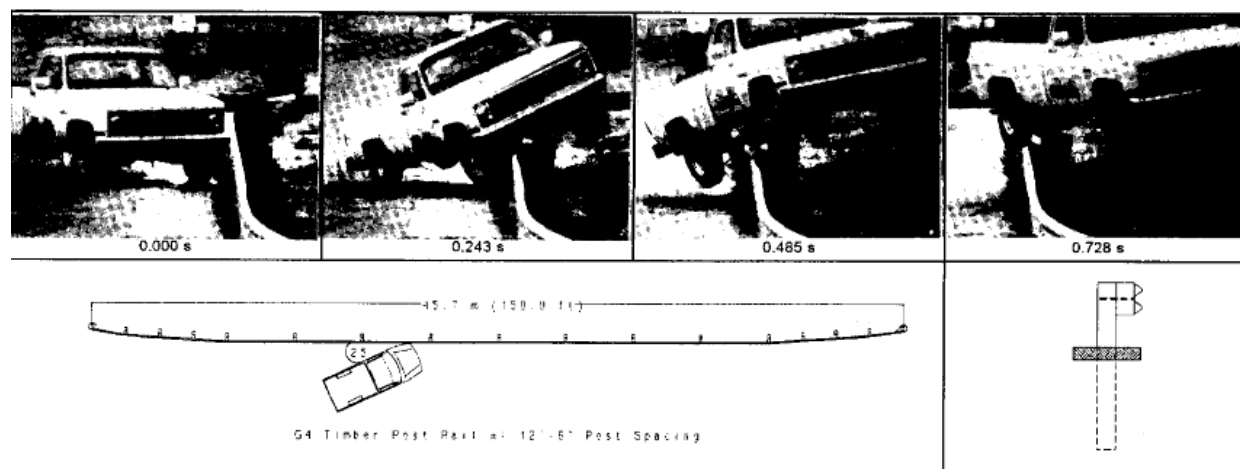
The test resulted in the vehicle vaulting over the barrier, as shown in Figure 33 (taken from the test report).[Mak93] The vaulting was attributed to “lack of torsional rigidity of the w-beam rail element and increased post spacing.” As the rail deflected the w-beam twisted allowing the front bumper to slide over the top of the rail. This exposed the front tire to direct contact with the w-beam rail, which resulted in the tire immediately beginning to climb the rail. The damage to the guardrail was minor and was confined to a 12.5-ft section of the rail. The maximum dynamic deflection was 20.4 inches.

General Information		Impact Conditions		Test Article Deflections (m)	
Test Agency	Texas Transportation Institute	Speed (km/h)	69.5 (43.2 mi/h)	Dyanmic	0.5 (1.7 ft)
Test No.	04820-1	Angle (deg)	24.5	Permanent	0.3 (1.0 ft)
Date	05/18/93				
Test Article		Exit Conditions		Vehicle Damage	
Type	W-Beam Guardrail	Speed (km/h)	58.5 (36.4 mi/h)	Exterior	
Installation Length (m)	30.5 (100.0 ft)	Angle (deg)	14.0	VDS	11LFQ-1
Size and/or dimension and material of key elements	12'-6" Post Spacing			CDC	11LFLW3
Soil Type and Condition	Strong soil	Occupant Risk Values		Interior	
Test Vehicle		Impact Velocity (m/s)		OCDI	
Type	1985 Chevrolet Truck	x-direction	3.3 (10.7 ft/s)	Post-Impact Behavior	
Designation	2000P	y-direction	1.9 (6.1 ft/s)	Max. Roll Angle (deg)	20.1
Model	C-20	THIV (optional)		Max. Pitch Angle (deg)	12.3
Mass (kg) Curb	2097 (4,623 lb)	Ridedown Accelerations (g's)		Max. Yaw Angle (deg)	5.8
Test Inertial	2000 (4,409 lb)	x-direction	3.4

Figure 33. Summary of TTI Test 0482-1 on the G4(2W) with 12.5-ft post spacing. [Mak93]

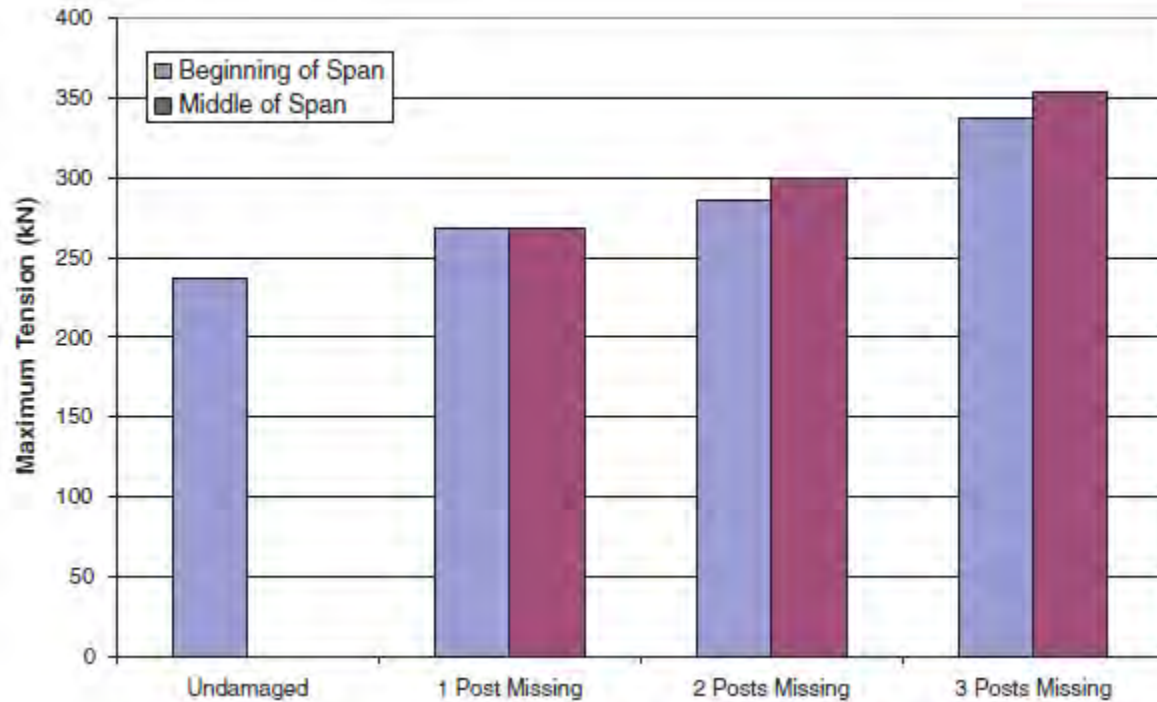
As discussed earlier, a major concern of pocketing is rail-splice rupture. Gabler *et al.* evaluated the potential for splice rupture by recording and assessing increased magnitude in rail tension through the unsupported section of rail. The results indicate that rail tension increases as the damaged section included more and more missing posts, as shown in Figure 34. It was concluded by Gabler *et al.* that “the likelihood of the rails rupturing during impact increased as more posts were removed.”

Figure 34. Maximum rail tension as a function of missing posts.[Gabler10]

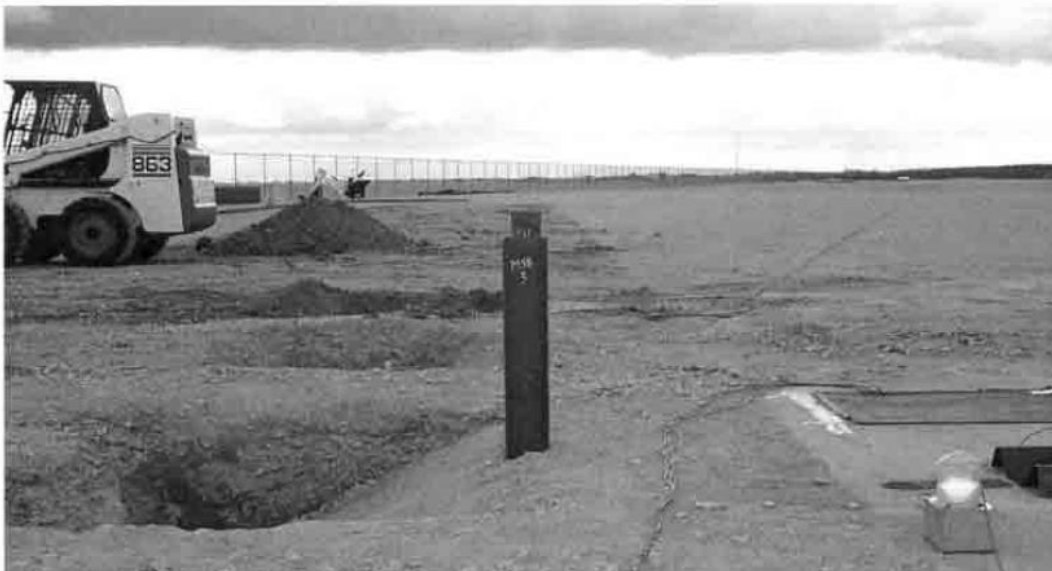
Figure 36. Typical steel post test installation for bogie impact testing. [Polivka00b]

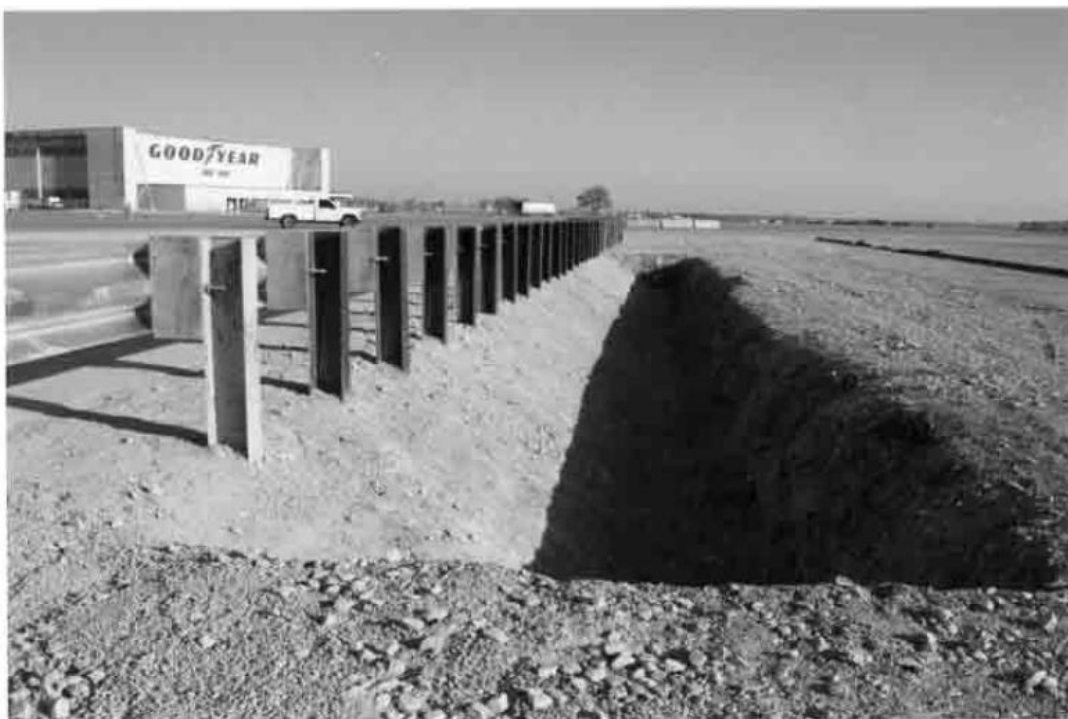
Figure 37. W-beam guardrail adjacent to 2:1 foreslope for full-scale crash test.[*Polivka00b*]

The test installation, shown in Figure 37, was constructed adjacent to a pit with 2:1 slope, 9 ft wide, 3 ft deep and 62.5 ft. long. The guardrail system was impacted with a 1994 GMC 2500 ¾-ton pickup weighing 4,462 lbs., in accordance with *NCHRP Report 350* TL-3 testing standards. The guardrail safely contained and redirected the vehicle and successfully met all safety performance criteria specified in *NCHRP Report 350*. The researchers noted, however, that "...it may be possible to obtain acceptable safety performance from a guardrail design which incorporates longer posts, a wider post spacing, or combinations thereof."

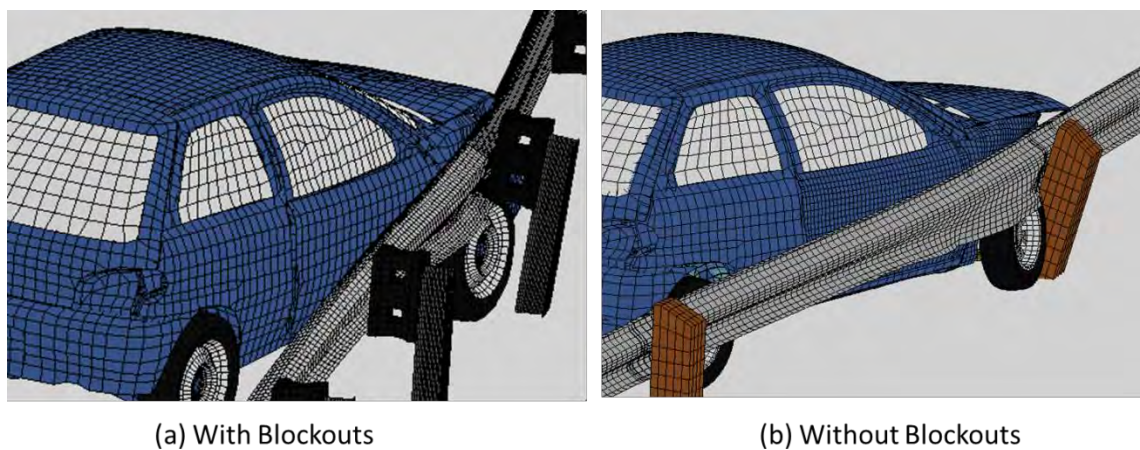
Figure 38 shows an illustration of how the blockouts serve to reduce the probability of wheel snag. In Figure 38(a) the eight-inch blockout provides adequate separation of the rail from the post to prevent wheel contact with the post; whereas in Figure 38(b) the wheel impacts against the post even at very low rail deflection. Full-scale tests on w-beam guardrail systems have shown that the front wheel on the impact side of the vehicle often snags on the guardrail posts as the top of the posts are pushed back by the rail element, exposing the lower section of the post to impact by the wheel, as shown in the test photo in Figure 39.[Mak94]

Figure 38. Illustration of how blockouts help reduce possibility of wheel-snap.[Ray04]

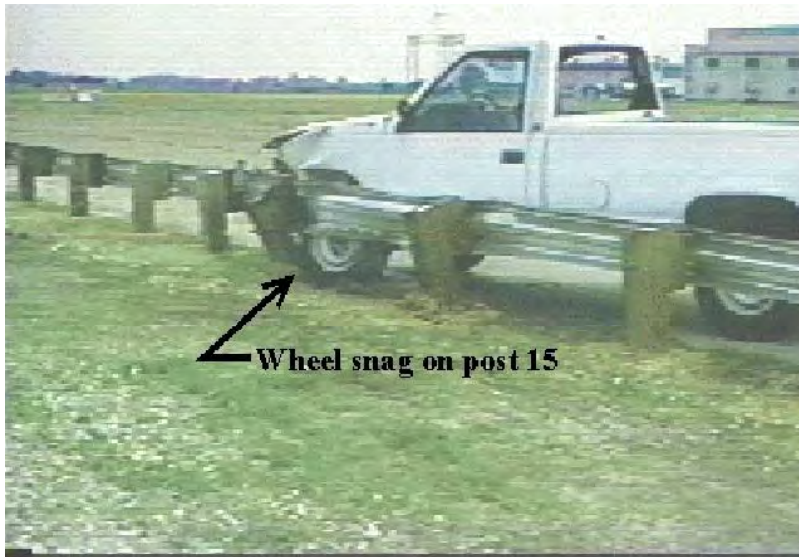
Figure 39. Wheel snag against guardrail post in TTI Test 471470-26.[Mak94]

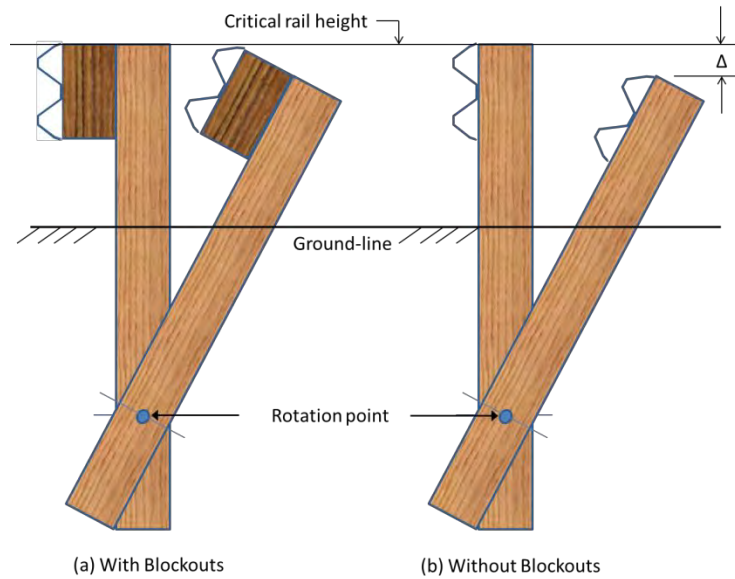
Figure 40 shows an illustration of how the blockouts function to keep the rail above the critical height as the posts deflect. During impact, the rail element imposes a lateral load on the posts and as the posts are pushed back they rotate at a point below grade. For a 6-ft long strong-post with a rail height of 27 inches, the rotation point is typically between 25 and 30 inches below grade.[Rohde96] At post rotations less than approximately 30 degrees, the post with the blockout (Figure 40(a)) maintains the critical rail height, while the post without the blockout (Figure 40(b)) results in the rail being pulled down significantly by the rotating post. The release of the rail from the post is therefore much more critical when a blockout is not present.

Figure 40. Illustration of how blockouts help to maintain critical rail height during post deflection.

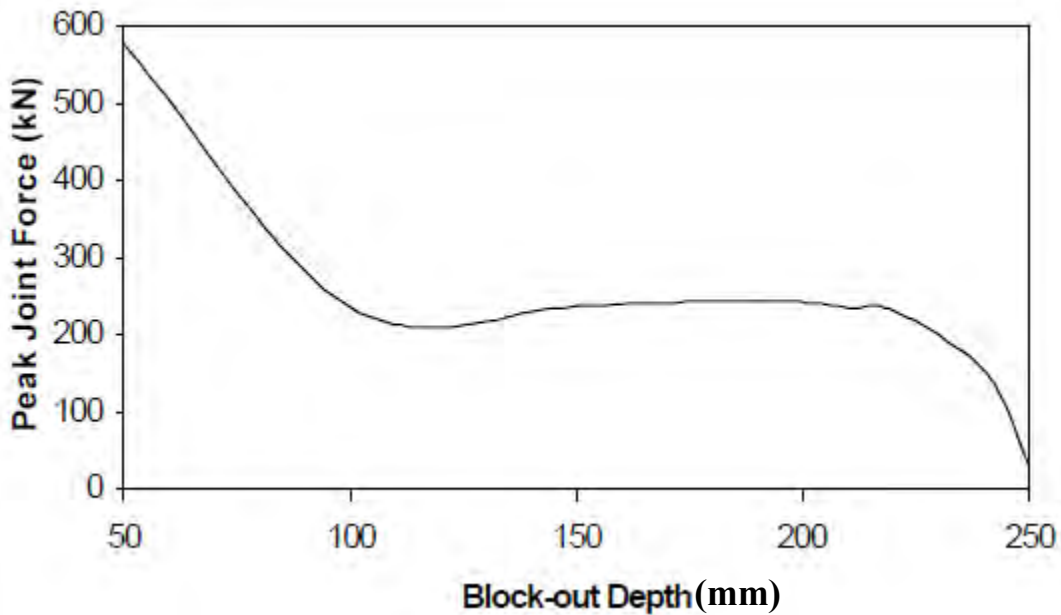
Karlsson used finite element analysis to evaluate the interaction between the vehicle wheel and guardrail posts in simulations of *Report 350 TL-3* impact conditions.[Karlsson00] Several design alternatives for alleviating the effects of wheel snagging were investigated, including the use of longitudinal failure fuses on the posts as discussed earlier. Another alternative was the use of deeper blockouts to increase the separation distance between the rail and posts. The results from Karlsson’s study are shown in Figure 41 where the peak force between tire and post is plotted as a function of blockout depth. These results correspond to strong-post guardrails with a 27-inch rail-mounting height. The analyses indicated that (1) the impact forces decrease with increasing blockout depth, (2) the impact forces are approximately constant for blockout depths between 4 to 8 inches, and (3) a minimum blockout depth of 10 inches would be required to avoid wheel snag on strong-post w-beam guardrails (Note: the standard blockout depth on most strong-post guardrail systems is 8 inches). Figure 41 also suggests there are diminishing returns for using block-outs much greater than 10 inches (254 mm).

Figure 41. Peak tire-post impact force as a function of blockout depth for Report 350 TL-3 impacts.[Karlsson00]

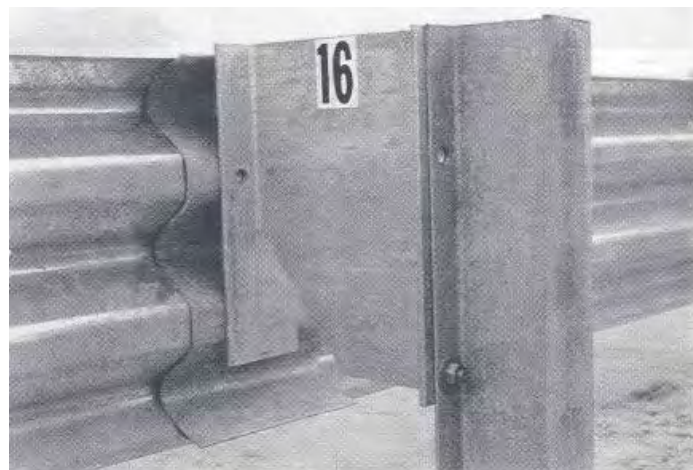
Figure 42. Modified thrie-beam guardrail (SGR09b).[\[Sheikh09\]](#)

This behavior is common in all strong-post guardrail systems that use structural-steel posts with low torsional rigidity (e.g., wide-flange posts), including the modified thrie-beam guardrail system shown in Figure 42. The modified thrie-beam guardrail (SGR09b) uses the same W6x9 steel posts as the G4(1S) system with a W14x22 blockout. This system was successfully tested for *NCHRP Report 350 TL-3* at the Texas Transportation Institute. [*Mak99a*] It was concluded from the results of the test (i.e., Test 471470-30) that:

The primary components of the modified thrie-beam guardrail system include the same 12-gauge thrie-beam rails, W6x9 steel posts, and standard connection hardware as the standard G9 thrie-beam guardrail. In addition to a taller rail height, the modified thrie-beam guardrail also has a unique deep structural steel blockout, which is designed to help keep the face of the rail vertical during impacts, but is unfortunately susceptible to bending through the web (see Figure 42). So, although many damage modes will be similar for these two systems, the differences in the damage modes for the blockout may result in significant differences in guardrail performance.

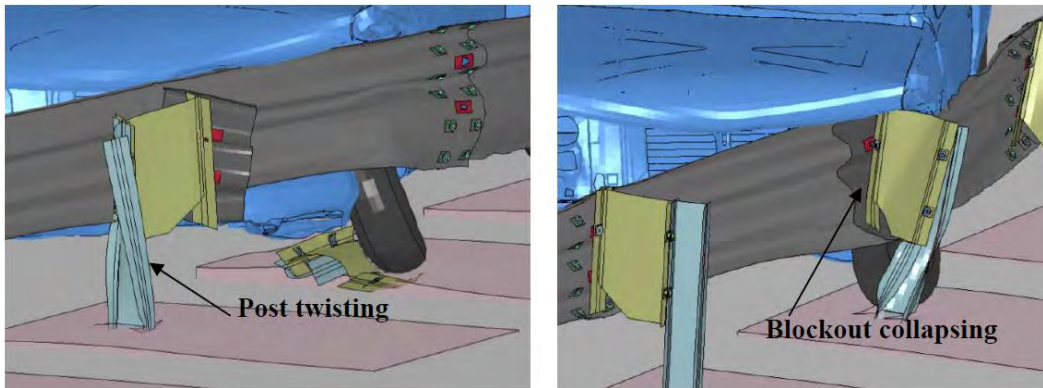
The results of their analyses indicated that the performance of the SGR09b guardrail would not likely be acceptable in high-speed (e.g., 85 mph) impact events. They also concluded that the overall deformation mode of the blockout-and-post components, shown in Figure 43, leads to the poor performance of the system and suggested that these components be replaced by wood posts and blockouts. Although this system has been shown to perform well in *Report 350* TL-4 conditions, it was concluded that performance would be further improved if the post and blockout were designed such that they had sufficient lateral stiffness to allow the post to rotate properly in the soil as the system deflected to reduce the potential for wheel-snap on the posts.

Figure 43. Deformation of three-beam guardrail during impact with 4,577-lb vehicle at 85 mph and 25 degree impact.[Sheikh09]

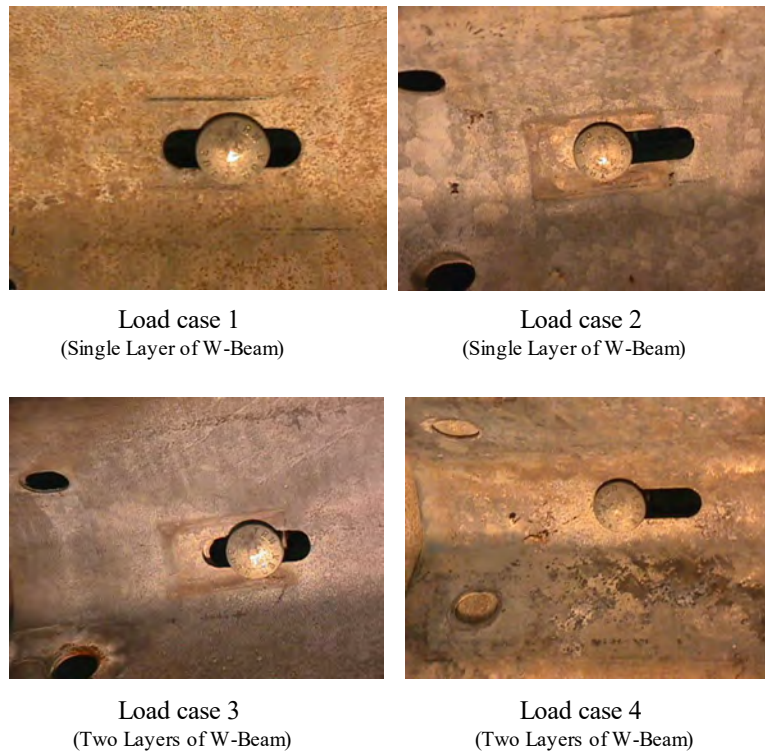
As with the design of the weak post w-beam guardrail [Engstrand00; Ray01a], the rail-to-post connection is also an important design consideration for strong post systems. In a study by Plaxico *et al.*, the force and energy required to fail the post-bolt connection (i.e., bolt head pulling through the w-beam slot) in strong post guardrail systems was determined through quasi-static laboratory testing.[Plaxico03] Four scenarios were investigated which are illustrated in Figure 44:

Figure 44. Position of bolt in slotted hole in w-beam for each load case.[Plaxico03]

Further, as shown in the literature review, the force magnitude required to detach the rail from the post can vary from 4,050 lb to 14,500 lb depending on the position of the bolt head in the slotted rail, and if the connection is at a splice (refer to Figure 44). Therefore, analyses may indicate that the criteria for assessing rail-post connections at a splice may differ from that for connections at non-splice locations.

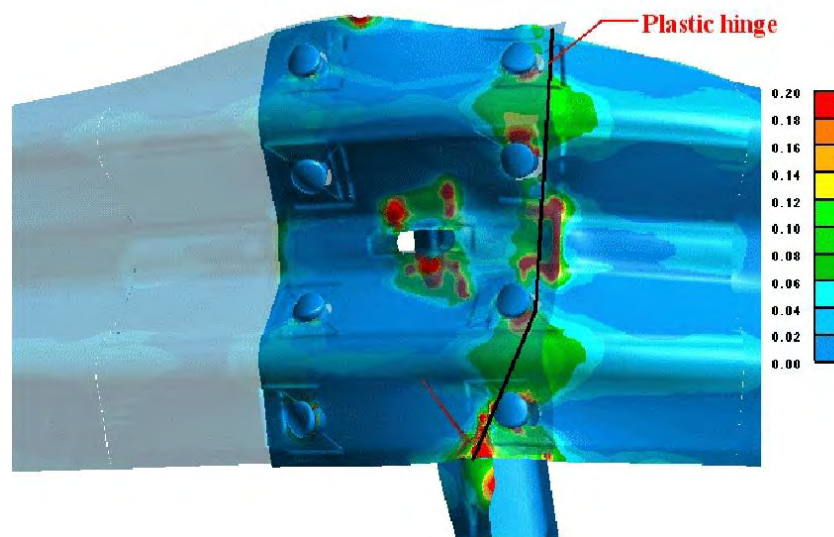
Figure 46. Effective plastic strains in the back layer of w-beam in a guardrail splice showing the formation of a plastic hinge. [Ray01b]

Ray *et al.* concluded that W-beam guardrail splice failures are usually caused by the complex multi-axial state of strain experienced by the splice when it is located near a guardrail post. When subjected to these multidirectional loads, stress concentrations develop around the bolt holes in the back layer of w-beam in the splice connection and this often results in a small fracture or tear in those locations. Once a tear is initiated, the tension in the rail may cause the tear to propagate through the whole w-beam section causing the guardrail to rupture completely.[Engstrand00; Ray01a]

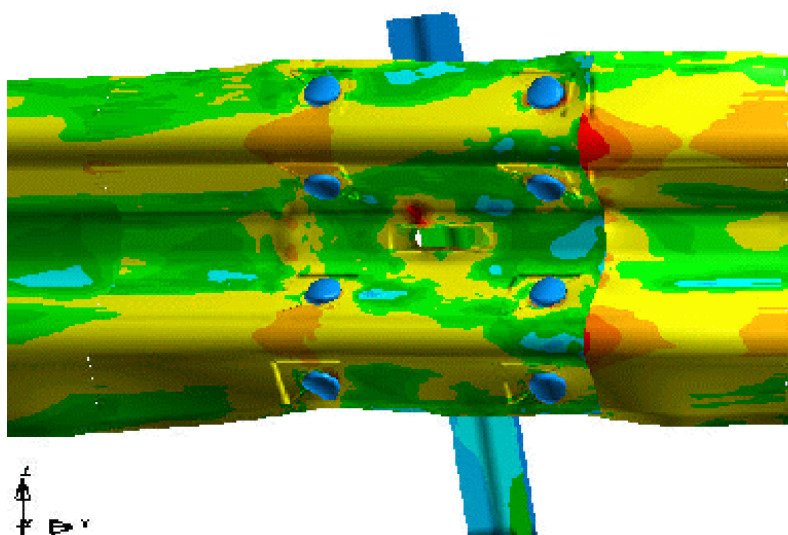
Figure 47. Von Mises stress contour plot showing relatively low stresses on the top layer of rail in the rail splice.[Ray01b]

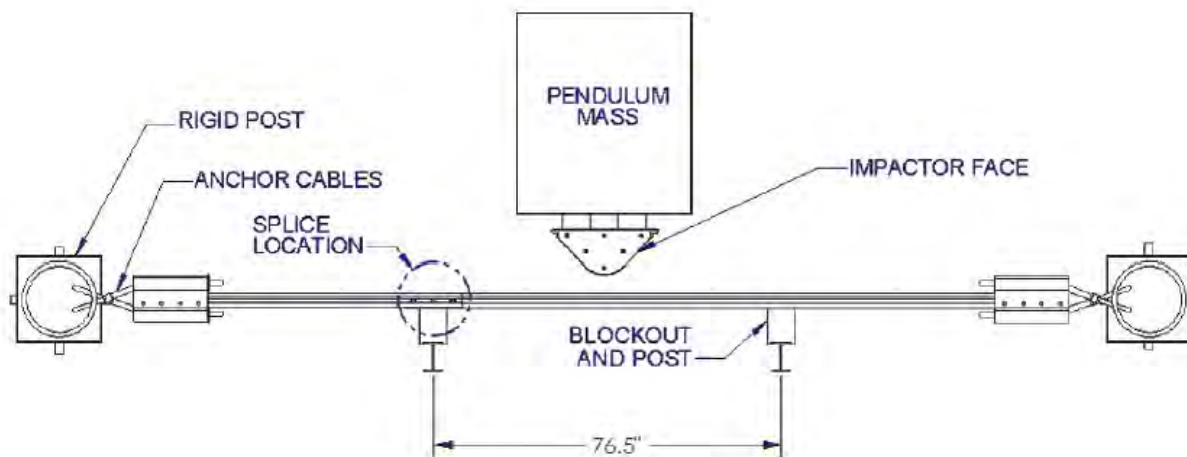
Gabler, Gabauer and Hampton evaluated the effects of splice damage using pendulum tests in Report 656.[*Gabler10*] The test article was an 18-ft section mockup of the modified G4(1S) with routed wood blockouts, as illustrated in Figure 48. Each end of the w-beam rail was anchored to rigid posts with two 3/4-inch diameter swaged cables (i.e., AASHTO component FCA01).

Figure 48. Pendulum test setup for the Gabler et al. study. [*Gabler10*]

Gabler, Gabauer and Hampton evaluated the effects of vertical tears in the w-beam rail using pendulum tests in Report 656.[*Gabler10*] The test setup was shown earlier in Figure 48. Three tests were conducted: Test 01-3 and Test 03-5 included a 4-inch cut made on the top of the rail element, and Test 08-2 included a 0.5-inch cut on the top of the rail. In each test case, the test article was impacted perpendicular to the face of the rail with a 4,545-lb pendulum at a nominal speed of 20 mph. The “tear” propagated in all three tests and resulted in complete rupture in Tests 01-3 and 03-5. It was concluded that “no vertical tear is safe” and that “vertical rail tears of any length ... should be repaired with high priority.” [*Gabler10*]

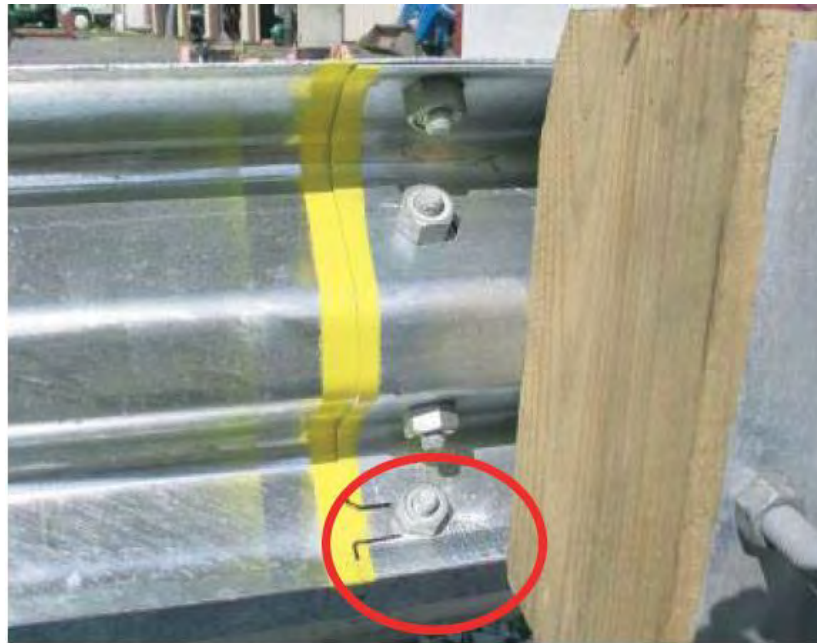
In their tests the damage mode was fabricated by cutting out the material around one of the bottom splice bolts, as shown in Figure 49. The damage mode was essentially representative of a missing splice bolt at that location. The test article was impacted perpendicular to the face of the rail with a 4,545-lb pendulum at a nominal speed of 20 mph. The test article contained the pendulum and “no serious splice separation was observed.” The results of the Gabler et al. study verifies the conclusions from Ray *et al.* and Polivka *et al.* that splice failure is not likely the result of reduced rail capacity.

Figure 49. Fabricated splice damage mode evaluated by Gabler et al. [Gabler10]

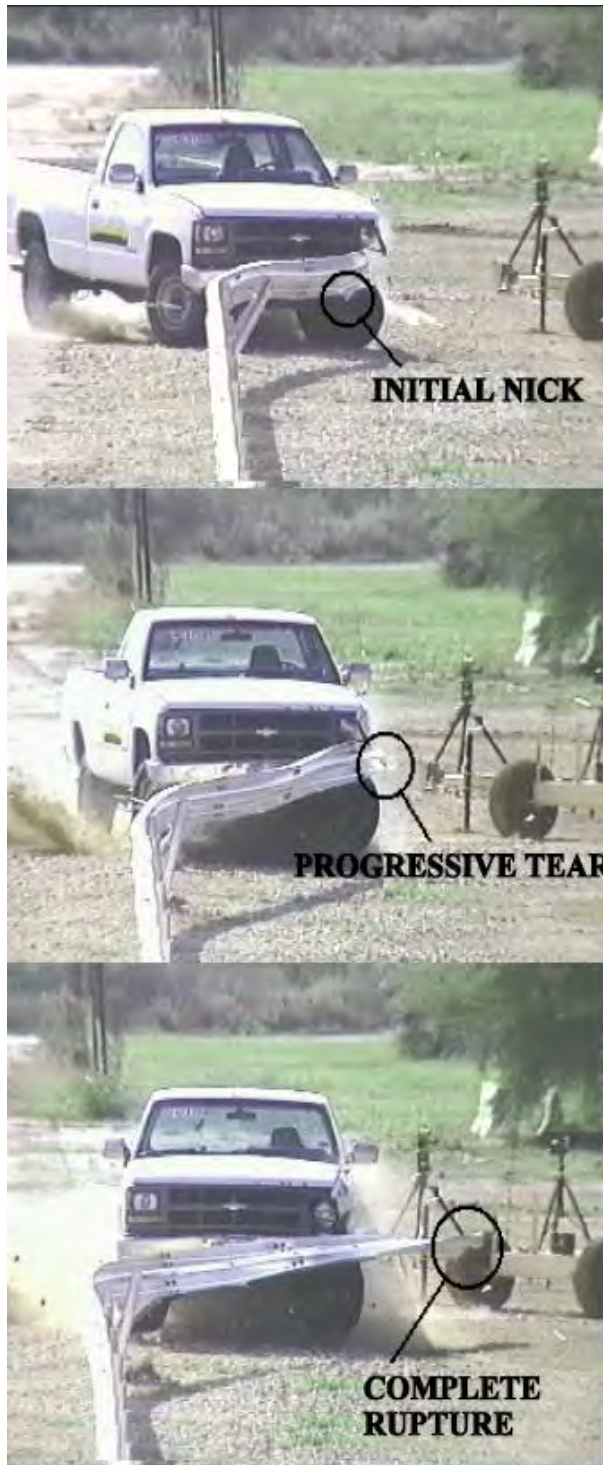
This failure mode was demonstrated in a full-scale test on the weak-post w-beam system conducted by the Texas Transportation Institute under *Report 350* Test 3-11 impact conditions.[Buth00a] A small “nick” formed at the bottom edge of the w-beam rail as the rail was pulled over the top of the second post downstream of the impact point, as shown in the top photo of Figure 50. During impact, the friction between the vehicle and the w-beam rail causes the section of rail upstream of the vehicle (i.e., behind the vehicle) to be under much higher tension than the down-stream sections of rail. As soon as the vehicle moved past the tear, the tear was suddenly on the tension side of the rail, resulting in crack propagation and, finally, complete rupture of the rail, as shown in Figure 50.

**Figure 50. Test 473750-1 on a weak-post w-beam guardrail resulting in rail rupture.
[Buth00a]**

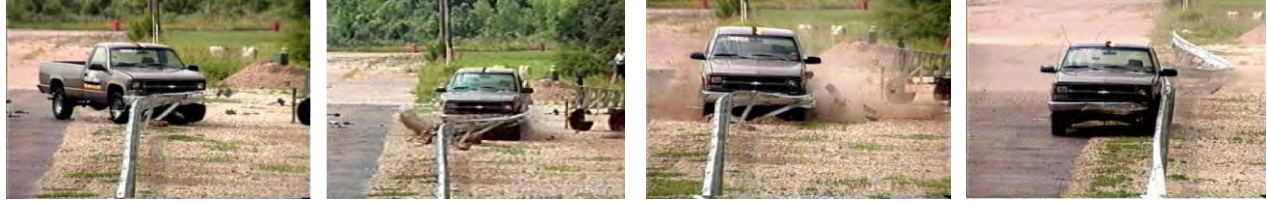
The modified weak-post w-beam guardrail system with the higher 32.25 mounting height was subjected to a full-scale crash test according to *NCHRP Report 350* Test 3-10 (i.e., small car test) and Test 3-11 (e.g., pickup test), as shown in Figure 51 and Figure 52, respectively. The tests demonstrated that the modified design met all *Report 350* performance requirements for TL-3 [*Buth00c; Buth00e*] The system was later successfully tested under *MASH* TL-3 conditions.[*Bullard10*]

Figure 51. Sequential view of Report 350 Test 3-11 on the modified G2 at 32.25 inch rail height.[Buth00c]

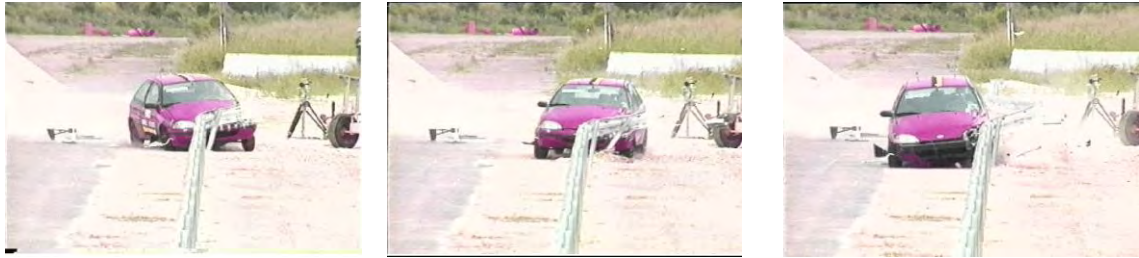
Figure 52. Sequential view of Report 350 Test 3-10 on the modified G2 at 32.25 inch rail height.[Buth00e]

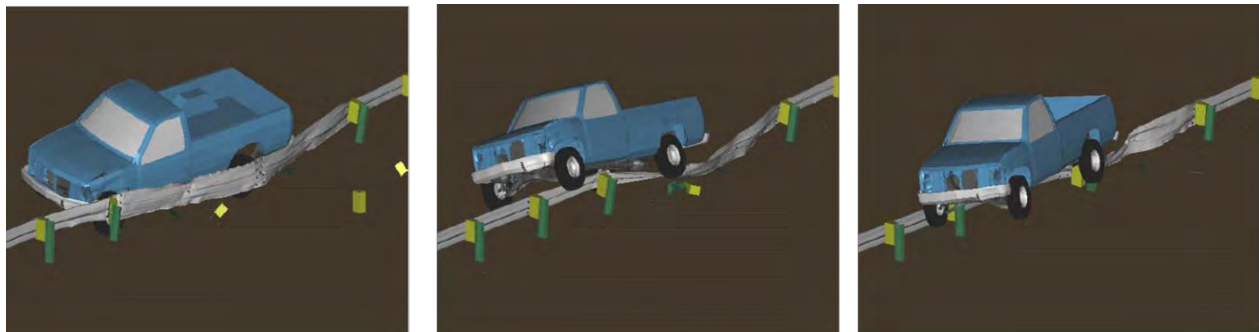
(a) 27-inch rail height

(b) 25.5-inch rail height

(c) 24-inch rail height

Figure 53. FEA results for Report 350 Test 3-11 on the G4(1S) guardrail with rail heights of (a) 27 inches, (b) 25.5 inches and (c) 24 inches.[Marzougui07a]

Marzougui *et al.* performed a study for the Federal Highway Administration to investigate the effects of rail height on the safety performance of the modified G4(1S) with routed wood blockouts using finite element analysis and full-scale testing.[*Marzougui07b*] Marzougui’s analyses involved simulations of *Report 350* Test 3-11 on a model of the modified G4(1S) with the rail height of ± 1.5 inches and ± 3 inches, relative to the standard rail height of 27 inches (i.e., rail heights of 24, 25.5, 27, 28.5 and 30 inches).

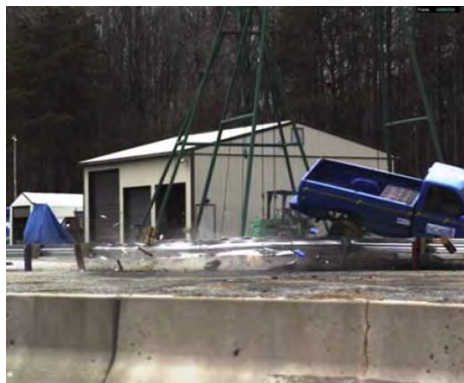
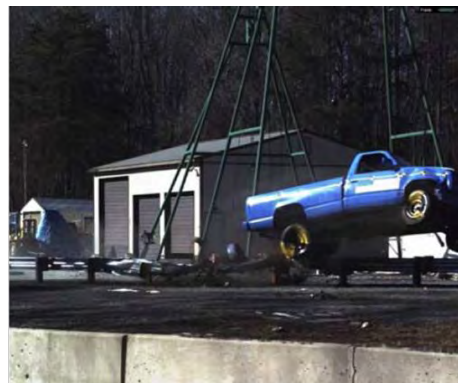
(a) 27-inch rail height

(a) 24.5-inch rail height

Figure 54. Full-scale test results for *Report 350* Test 3-11 on the G4(1S) guardrail with rail heights of (a) 27 inches and (b) 24.5 inches.[Marzougui07a]

The results of Marzougui’s study indicated that a rail height of 27 inches for the G4(1S) guardrail would successfully redirect the pickup under *Report 350* TL-3 conditions; however, “reducing rail height by as little as 1.5 inches could hinder the ability of the barrier to redirect pickup trucks and large SUVs.” Figure 53 shows the results of the analyses for rail heights of 27 inches (i.e., standard height), 25.5 inches (i.e., rail lowered 1.5 inches) and 24 inches (i.e., rail lowered 3 inches). Figure 54 shows the results of the full-scale tests for rail heights of 27 inches and 24.5 inches (i.e., rail lowered 2.5 inches).

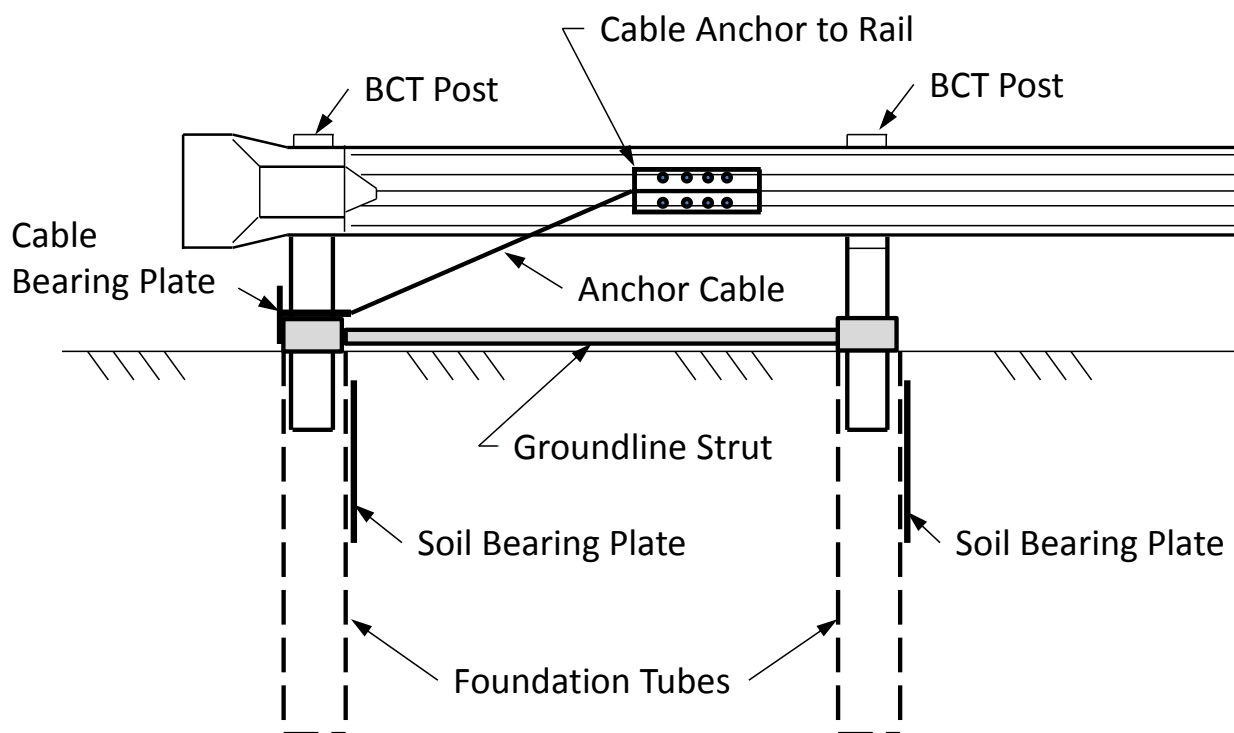
(MELT). The basic design of the anchor mechanism, illustrated in Figure 55, entails an anchor cable (3/4-inch diameter) with one end fastened to the rail element and the other fastened to the end-post near the groundline. A bearing plate is used to prevent the cable from pulling through the hole in the end-post and to distribute the load to the foundation tube (i.e., the bearing plate overlaps the top of the foundation tube). The end-post and the adjacent post are both installed in 5-foot long steel foundation tubes with a soil-bearing-plate (18 inches long by 24 inches wide) attached to provide additional resistance from the soil. A steel strut is then laid at the groundline which connects the two foundation tubes together making them work as a system. When the guardrail is struck, the anchor cable transfers the load to the foundation tubes to resist axial movement of the rail; the resulting tension in the rail helps to limit lateral deflections of the guardrail in the impact zone. Figure 56 shows a photo of a generic end-anchor for the modified G4(1S) with wood blockouts that was used in full-scale crash test 2214-WB1.[*Polivka06a*]

Figure 55. Sketch of typical guardrail anchor system.

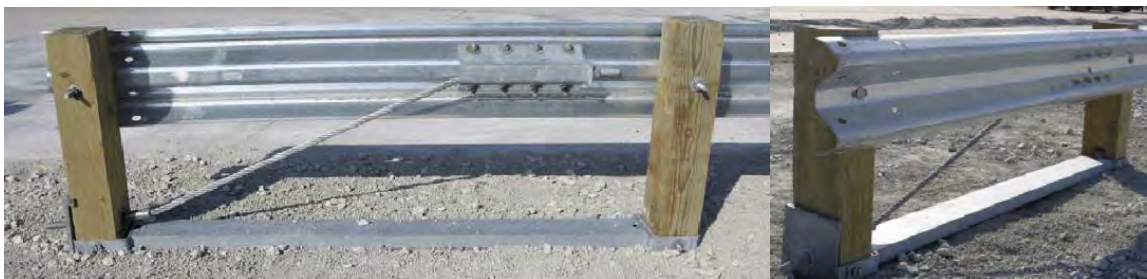
Figure 56. Generic end-terminal used in full-scale Crash Test 2214-WB1 of a strong-post guardrail system.[*Polivka06a*]

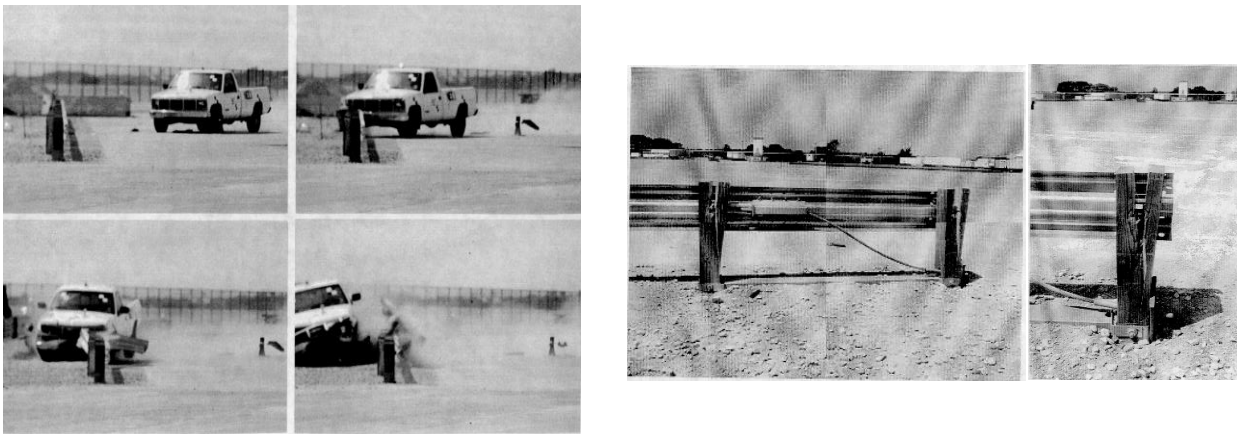
If the anchor fails or experiences excessive movement during loading, the “slack” in the rail generally results in pocketing. For example, Polivka *et al.* and Bullard *et al.* showed through full-scale testing that poor guardrail performance is often associated with large anchor movement. [Polivka00a; Bullard00] In a full-scale test (i.e., Test NEC-1) conducted at the Midwest Roadside Safety Facility at the University of Nebraska-Lincoln to evaluate the effects of a 4-inch curb placed flush behind the face of a modified G4(1S) guardrail system, the anchor posts split during the collision, as shown in Figure 57, causing a loss of tension in the w-beam which resulted in pocketing. The test was conducted under *NCHRP Report 350 TL-3* conditions. [Polivka00a] The guardrail ruptured at a splice connection allowing the vehicle to penetrate behind the system. The splice failure was attributed to contact and snagging of the post blackout against the w-beam rail splice. The post twisted as it was pushed back in the soil, causing the bottom corner of the blackout to push up against the corner of the w-beam rail splice. This resulted in a tear in the w-beam at the lower downstream bolt location.

Figure 57. Test results for Test NEC-1 on modified G4(1S) with wood blockouts and 4-inch curb. [Polivka00a]

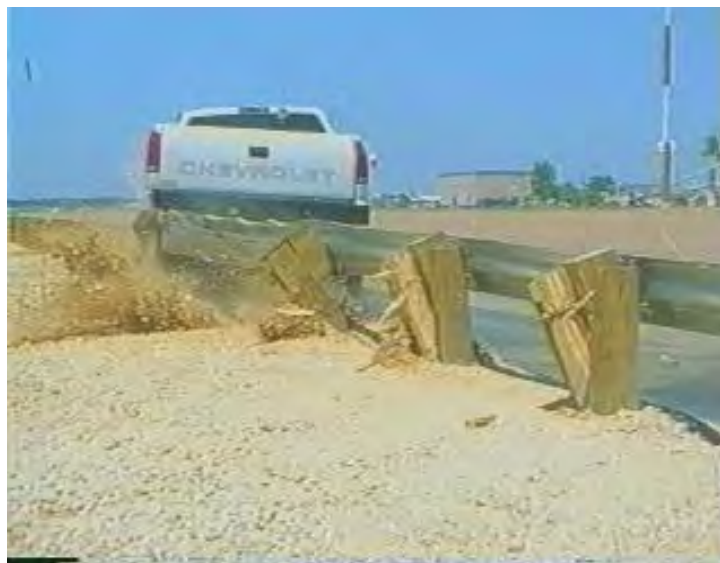
Researchers at the Texas Transportation Institute conducted a *NCHRP Report 350 TL-3* test on a G4(2W) guardrail with a 4-inch curb set out one inch from the face of the w-beam rail (i.e., Test 404201-1). [Bullard00] During the test, there was significant movement of the anchor system as the foundation of the anchor posts moved in excess of 2.75 inches. The test was successful; however, there was considerable damage to the guardrail system due to the movement of the anchor, as shown in Figure 58, and it was stated in the test report that the guardrail was at its performance limit.

Figure 58. Guardrail damage in Test TTI 404201-1.[Bullard00]

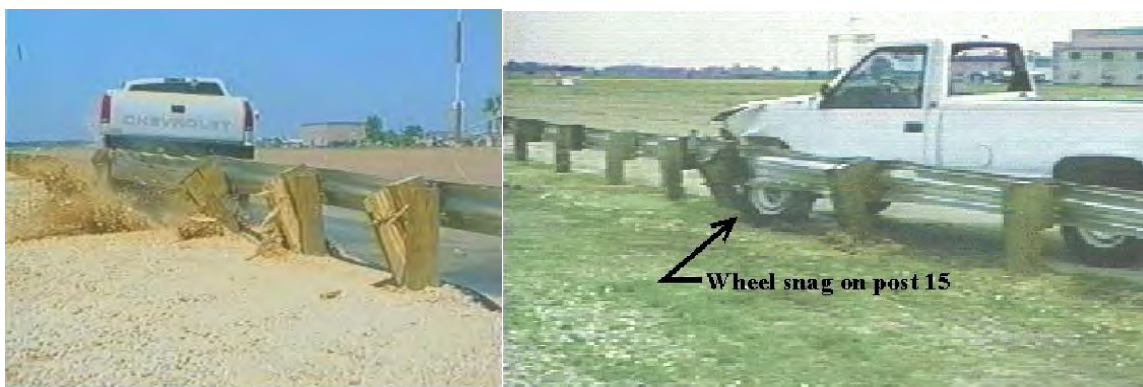
Damage modes related to the guardrail posts, on the other hand, may result in a different response for wood post systems when compared to the response for steel post systems. For example, under relatively severe impact conditions, as shown in Figure 59, wooden posts tend to either fracture at the ground line, split along the vertical direction of the post, or remain essentially undamaged (i.e., the posts simply rotate in the soil); whereas the steel W6x9 posts of the G4(1S) system, which have relatively low torsional rigidity, tend to twist as they are pushed back during impacts and subsequently bend about the weak axis of the post, as illustrated in Figure 60. Although the impact performance may be somewhat similar for these two systems when struck either in their undamaged state or when damage levels are relatively low, their performance under somewhat higher levels of damage *may* change due to the differing damage modes associated with the two very different guardrail post types.

Figure 59. Typical damage modes for wood post guardrails.[Bullard00;Mak95]

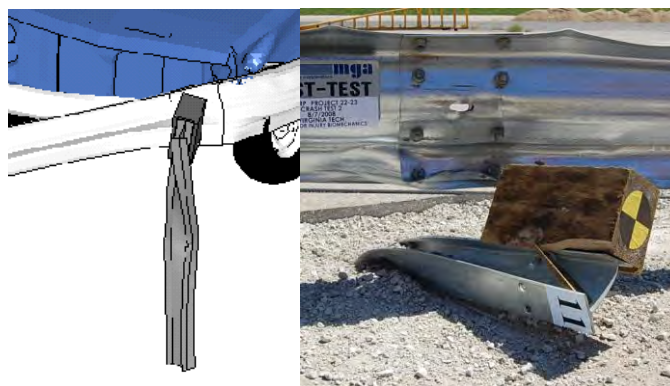
Figure 60. Typical damage mode for steel wide-flange posts.[Fleck08b]

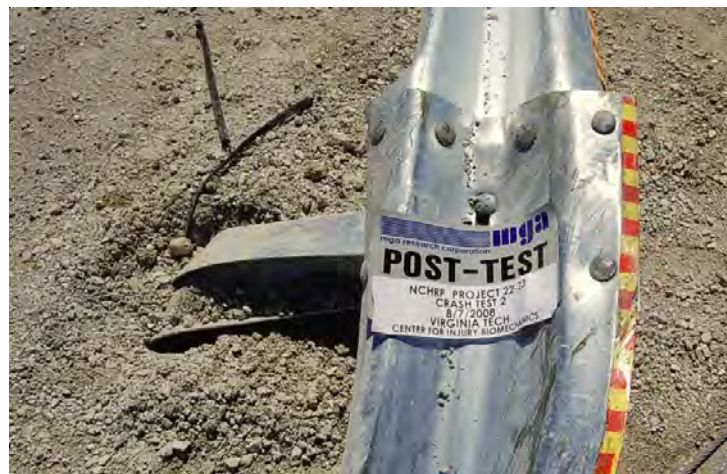
It was thus implied in Report 656 that the reason for the override was the result of a post-rail connection that did not release properly, as shown in Figure 61. As the guardrail post located downstream of the impact point deflected and rotated back, the undetached rail was pulled down with the post, allowing the vehicle to override the system.

Figure 61. Post-test photo for Test MGA C08C3-027.2 showing the un-failed rail-post connection which resulted in the post pulling the rail down during impact.[*Fleck08b*]

Report 656 indicates that the separation of the rail from the post actually improved vehicle stability during impact and redirection. When only a single connection was broken, the deflection of the system was essentially identical to the undamaged guardrail performance; whereas when two posts were detached from the rail with a separation distance of three inches, guardrail deflection was increased 5.6 percent. The improvement in vehicle stability should be expected since early release of the rail from the post as the vehicle approaches the post is a fundamental part of the design of the post-rail connection, which is necessary for reducing the potential for severe snag on the post as well as for reducing the risk of the post pulling the rail down as the post rotates back during impact (refer to the literature review for more discussion). In fact, a more critical case would be a non-failed connection on a deflected system, such as occurred in Test C08C3-027.2 and shown in Figure 61.

- Low deflection of the guardrail (i.e., insufficient deflection to fail the connection),
- Bolt head installed too close to the edge of the w-beam slot (see further discussion in the literature review), or
- Loss of tension in the rail which causes the rail to slip, resulting in the bolt head “jamming” into the corner of the slot, as shown earlier in Figure 61.

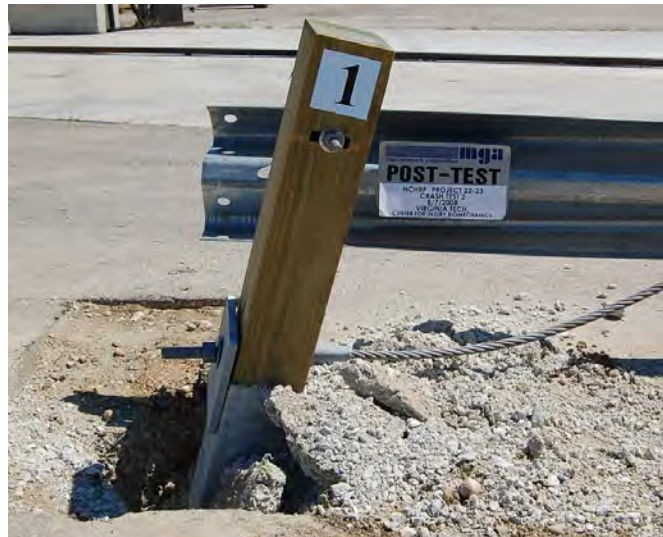
Since the rail-post connection is “designed” to release as post deflection increases, it was not clear that the test was successful in confirming the effects of rail deflection on guardrail performance; but rather in confirming the effects of improper release of the rail-post connection. So, the real question was then, “*What caused the rail-post connection to function improperly in the test?*” The most likely answer was a loss of tension in the rail resulting from the excessive movement of the anchor system, as shown in Figure 62.

Figure 62. Post-test photo for Test MGA C08C3-027.2 showing the excessive anchor movement that occurred during the test.[Fleck08b]

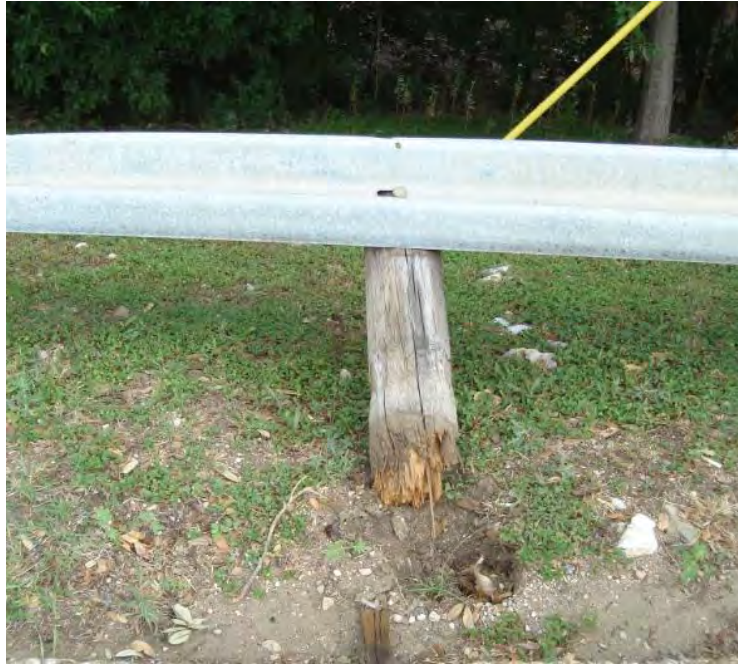
One challenge regarding evaluation of rotted or weakened posts was how to quantify the degree of rot or insect damage in terms of post strength. Figure 63 shows a photo of a wooden guardrail post that fractured just below the groundline due to rot. Although deterioration at the

location of the break seems evident in the photo, the fact that the damage was below grade and not visible makes this type of damage difficult to identify.

Figure 63. Post fracture below groundline due to rot. [Photo provided by Mark Bloshock]

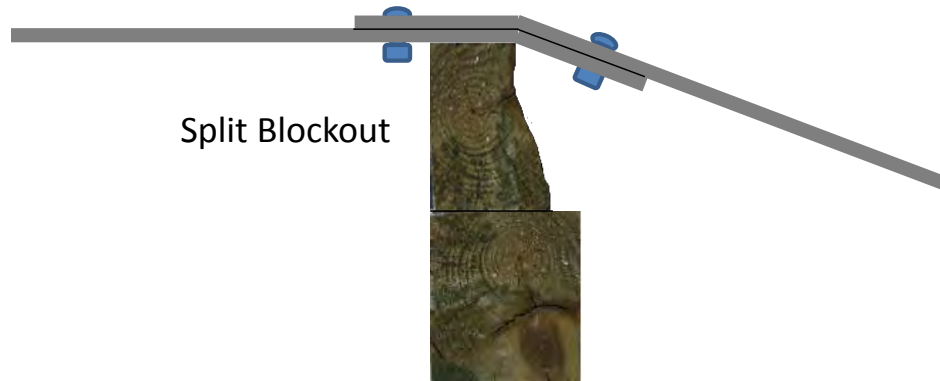
Figure 64. Illustration of possible splice deformation mode resulting from a split blockout.

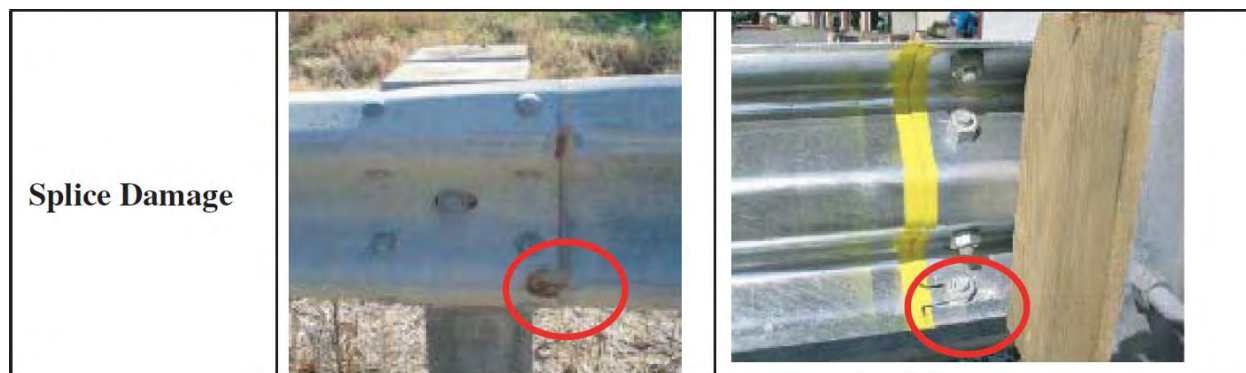
Although w-beam splice damage was addressed in Report 656, additional splice damage modes should be considered for further investigation in this study to more thoroughly quantify their effects on rail capacity. For example, Report 656 evaluated the damage mode shown in Figure 66, which involved a simulated tear-out of a splice bolt at the lower up-stream section of the splice. Note, however, that the field installation photo in Figure 66 (left photo) shows the damage being located at the lower, downstream splice bolt, which would result in different loading (or stress concentrations around the bolt holes) than the one studied in Report 656 (right photo).

(a) Field Installation damage

(b) Simulation damage

Figure 66. Splice damage mode investigated in Report 656. [Gabler10]

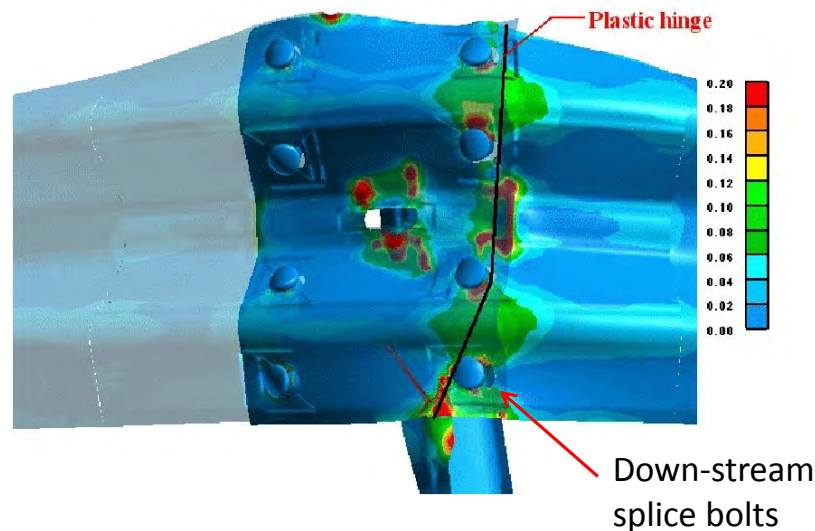
Figure 68. Effective plastic strain contour plot at a splice connection. [Ray01b]

To evaluate splice damage, the damage modes for the splice connection should be imposed onto the test sample by a pre-impact test, since this type of damage is difficult (if not impossible) to achieve otherwise. Since small tears in the splice bolt holes are likely to be hidden by the bolt head and/or nut, it may be reasonable to quantify the degree of damage by such parameters as degree of flattening, angle of bend in the splice, measure of separation between the two rail elements at the downstream end of the splice, etc. The evaluation for quantifying the reduction in rail capacity as a function of splice damage could be achieved through pendulum testing or a combination of pendulum testing and finite element analysis. Pendulum tests will obviously indicate when failure has occurred, but the relative increase in stress levels at the critical locations in the splice would be better assessed through FEA, as illustrated in the effective-plastic-strain contour plot of the weak-post w-beam system in Figure 68.
