Criteria for Restoration of Longitudinal Barriers, Phase II (2021)

Criteria for Restoration of Longitudinal Barriers, Phase II

Contractor's Final Report for NCHRP Project 22-28
Submitted June 2015

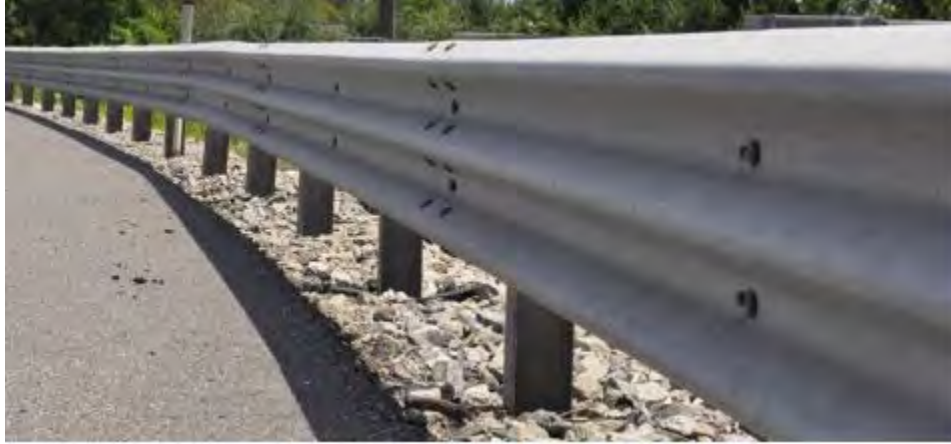
Figure 69. Photo of the standard thrie-beam guardrail.

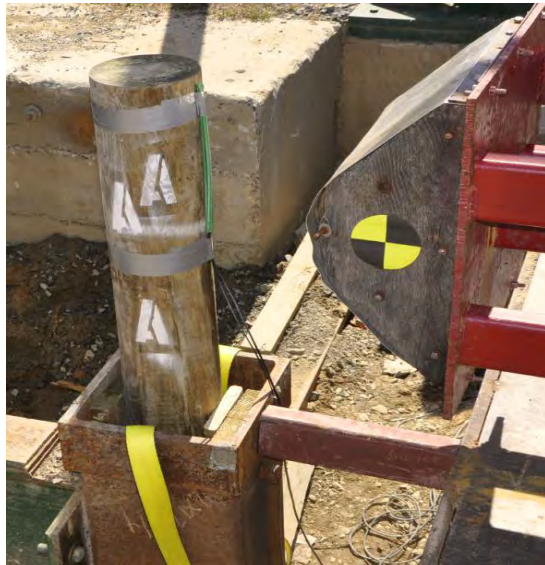
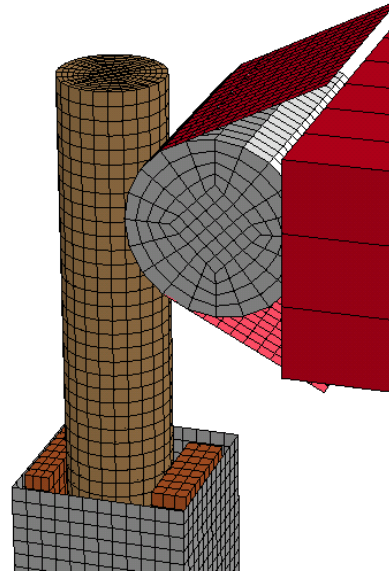
Figure 77. Test set-up and FEA model used in wood-model validation.

(a) Test 13009L

(b) FEA Model

tests involved a 2,372-lb rigid-nose pendulum striking the posts at 21.5 inches above grade. The posts were 66 inches long and were embedded 38 inches inside a 12x12 inch steel tubular sleeve with “rigid” fixity. See Chapter 8 for more details regarding the test setup. Figure 77 shows a side-by-side view of the physical test set-up and the finite element model.

These impact conditions were simulated using the finite element model shown in Figure 77. As a starting point, the pre-defined material parameters in LS-DYNA for clear wood, Grade DS-65 and Grade 1 were used to model the wood material (refer to Table 28). The results from those three analysis cases are shown in Figures 80 through 82. The dashed lines in the plots correspond to the results from the physical tests.

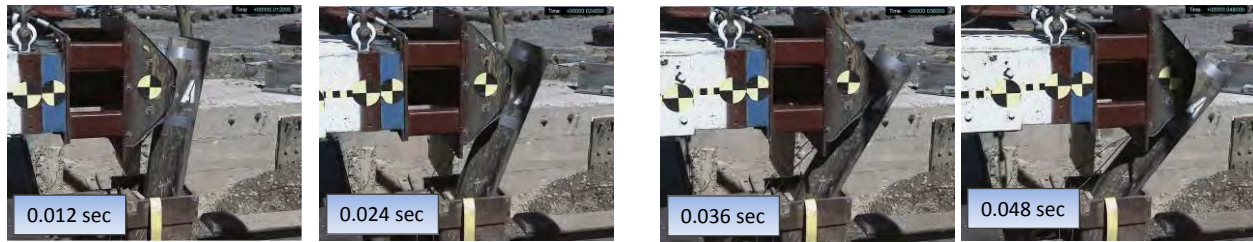
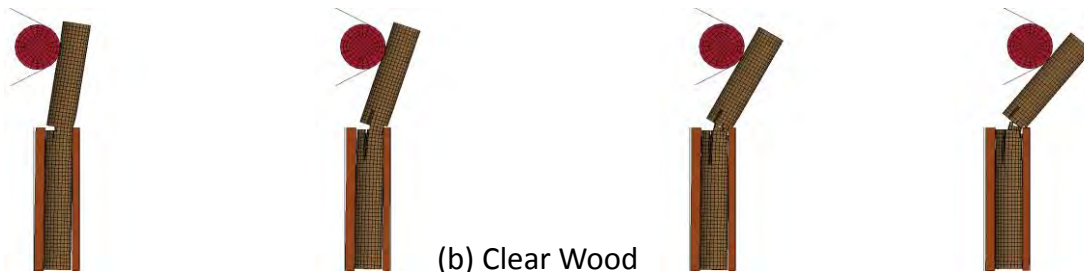
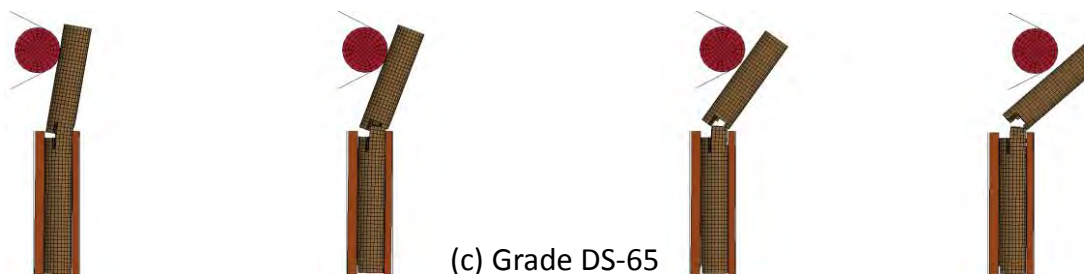
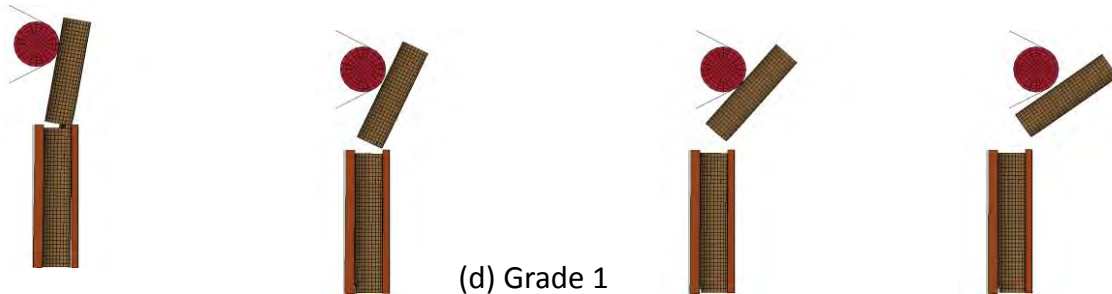
Figure 82. Sequential views of (a) Test 13009L and analyses for post model with pre-defined MAT143 properties for (b) clear wood, (c) grade DS-65 and (d) grade 1.

(a) Test 13009L

(b) Clear Wood

(c) Grade DS-65

(d) Grade 1

The analysis results using Grade 1 properties matched reasonably close to the results from the physical tests. The peak impact force for the analysis was 20.8 kips and the total energy absorption was 34 kip-inches. The Grade 1 properties also resulted in a more brittle failure response of the post, as illustrated in the sequential views in Figure 82.

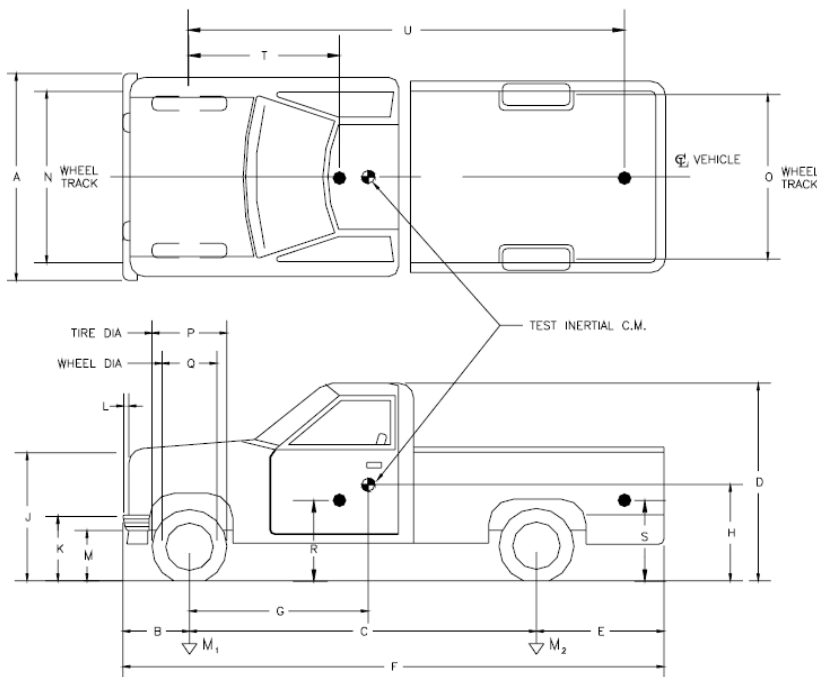
Vehicle Geomerty (inches)

Test Vehicle	FE Model	Error %
A	73.2	73.3	0.2
B	31.5	35.6	12.9
C	131.9	144.3	9.4
D	70.9	73.2	3.3
E	52.8	52.8	0.1
F	216.1	232.7	7.7
G	60.7	50.3	-17.1
H	-	27.8	-
J	41.1	42.3	2.8
K	25.6	26.0	1.5
L	3.5	4.1	16.7
M	16.9	18.0	6.3
N	61.8	65.2	5.4
O	63.8	65.2	2.2
P	31.1	28.0	-9.9
Q	17.3	16.4	-5.5
R	28.0	27.6	-1.4
S	40.6	-	-
T	59.1	54.6	-7.5
U	163.8	-	-

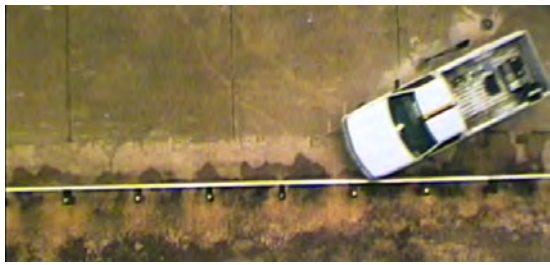
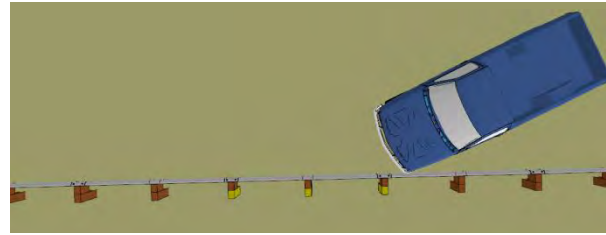
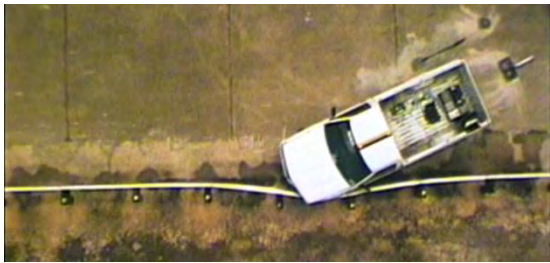
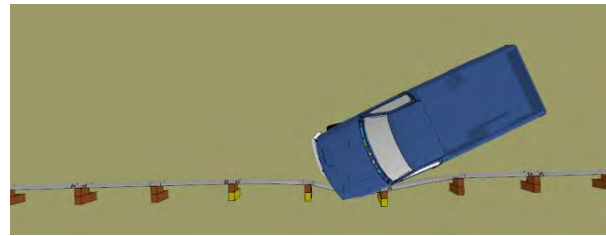
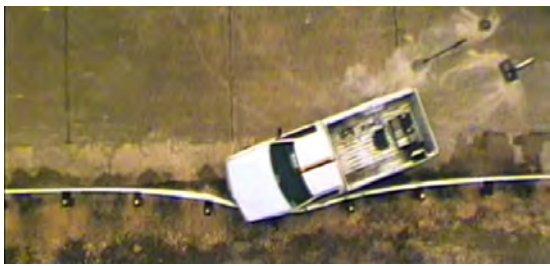
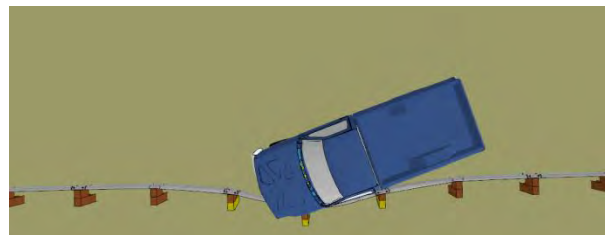
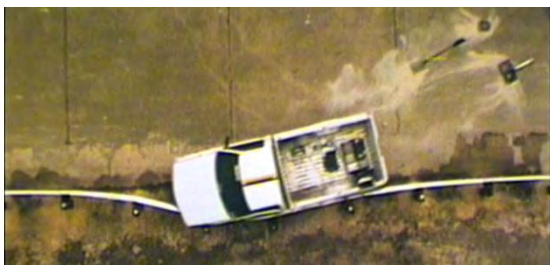
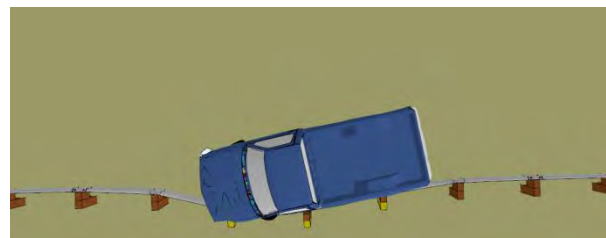
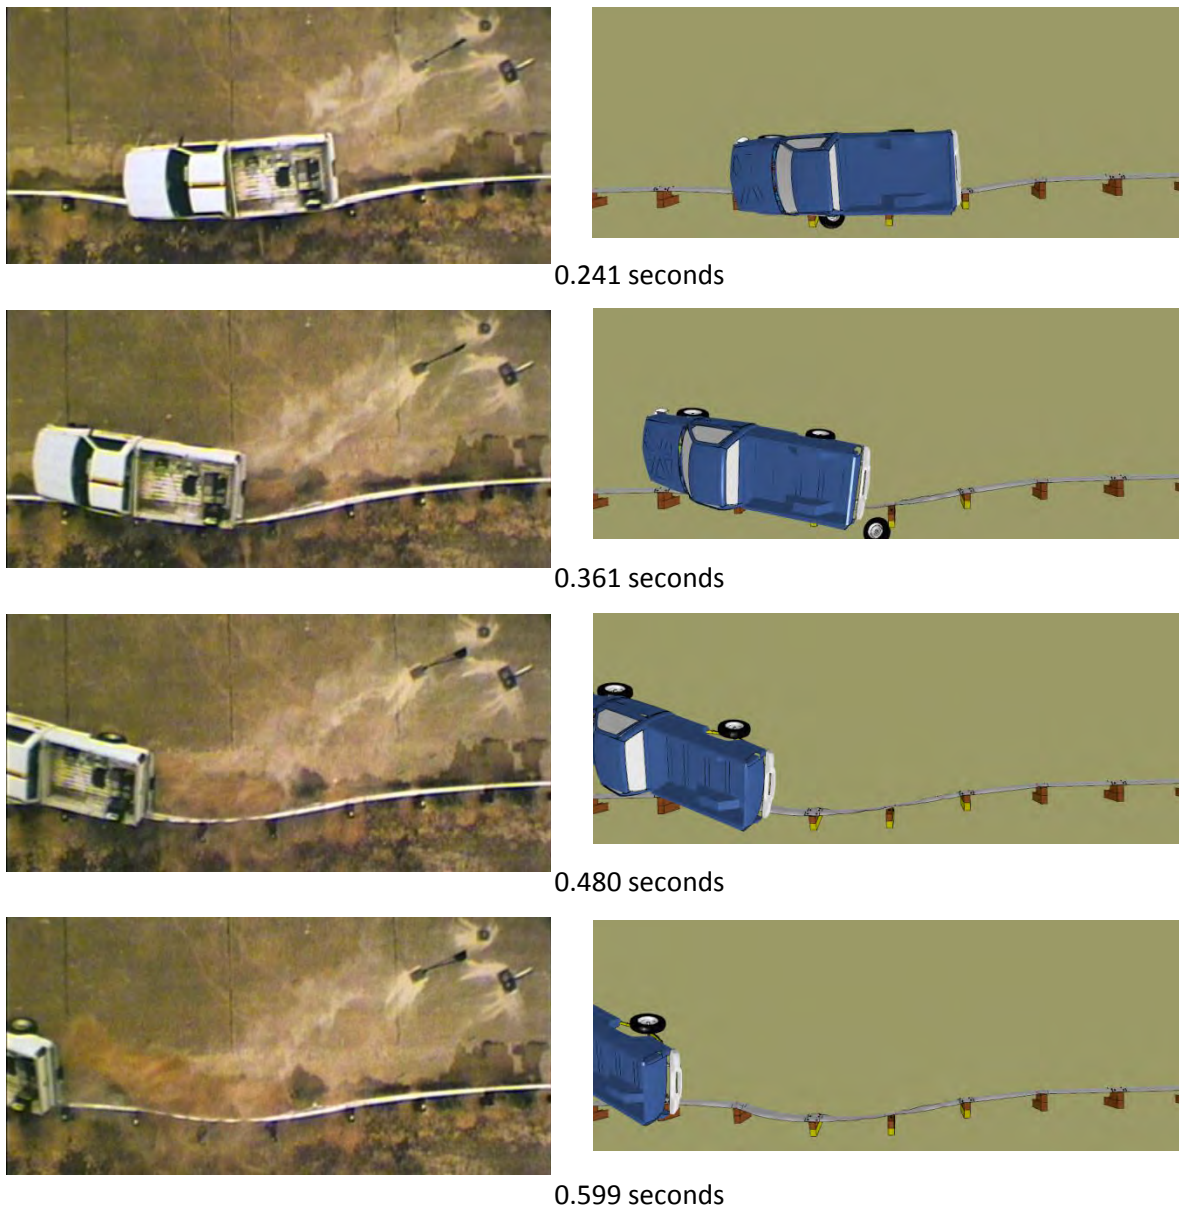
Figure 92. Sequential views of TTI Test 471470-26 and FE analysis from overhead viewpoint.

Figure 92. [CONTINUED] Sequential views of TTI Test 471470-26 and FE analysis from overhead viewpoint.

A qualitative assessment was made by comparing sequential snapshots of the full-scale crash test with the results of the simulation to verify vehicle kinematic response as well as sequence and timing of key phenomenological events. The results from the FE analysis compare reasonably well with the results from full-scale crash test 471470-26. Figure 92, Figure 93 and Figure 94 show sequential snapshots of the impact event from an overhead viewpoint, a downstream viewpoint, and from an oblique (downstream and behind the barrier) viewpoint, respectively. The model appears to simulate the basic kinematic behavior of the pickup and adequately captures the basic phenomenological events that occur during impact. Table 2 provides a list of phenomenological events and their corresponding time of occurrence for both the full-scale test and the FE analysis.

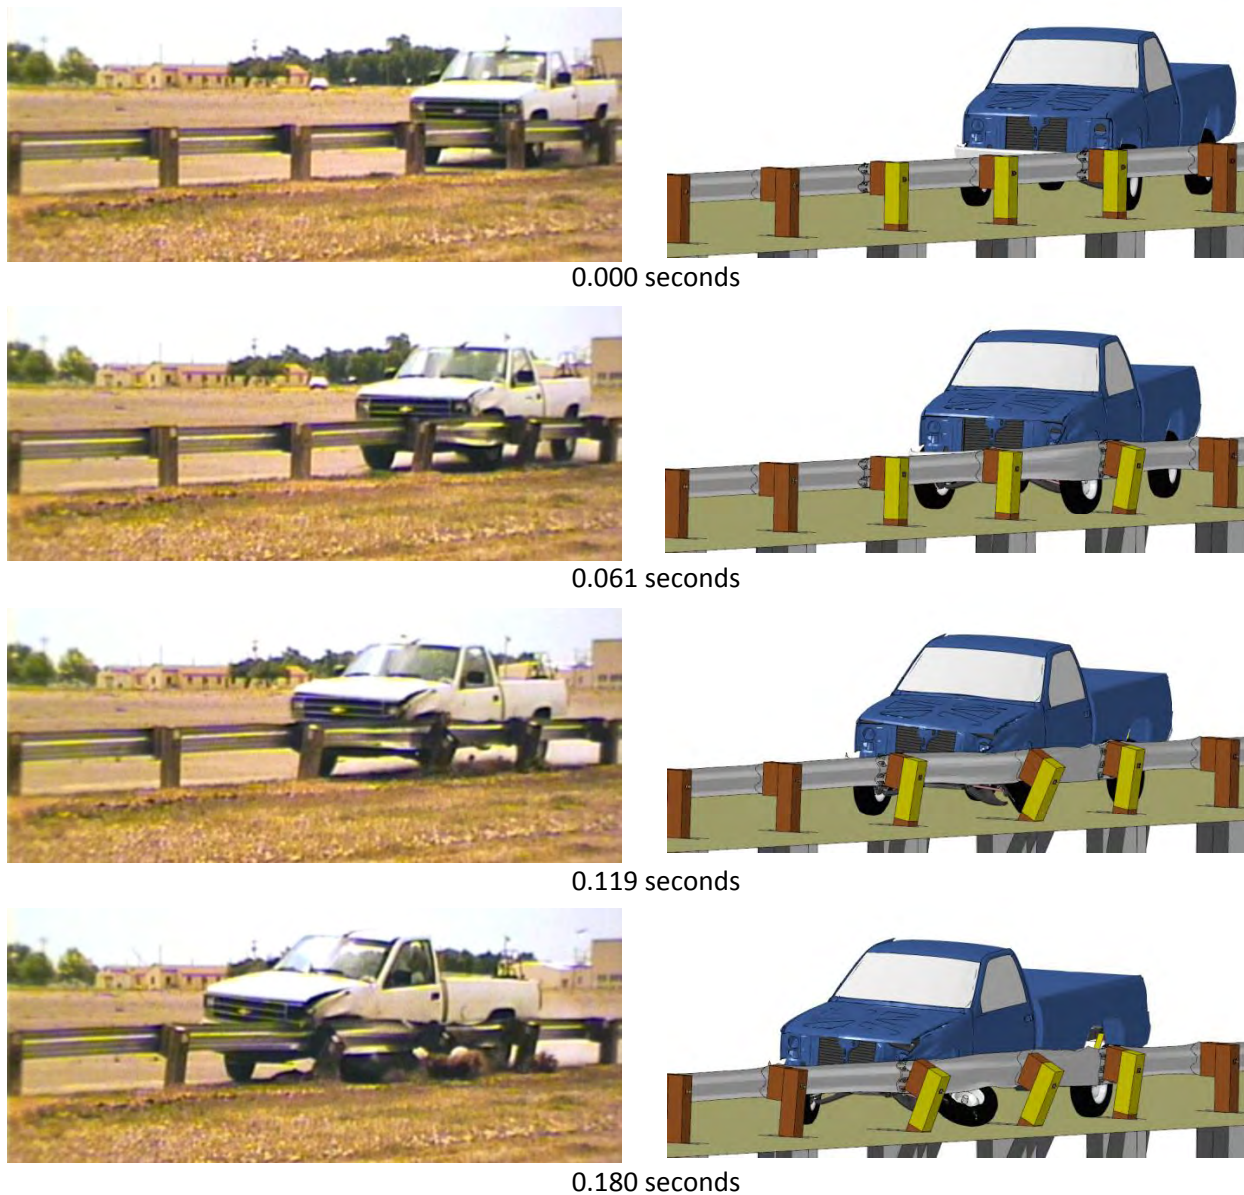
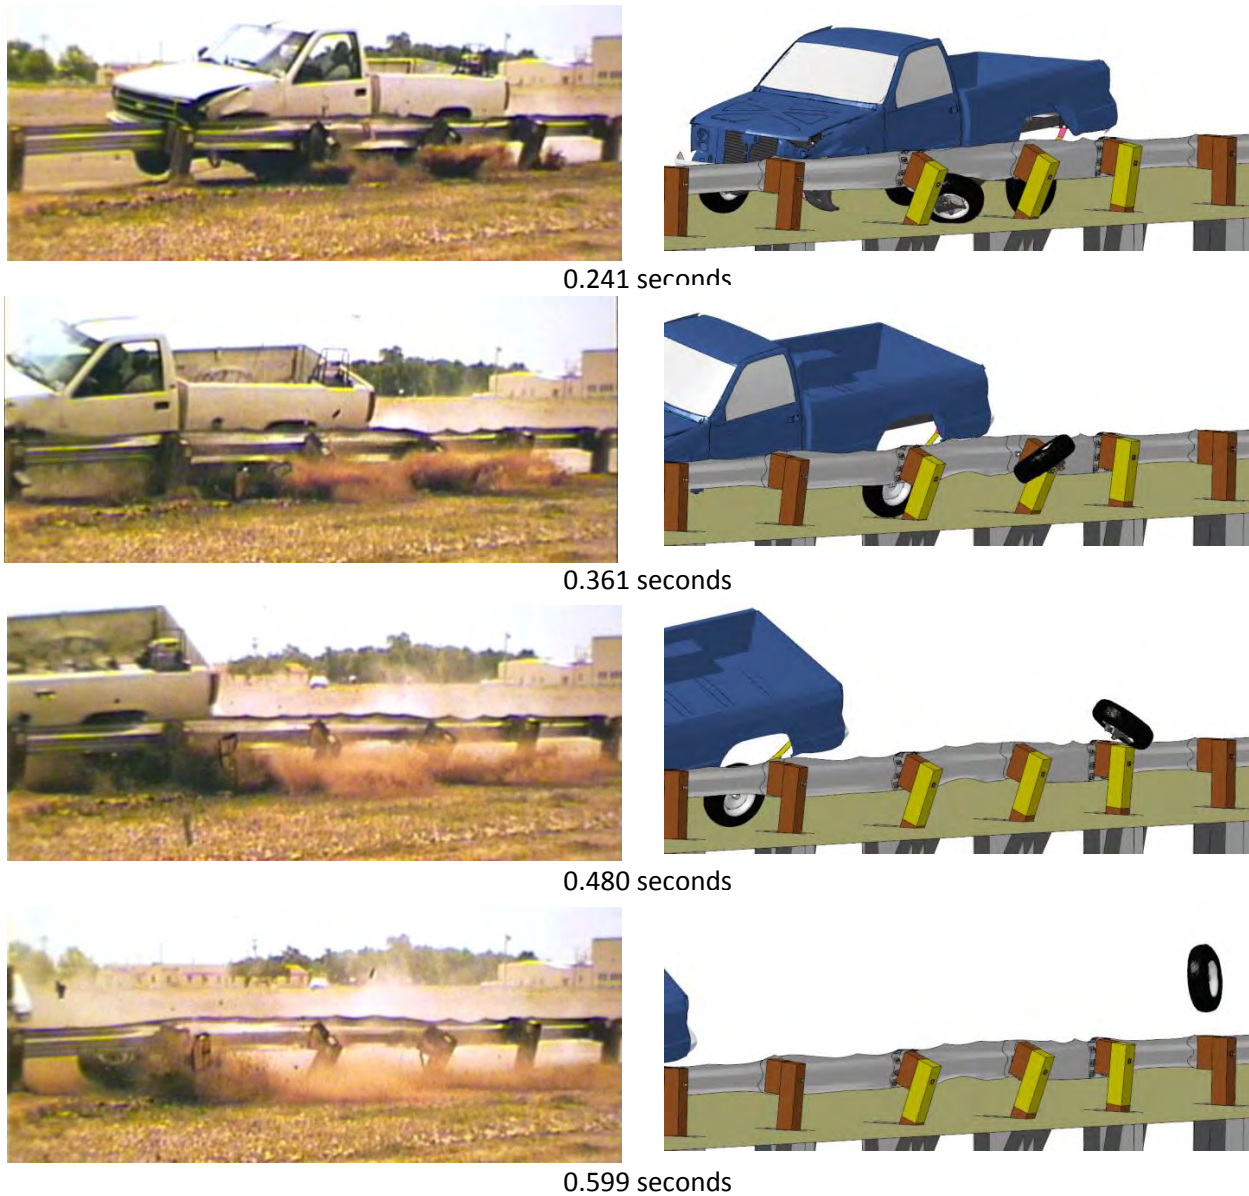
Figure 94. Sequential views of TTI Test 471470-26 and FE analysis from an oblique viewpoint behind the system.

Figure 94. [CONTINUED] Sequential views of TTI Test 471470-26 and FE analysis from an oblique viewpoint behind the system.

The most notable differences between the analysis and the test were the angular displacements of the vehicle. The increased pitch of the vehicle in the analysis allowed the rear bumper to pass over the top of the rail. Refer to Figure 94 starting at time 0.241 seconds. This event resulted in an increased yaw angle of the vehicle during redirection in the analysis and was likely caused by too high of friction between the vehicle and barrier.

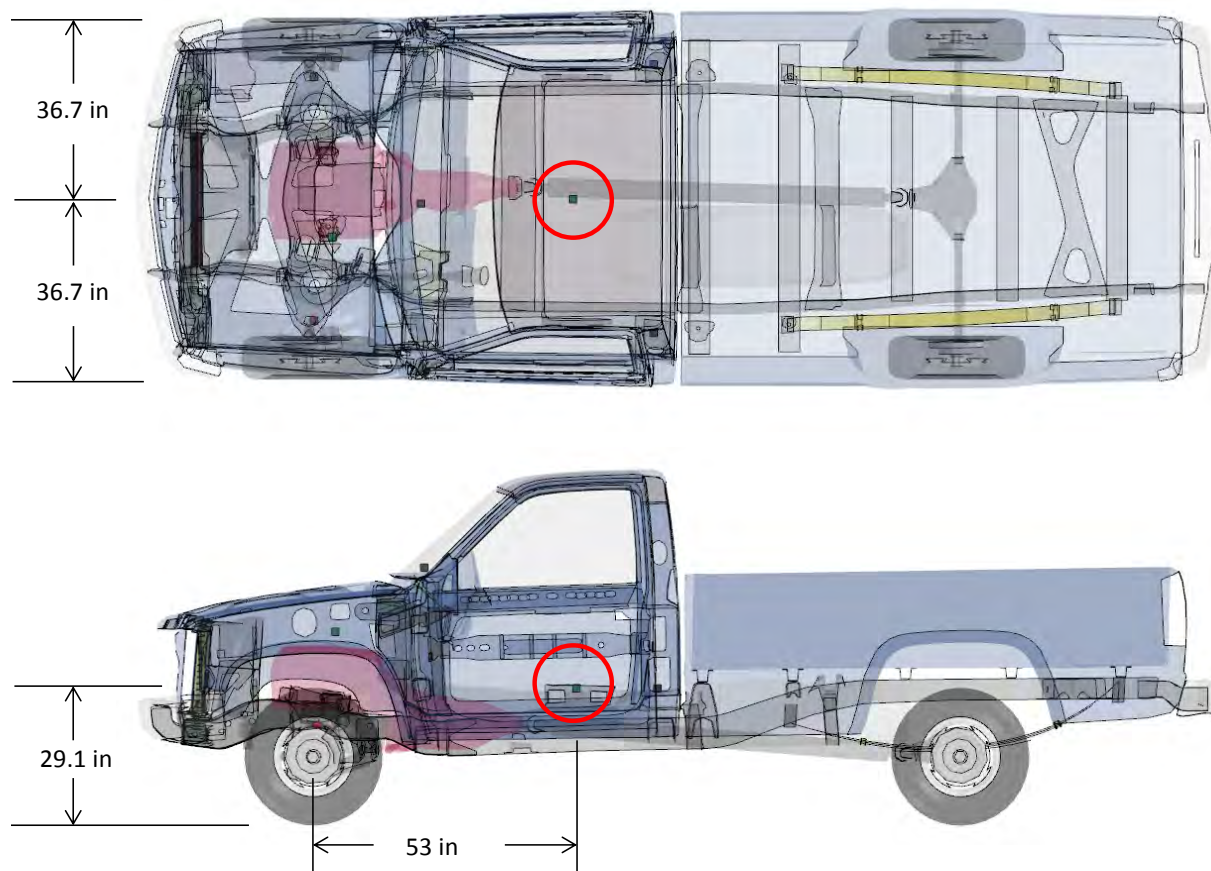
Figure 95. Location of accelerometer in FE model.

Acceleration-time histories and angular rate-time histories were collected from several locations in the model using the *Element-Seatbelt-Accelerometer option in LS-DYNA, which is the preferred method suggested by LS-DYNA for collecting acceleration data.[*LSDYNA13*] The accelerometers were connected to the vehicle model using *Nodal-Rigid-Body-Constraints (NRBs). The time-history data was collected from each accelerometer in a local reference coordinate system that was fixed to the vehicle with the x-direction coincident with the forward direction of the vehicle; which is consistent with the way the test data was collected from physical accelerometers. The data was collected at a frequency of 30 kHz which was determined to be sufficient to avoid aliasing of the data. The model was instrumented with eight accelerometers with one positioned near the center of gravity of the vehicle on the cabin floor, as identified in Figure 95.

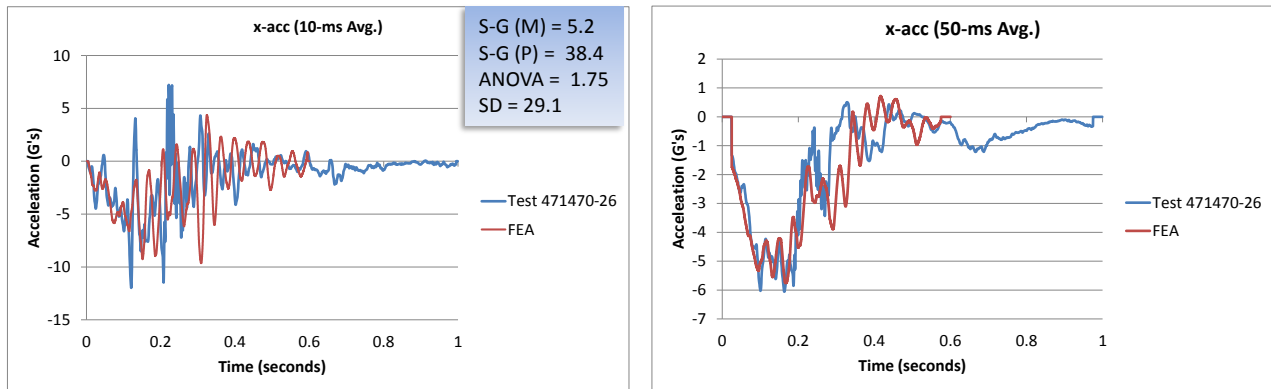
Figure 96. Longitudinal acceleration-time history plot from accelerometer at c.g. for full-scale Test 471470-26 and FEA (10-ms and 50-ms moving averages).

Figure 96, Figure 97, and Figure 98 show a comparison of the 10-millisecond moving average and the 50-millisecond moving average acceleration-time history at the c.g. of the pickup (i.e., longitudinal, transverse and vertical channels, respectively) for the test and FE analysis. Figure 99, Figure 100, and Figure 101 show comparisons of the yaw, roll, and pitch rates and displacements at the c.g. of the pickup for the test and FE analysis. Values for the quantitative evaluation metrics are also shown on the time-history plots. These quantities were computed from the raw acceleration data and are shown with these plots only for reference. The values in red font indicate poor correlation between test and analysis results, while the values in black font indicate good correlation. The quantitative metrics are discussed in more detail in the Quantitative Evaluation section of this chapter.

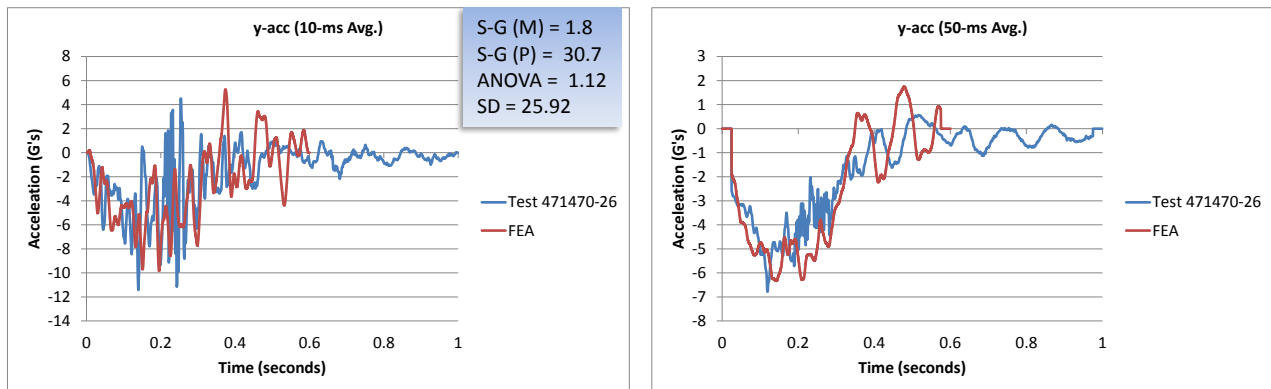
Figure 97. Lateral acceleration-time history plot from accelerometer at c.g. for full-scale Test 471470-26 and FEA (10-ms and 50-ms moving averages).

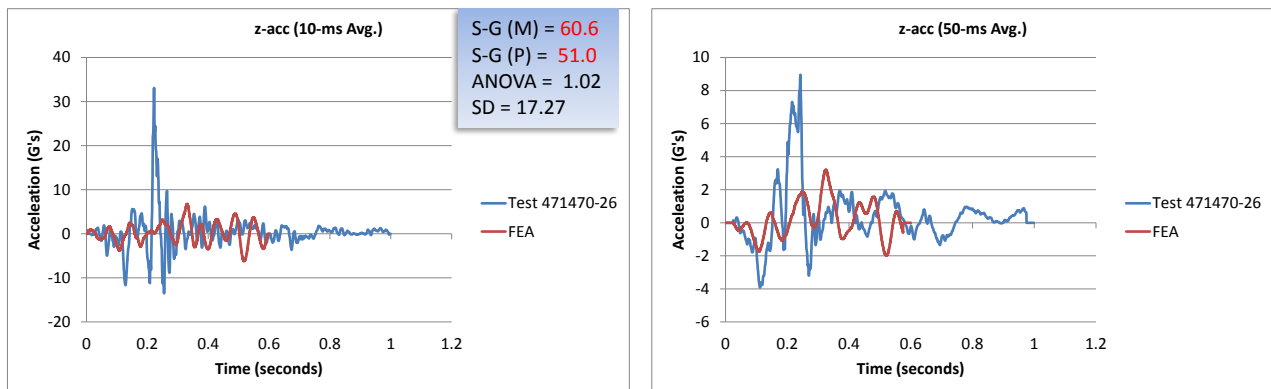
Figure 98. Vertical acceleration-time history plot from accelerometer at c.g. for full-scale Test 471470-26 and FEA (10-ms and 50-ms moving averages).

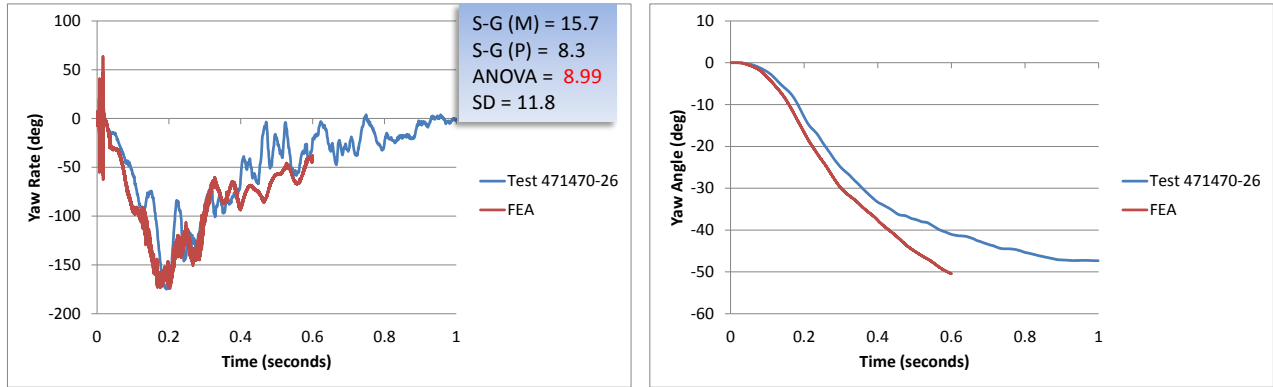
Figure 99. Yaw-time history plot from accelerometer at c.g. for full-scale test 471470-26 and FEA (angular rate and displacement).

Similarly, the pitch angle magnitude was comparatively less than that for the yaw and roll channels (refer to Figure 99, Figure 100 and Figure 101). The weighted metrics computed in RSVVP in the multi-channel mode all satisfy the acceptance criteria; therefore, the time history comparison can be considered acceptable.

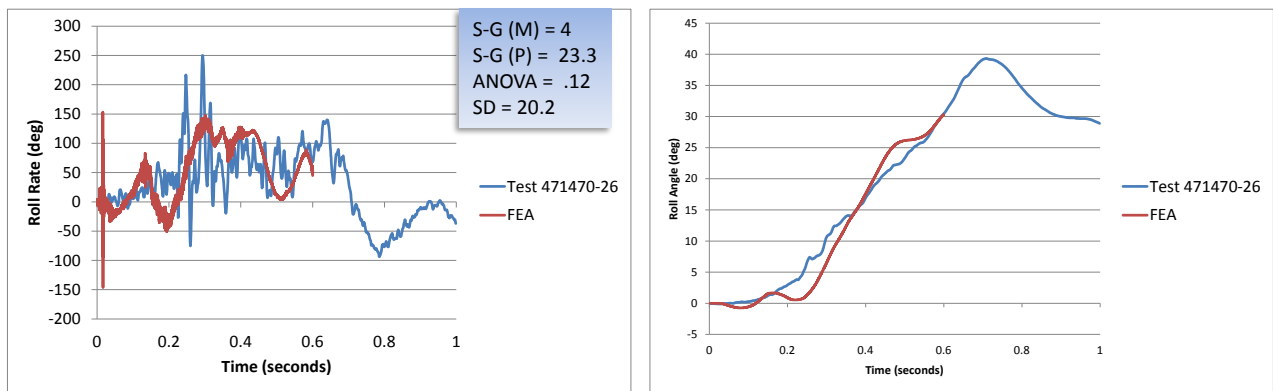
Figure 100. Roll-time history plot from accelerometer at c.g. for full-scale test 471470-26 and FEA (angular rate and displacement).

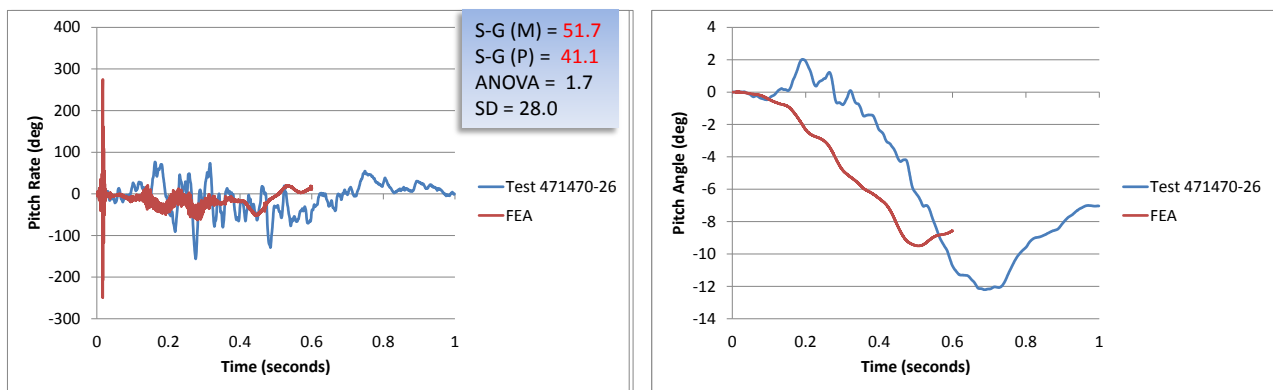
Figure 101. Pitch-time history plot from accelerometer at c.g. for full-scale test 471470-26 and FEA (angular rate and displacement).

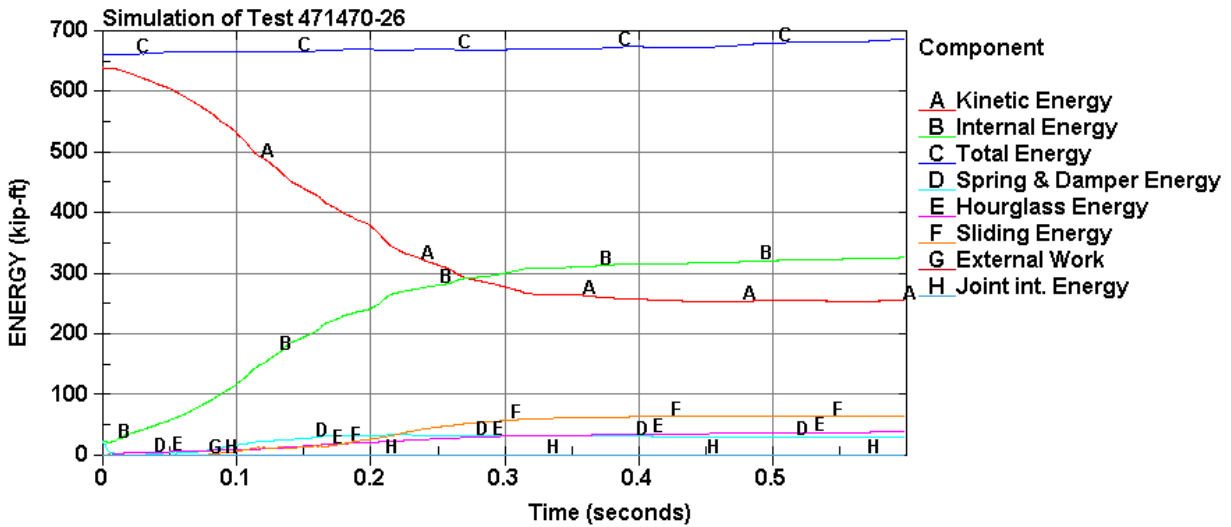
Figure 102. Plot of global energy-time histories from the analysis.

The first step in the validation process is to perform global checks of the analysis to verify that the numerical solution is stable and is producing physical results (e.g., results conform to the basic laws of conservation). The analysis was modeled as a closed system, which means that energy is not being added or removed during the analysis. Thus, the total energy should remain constant throughout the analysis and should be equal to the initial kinetic energy of the impacting vehicle. The one exception in this case is any kinetic energy generated due to the gravity load (which should be minimal during the short time period of the crash event relative to the initial kinetic energy of the vehicle). Table 32 shows a summary of the global verification assessment based on criteria recommended in Report W179. Figure 102 shows a plot of the global energy-time histories from the analysis.

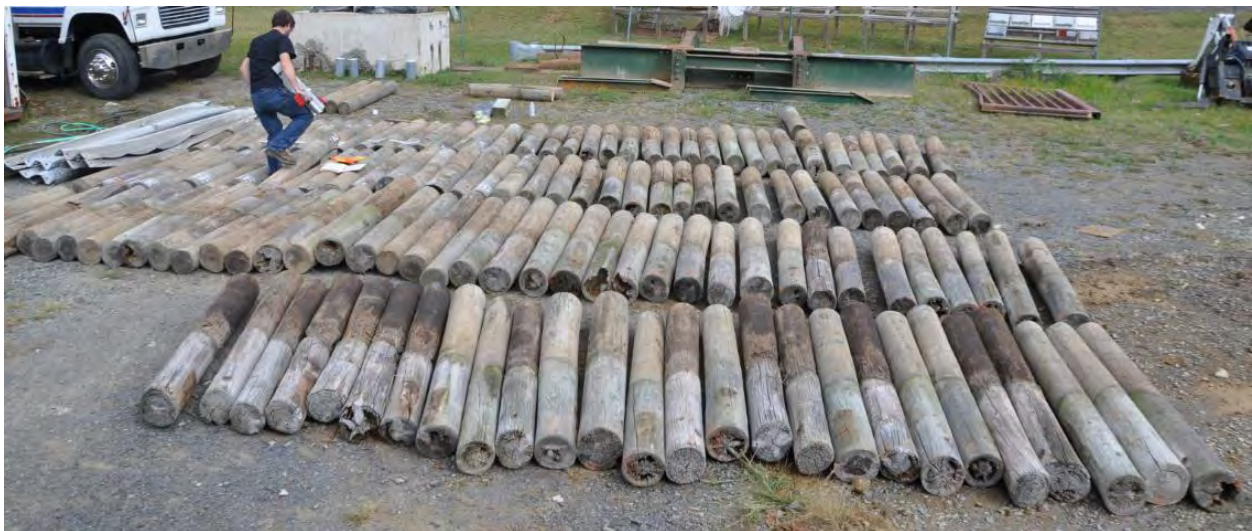
Figure 104. Posts from Ohio DOT procured for the Physical Test Program.

The Ohio Department of Transportation (ODOT) provided 140 guardrail posts with various levels of deterioration for the test program. These posts were extracted from the ground from damaged guardrail installations in Ohio. It has not been confirmed, but all the posts are assumed to be of the Southern Yellow Pine (SYP) species, which is the post type primarily used in Ohio. The posts all had round cross-section with nominal diameter size of 8 inches. The actual diameter size varied from 6.45 inches to 9.15 inches with standard deviation of 0.62 inches. In some cases the smaller diameters were a result of shell loss due to deterioration. The post lengths varied from approximately 5 to 6 ft, with the two most common lengths being 5 ft – 6 inches and 5 ft – 10 inches. Figure 104 shows a photo of the guardrail posts provided by the Ohio DOT for use in the physical test program. In addition to the deteriorated posts, ODOT also donated three new (or unused) guardrail posts to the project so that the Resistograph measurements from the in-service posts could be compared directly to the corresponding values for new posts.

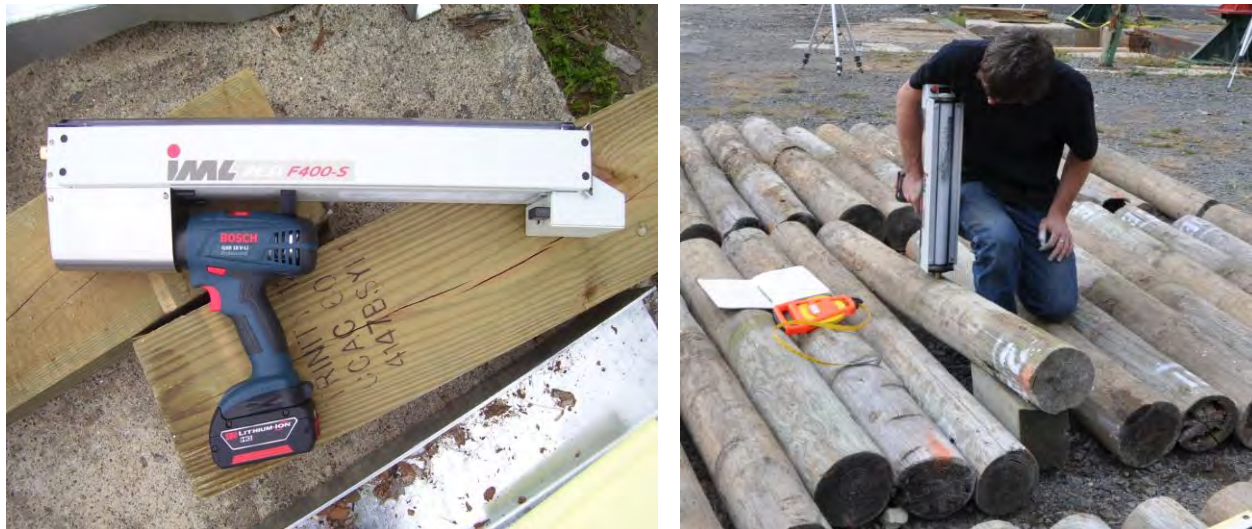
Figure 105. IML Resi-F400 S Resistograph.

The deterioration of each post was measured using an IML Resi-F400 S Resistograph, shown in Figure 105. The resistograph was equipped with a 1/16 inch in diameter drilling needle 19 ⁵/₁₆ inches long. The resistograph measurements were recorded at increments of approximately 0.004 inches of drilling depth. The measurements were taken just below, or at, the groundline where the highest levels of deterioration were visually evident. With the posts extracted from ground, this critical area of the post was readily accessible, so the measurements were made at 90 degrees to the post.

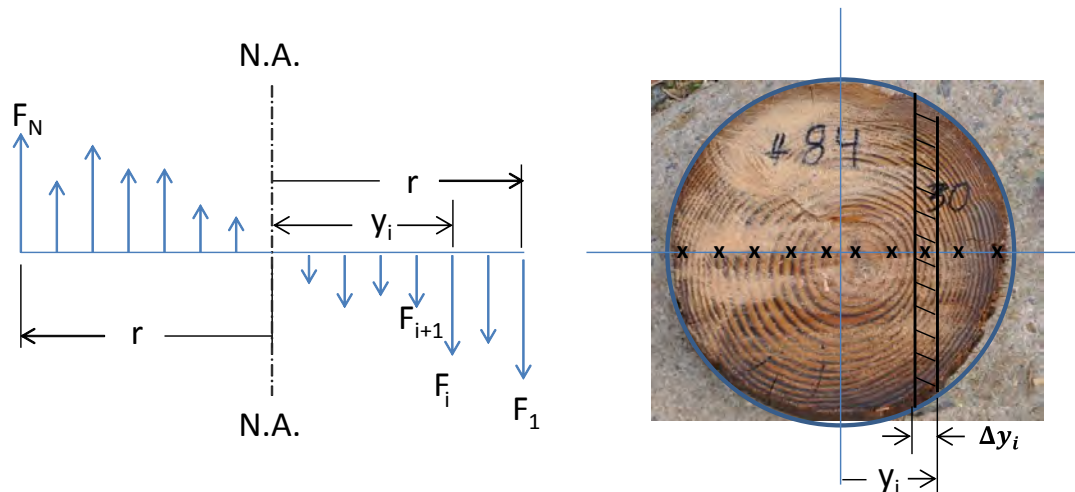
Figure 107. Schematic illustrating internal force distribution through cross-section of a circular shaped post.

If the internal force at Point A in Figure 106 is approximated in terms of discrete forces, F_i , acting at fixed increments, y_i , through the cross-section of the post, as illustrated in Figure 107, then the equilibrium condition can be re-written as:

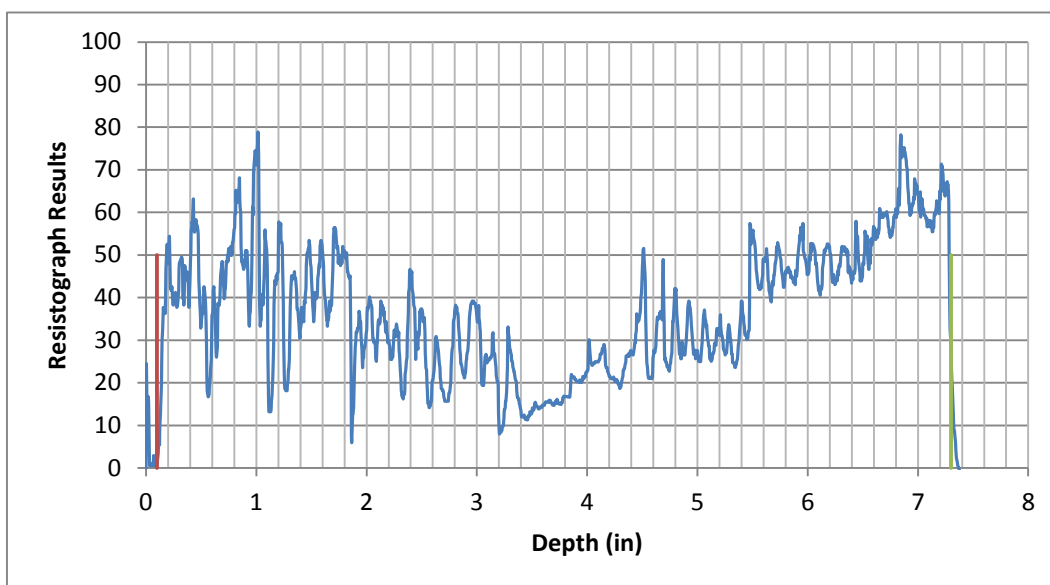
Figure 108. Resistograph results for Post A.

Figure 108 shows the resistograph results for one of the new posts (i.e., Post A), illustrating a typical drill-torque vs. depth plot through the cross section of a guardrail post. Note that the torque resistance is not constant through the cross-section due to the non-homogeneous nature of wood, and also tends to oscillate considerably at each increment as the needle passes through each ring (or layer) of the post. For the following calculations, the data is used in its raw form (i.e., unfiltered).

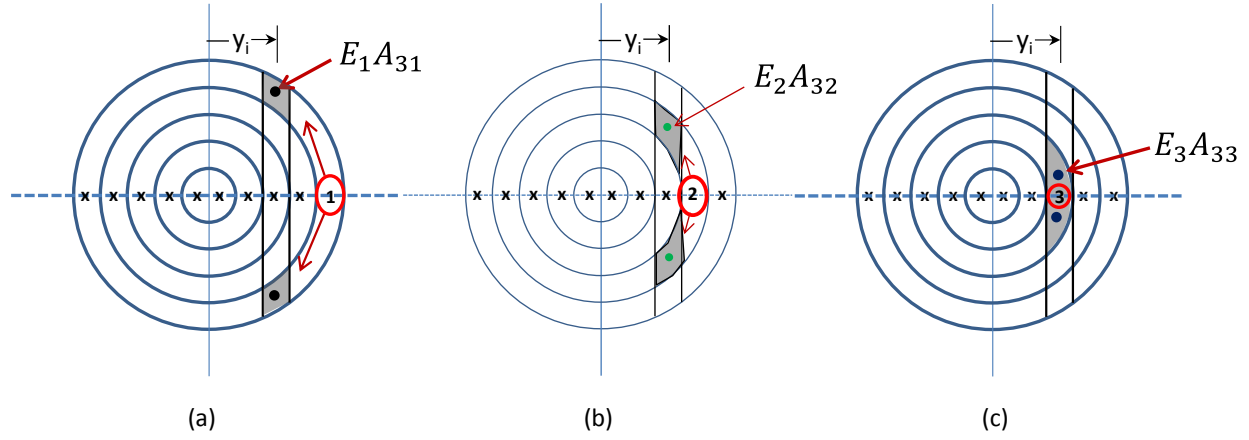
Figure 109. Schematic illustrating the local moduli and subareas associated with the various points through the post thickness at $y = y_i$.

The resistograph data is measured along the centerline of the post’s cross-section. It is assumed that the torque resistance amplitude at each point is directly proportional to the modulus (or strength) of the torque post fibers at that radial depth within the post. For example, the hashed cross-section of Figure 107 shows the overall area for the representative force, F_i , acting at $y = y_i$. As wood posts age and deteriorate, the properties of the wood will differ depending on its depth within the post. As illustrated in Figure 109, the crosshatched region at $y = y_i$ includes points at multiple depth locations through the post, where the number of points increases as y_i approaches zero (i.e., the neutral axis). Each of these points is associated with a local modulus, E_j , and a representative subarea, A_{ij} , as illustrated in Figure 109. For example, the shaded area in Figure 109(a) is representative of the subarea bounded by the two outermost rings which correspond to radii $r = y_1$ and $r = y_2$ and the two vertical lines $y = y_i$ and $y = y_{i+1}$. The properties of the post at

this location are assumed to be the same as that measured at Point 1 (outer most data point circled in Figure 109), which was taken directly from the resistograph data. Likewise Figure 109(b) and Figure 109(c) illustrate the local subareas at $y = y_i$ associated with the resistograph data points measured at Point 2 and Point 3, respectively, for $i=3$.

The relationship between the strain ϵ_R and E_j^* was not determined, so the value for ϵ_R was set to unity for calculations of M^* . The subarea A_{ij} , as illustrated previously in Figure 109, can be computed using the simple formula for defining the area bounded between two circles with limits of y_{i+1} to y_i as:

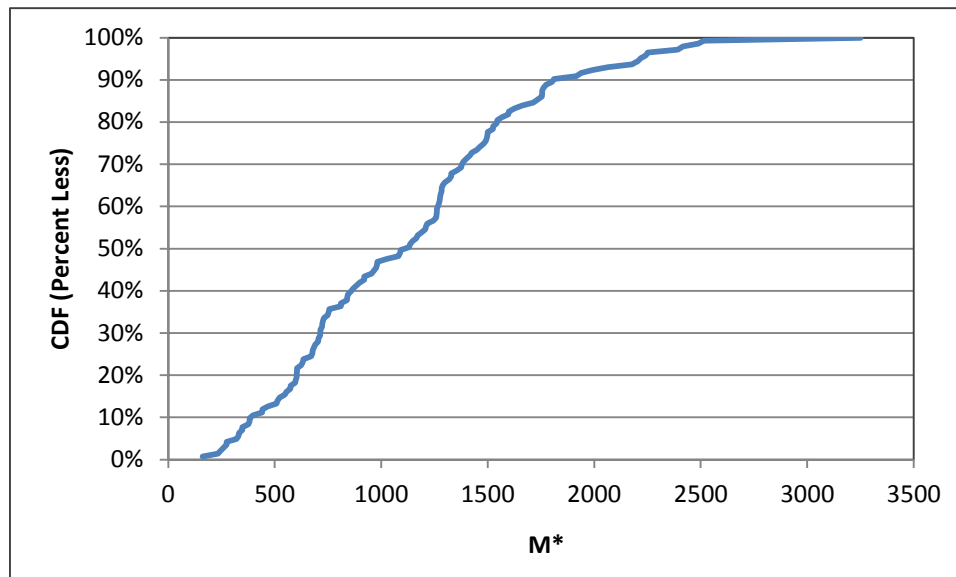
Figure 110. Cumulative distribution plot for M^* .

Resistograph measurements were taken for each of the 140 aged post specimens and the three new post specimens obtained from the Ohio DOT. The values for M^* ranged from 162 to 3251 with a mean value of 1123 and standard deviation of 11.3. The values for U^* ranged from 40.9 to 812.9 with mean of 294.6 and standard deviation of 140.9. Figure 110 and Figure 111 show the cumulative distribution function for M^* and U^* , respectively, which indicate relatively uniform distribution of scores.

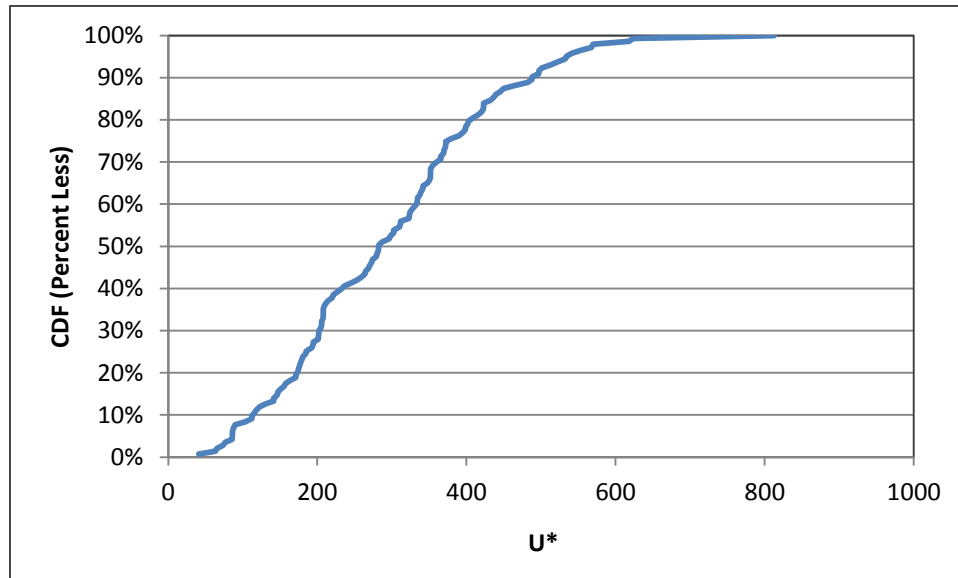
Figure 111. Cumulative distribution plot for U^* .

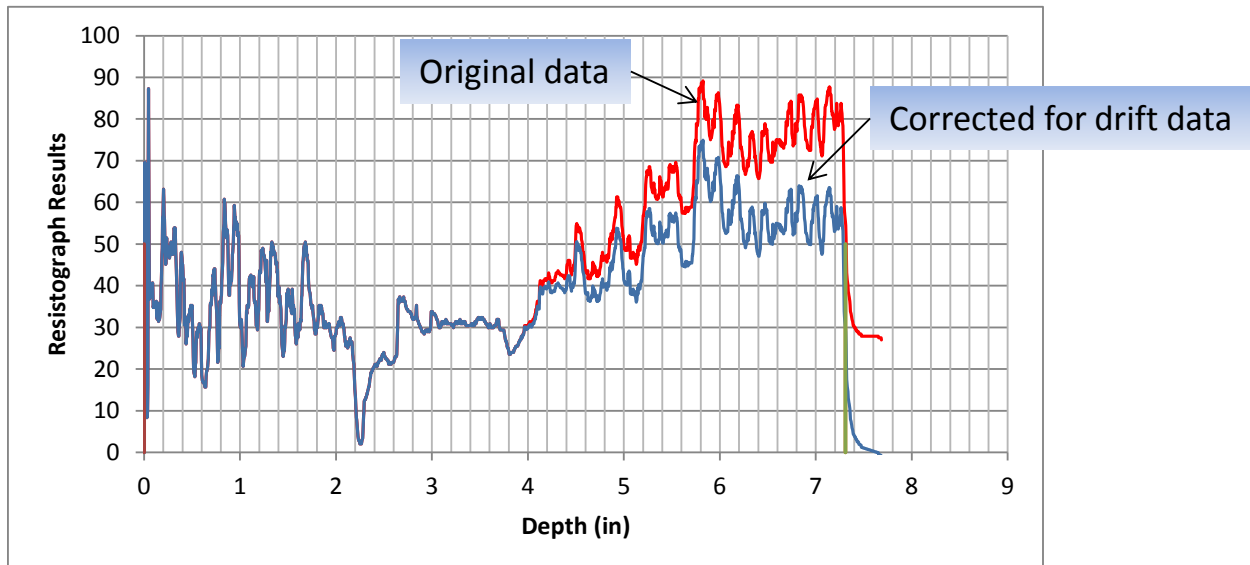
Figure 112. Resistograph data corrected for drift.

In some cases the resistograph data did not fall back to zero when the drilling needle passed through the back-side of the post. This indicated that the needle likely encountered a “check” or a knot at some point during the test that turned the needle from its straight path and affected subsequent results (e.g., friction and bending of the needle may have increased the resistance measurements). This was somewhat corrected in the data by estimating the most logical location for the start of the divergence and assuming that the error was increasing linearly for the duration of the test, as illustrated in Figure 112. A logical solution for avoiding this phenomenon would be to drill only half way through the diameter on each side of the post.

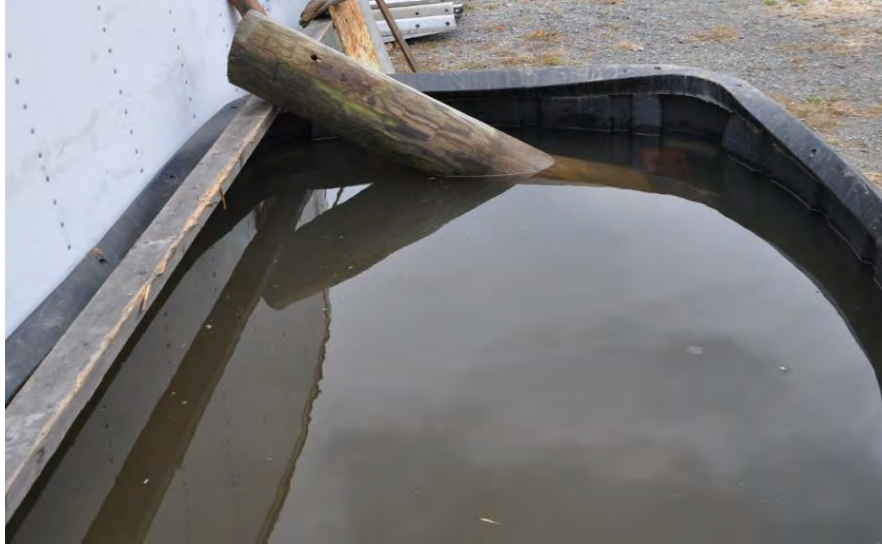
Figure 113. Photo of post specimen soaking in tank of water.

In order to reduce the effects of moisture content, each wood post specimen was saturated prior to testing. Each specimen was cut to 66 inches long, weighed, and then soaked for several hours in an open water tank as shown in Figure 113. Only the portion of the posts that were to be embedded into the steel sleeve (i.e., below groundline) was submerged in the tank to achieve realistic saturation of the posts (i.e., saturation below the groundline and air-dried above the groundline). The pre-soaked post specimens were again weighed just prior to testing. The circumferences of the posts were measured at the top, at the groundline and at the bottom of the posts to estimate the average diameter of the post. The average diameter, post length and weight of the post were then used to calculate the wet density for each post. The number of rings for each post was counted and used to determine the average ring density for each post. The moisture content was measured immediately after each pendulum test at several points through the cross-section of the post along the break-line using an [MT-10](#) moisture meter developed by AMPROBE. The moisture meter was not able to obtain accurate readings when the moisture content exceeded 50 percent. In those cases the moisture content was reported as “greater than 50 percent”.
