Criteria for Restoration of Longitudinal Barriers, Phase II (2021)

Criteria for Restoration of Longitudinal Barriers, Phase II

Contractor's Final Report for NCHRP Project 22-28
Submitted June 2015

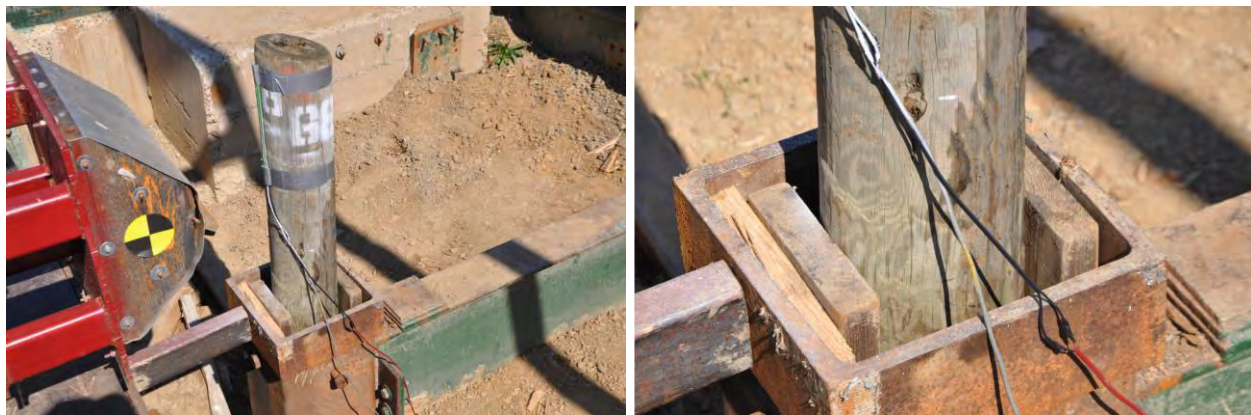
Figure 114. Rigid steel sleeve used for post mounting.

The tests were performed with the posts installed in a rigid steel sleeve, as shown in Figure 114. The sleeve was a 12 x 12 x ¼ inch steel tube fabricated from A500 Class B 58,000 psi structural steel. The top of the tube was reinforced with a 5-inch tall 13 x 13 x ½ inch steel tube welded to the main tube sleeve. The foundation sleeve was braced against the steel reinforced concrete wall on the inside of the ground-pit using a 7.4 ft long S20x86 structural steel section. The posts were mounted inside the sleeve at a nominal depth of 38 inches, except for the few cases in which the length of the post was too short (e.g., several of the posts were only 60 inches long, which resulted in an embedment of 32 inches). In all cases, the top mounting height of the posts was nominally 28 inches. The posts were held in place inside the sleeve using structural grade pine boards (e.g., 2x8) that were press-fit against the back-side of the sleeve using a 1.0-inch diameter grade 8 set-screw.

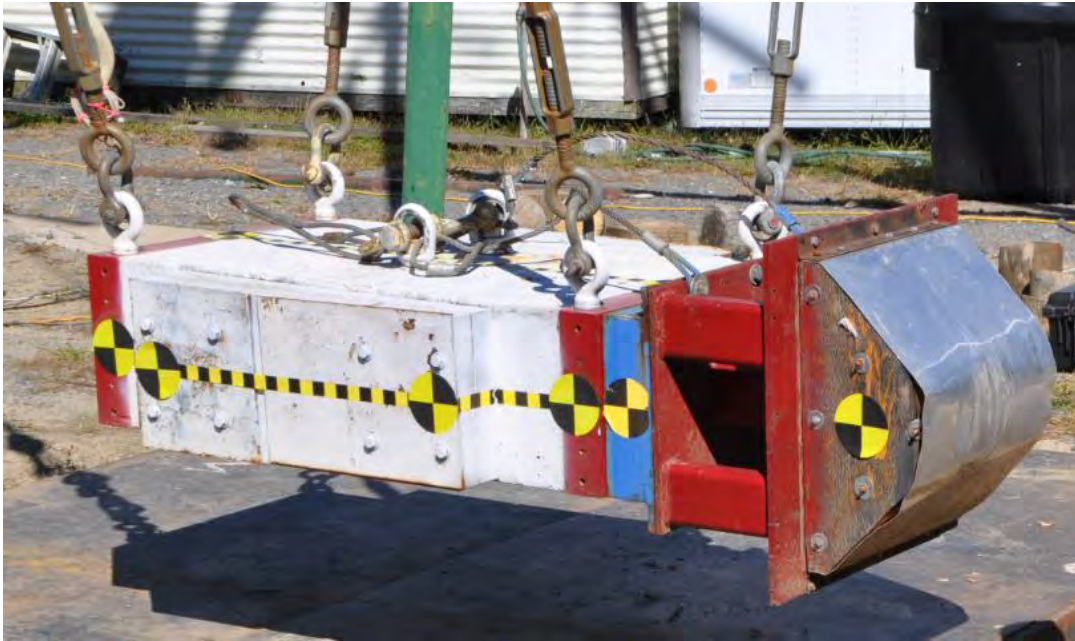
Figure 115. 2,372-lb pendulum device with semi-rigid nose.

The striker for the tests was a 2,372-lb concrete pendulum with a semi-rigid nose, as shown in Figure 115. The semi-rigid nose, which was developed by researchers from Virginia Tech during the first phase of this study, was fabricated from a wooden block and covered with sheet metal. [Gabler10] The radius of chamfer at the center of the impactor face was 6 inches, which was based on measurements of a 2006 Chevrolet 1500 pickup truck. [Gabler10]

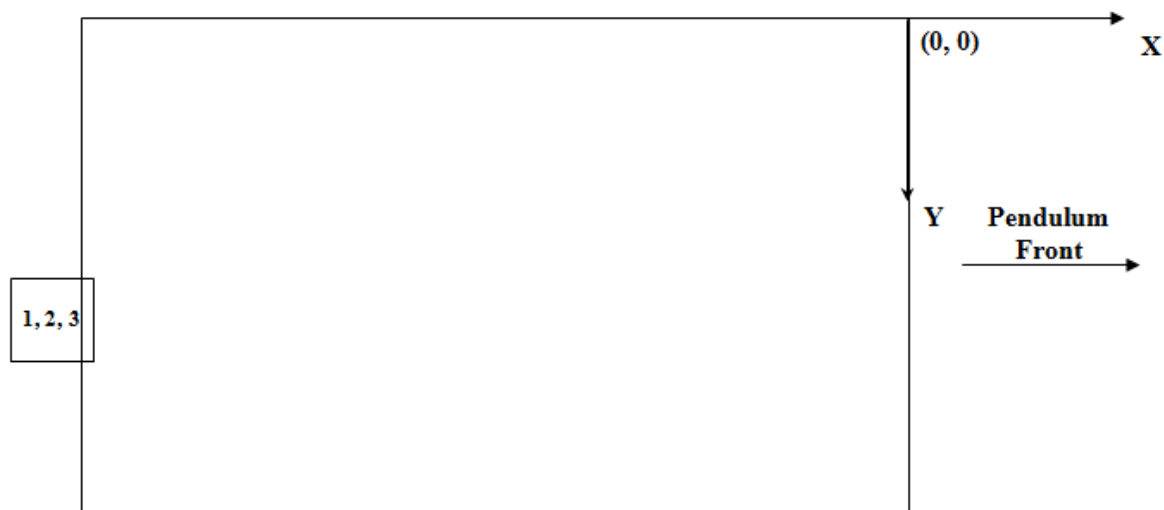
Pendulum top view with accelerometer blocks

CH.	LOCATION	X (cm) From frt.	Y (cm) From lft frt. corner	Z (cm) From ground	SERIAL NO.	AXIS
1	Rear Center of Pend.	43.0	127.0	71.0	D12153	-X
2	Rear Center of Pend.	43.0	127.0	71.0	D12748	-X
3	Rear Center of Pend.	43.0	127.0	71.0	D12820	-Z

Figure 116. Schematic of the accelerometer instrumentation for the pendulum tests.

The pendulum was instrumented with three accelerometers mounted onto the backside of the pendulum mass. Two of the accelerometers recorded data in the x-direction (forward direction) and the third accelerometer recorded data in the z-direction (vertical direction). Figure 116 provides a schematic showing the locations of the accelerometers.

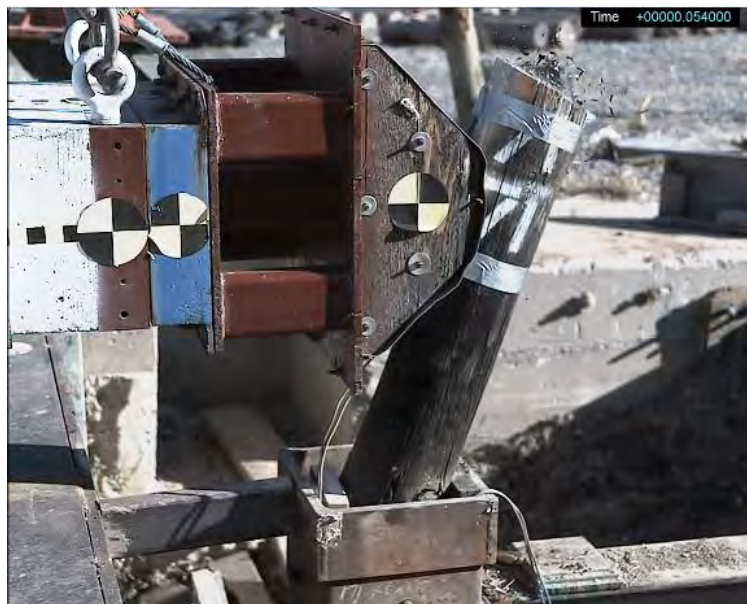
Figure 118. Photo of Test 13009G1 showing Post 71 breaking below groundline.

Although the intent of the rigid foundation tube was to create a “fixed” condition on the post at the groundline, the posts sometimes failed inside the foundation tube below the groundline, as illustrate in Figure 118. As a result, the moment arm (i.e., the distance from the impact point to the break point) was slightly different in each test. It was therefore decided to compute post capacity in terms of maximum resistive moment rather than maximum force. One complication, however, was that the posts do not generally fail along plane sections, let alone a perpendicular plane. To obtain a rough estimate for the length of the moment arm in each test, the average distance from the impact point on the post to the break line on the front and back side of the post was used.

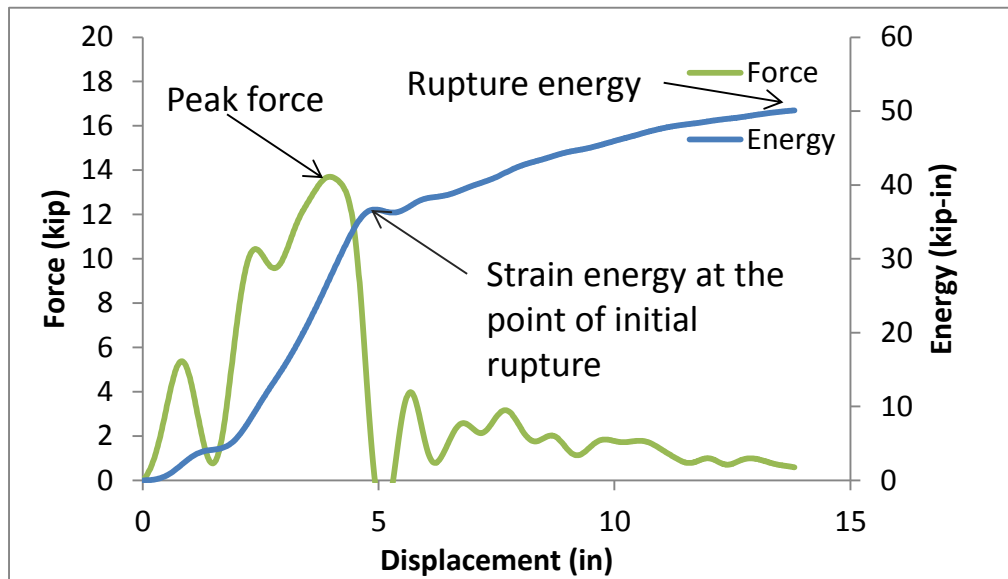
Figure 119. Typical force and energy curves annotated to illustrate location of peak force, initial rupture energy, and rupture energy computed from pendulum test results.

Table 41 provides the peak force, the strain energy at initiation of rupture, peak moment, and the energy at complete rupture for each post in Test Series 1. Figure 119 shows typical force and energy curves annotated to illustrate location of peak force, initial rupture energy, and rupture energy computed from the pendulum impact tests. The test summary sheets for this test series are shown in Appendix D.

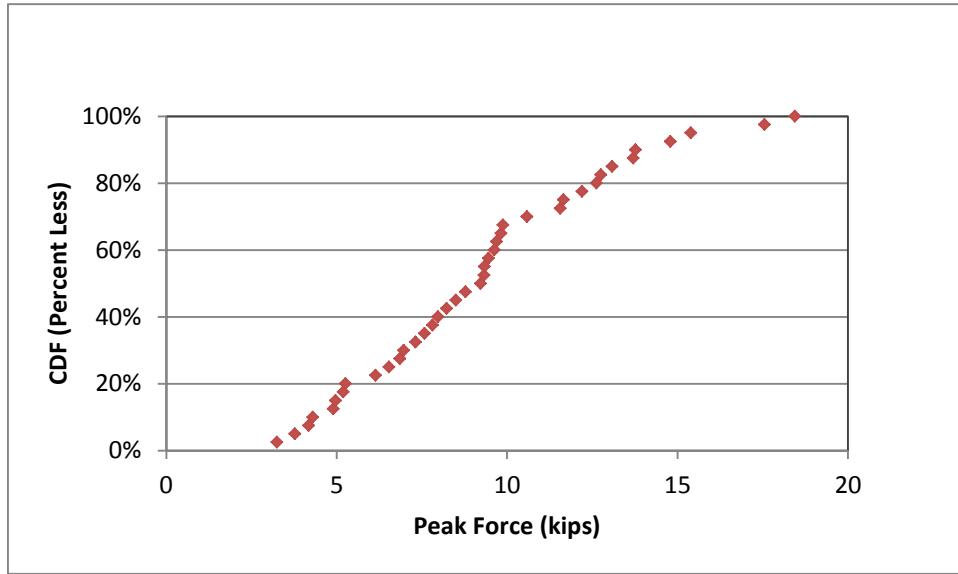
**Figure 120. Cumulative distribution plot for the peak force values measured in Test Series 13009 (Group 2).**

Table 42 provides the peak force, the strain energy at initiation of rupture, peak moment, and the energy at complete rupture for each post in Test Series 13009 Group 2. The test summary sheets for this test series are shown in Appendix E. For the 39 tests, the peak force ranged from 3.25 kips to 18.4 kips, with a mean of 9.32 kips and standard deviation of 3.75 kips. The strain energy of the post at the point of initial rupture ranged from 4 kip-in to 43.3 kip-in, with mean of 21.4 and standard deviation 11.5. The total energy absorbed by the post at the point of complete rupture ranged from 5.44 kip-in to 80.6 kip-in, with a mean of 27.7 and standard deviation of 16.0. These statistics are summarized in Table 43, and the cumulative distribution functions for these three strength capacity metrics are shown in Figures 120 through 122.

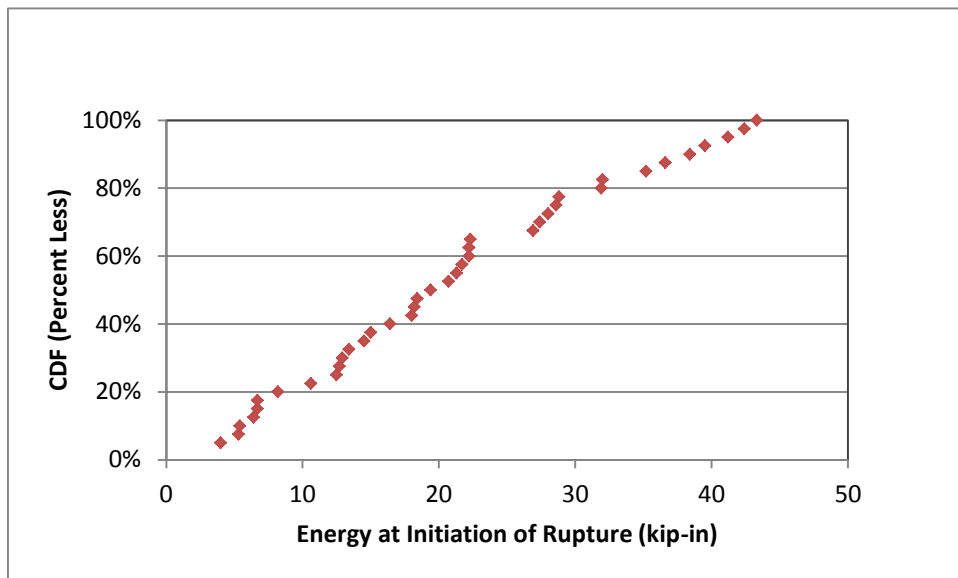
**Figure 121. Cumulative distribution plot for the strain energy in the post at initiation of rupture measured in Test Series 13009 (Group 2).**

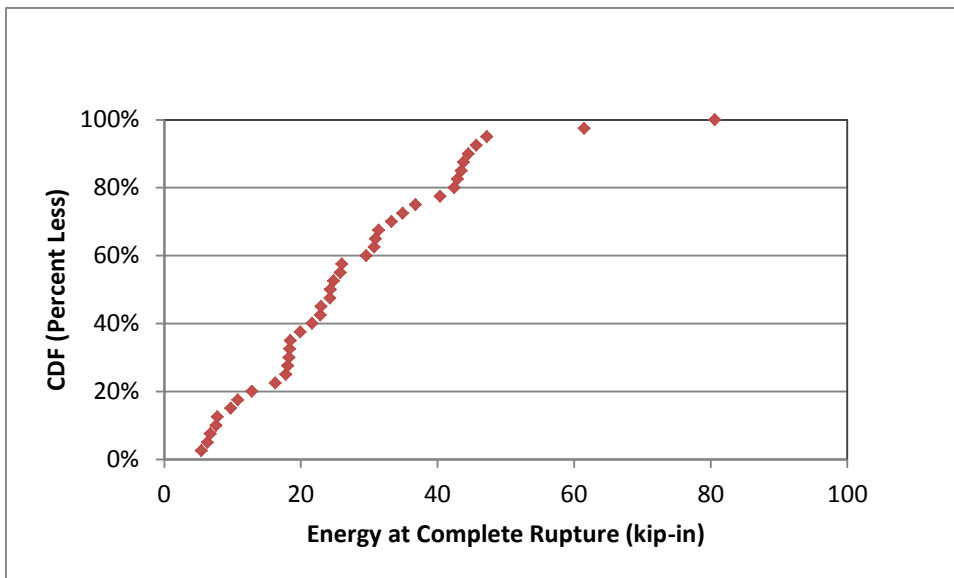
Figure 122. Cumulative distribution plot for the total energy absorbed by the post at complete rupture measured in Test Series 13009 (Group 2).

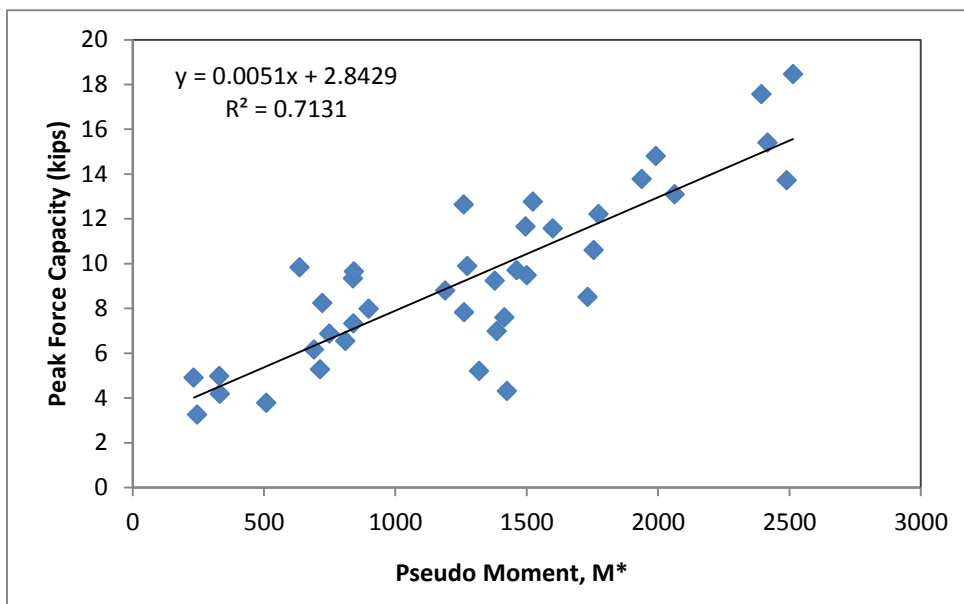
Figure 123. Peak Force vs. M^* for Test Series 13009 Group 2 (all data).

The data from Group 2 of Test Series 13009 were used to assess the relationship between the resistograph measurements to peak force and energy capacity of the posts. Figure 123 shows a plot of the peak impact force vs. M^* ; Figure 124 shows a plot of the maximum resistive moment vs. M^* ; Figure 125 shows a plot of the strain at initiation of rupture vs. U^* ; and Figure 126 shows a plot of the rupture energy vs. U^* . The linear regression of the data for the peak force and peak moment curves yielded R^2 values of 0.71 and 0.70, respectively, which indicated that both curves fit the data reasonably well. The linear regression fit of the energy at rupture initiation yielded an R^2 value of 0.66, which indicated that this curve was also a reasonable fit. The linear regression for the rupture energy data, however, yielded R^2 value of 0.43 which indicated a significant scatter in the data.

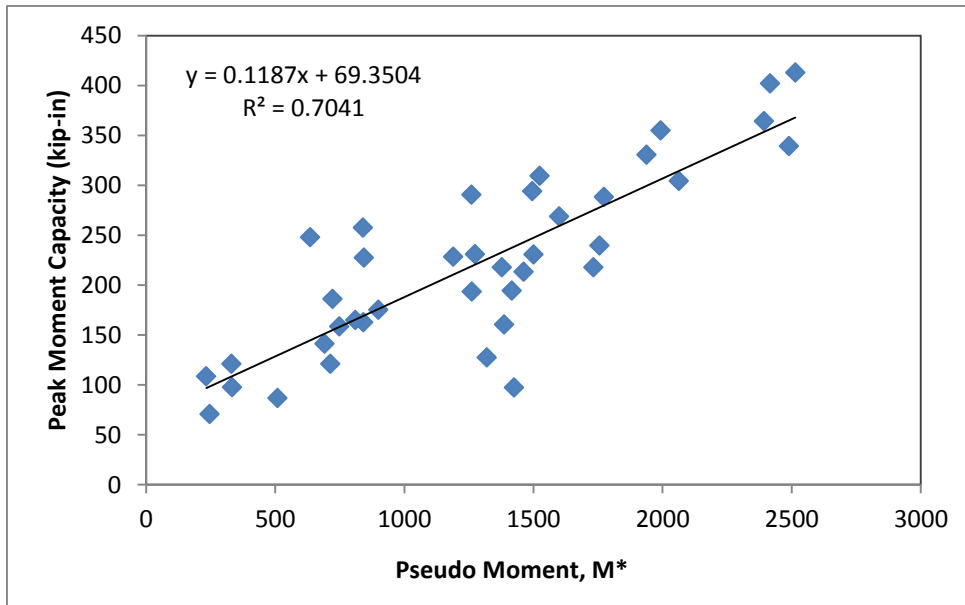
Figure 124. Peak Moment vs. M^* for Test Series 13009 Group 2 (all data).

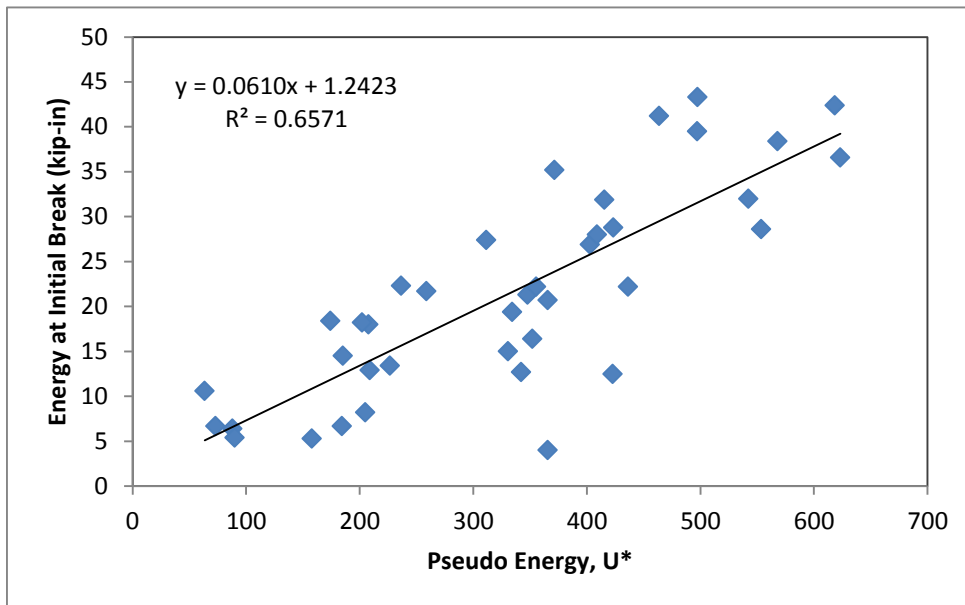
Figure 125. Energy at rupture initiation vs. U^* for Test Series 13009 Group 2 (all data).

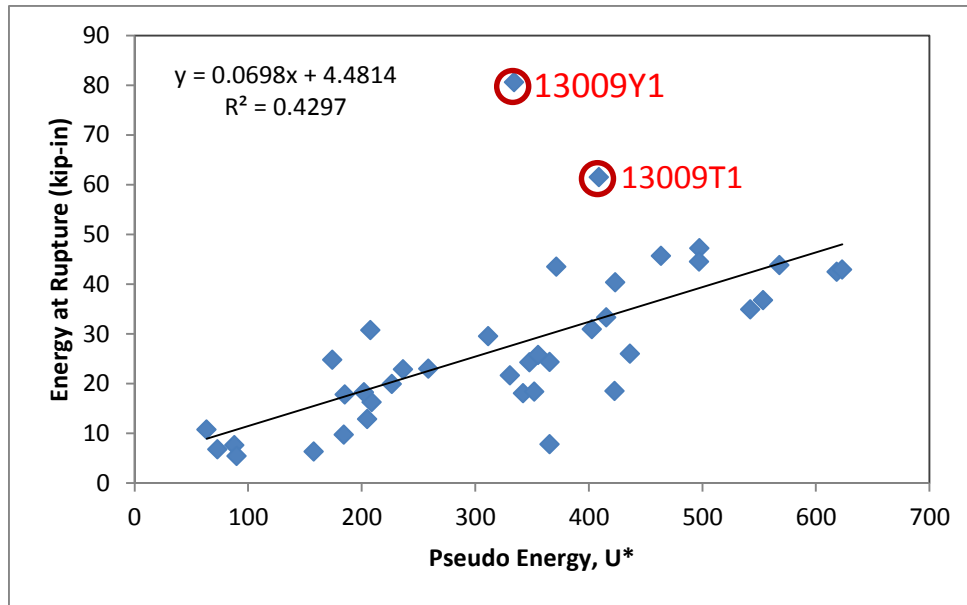
Figure 126. Rupture Energy vs. U^* for Test Series 13009 group 2 (all data).

In the plot for U^* vs. Rupture Energy, there were two data points that appeared to be outliers (see Figure 126). These points correspond to Tests 13009T1 and 13009Y1. The rupture of the post was very ductile in those two cases, resulting in a relatively high energy absorption compared to the rupture energy in all other tests (refer to Appendix E). There were no obvious signs for why those two posts resulted in such marked difference in behavior compared to the other posts. For example, visual inspection of the resistograph data for these two posts did not indicate any apparent error in the data (see Figure 131 and Figure 132). Also, the impact test results did not show significant error regarding the plots for Force vs. M^* or Energy at Rupture Initiation vs. U^* (see circled data points in Figure 129 and Figure 130).

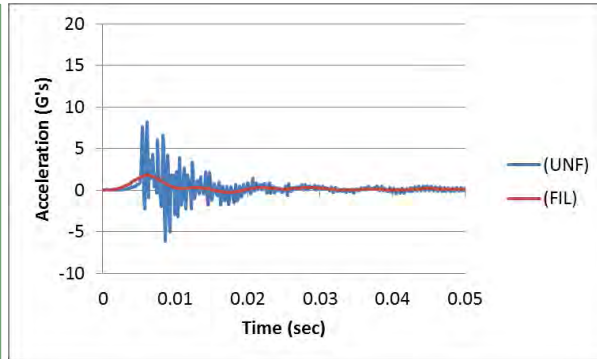
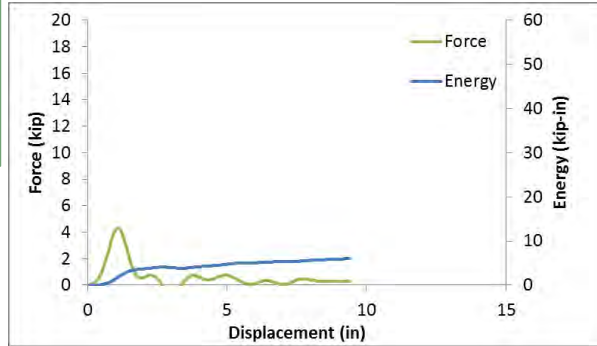
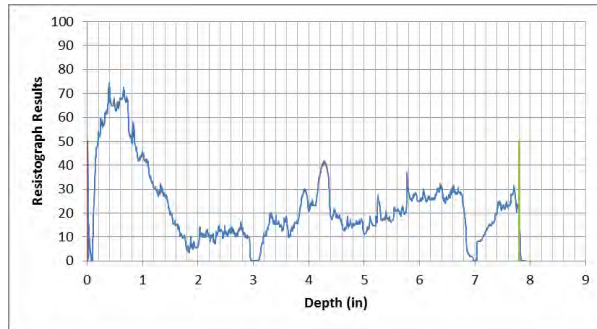
Figure 127. Test Summary Sheet for Test 13009Q1.

Test Information	
Test Number:	13009Q1
Test Date:	03-Oct-2013
Post Properties	
Post Number:	53
Post Type:	Round SYP
Post Length:	66 inches
Post Diameter:	7.64 inches
Moisture Content:	47.62%
Ring Density (avg.):	6.2 per inch
Resi Score S_{MOR} :	0.68
Resi Score S_U :	0.67
Pendulum Properties	
Weight:	2,372 lb
Impact Speed:	10 mph
Impact Height:	21.5 inches

Fractured Post

From visual inspection of the resistograph results (see Appendix E), it was apparent that at least two of the resistograph measurements were in error. These were for Post 53 of Test 13009Q1 and Post 21 of Test 13009 S1, as shown in Figure 127 and Figure 128, respectively. The resistograph data for these two posts showed abnormally high readings for very local sections of the posts, which indicate that the drilling needle likely encountered a knot at those locations or an error occurred when performing the resistograph test. This error was not discovered until after the post was destroyed in the pendulum test, so the resistograph reading could not be retaken. Excluding these data from the results yields better correlation with the test results. Figure 129 and Figure 130 show the results for Peak Force vs. M^* and Energy at Rupture Initiation vs. U^* , respectively, for the revised data set. The resulting R^2 values improved to 0.82 and 0.76 for these two correlation plots.

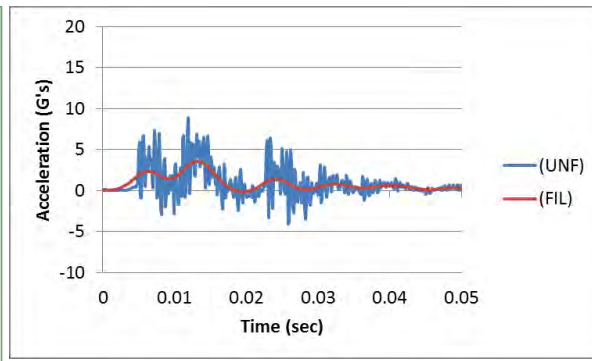
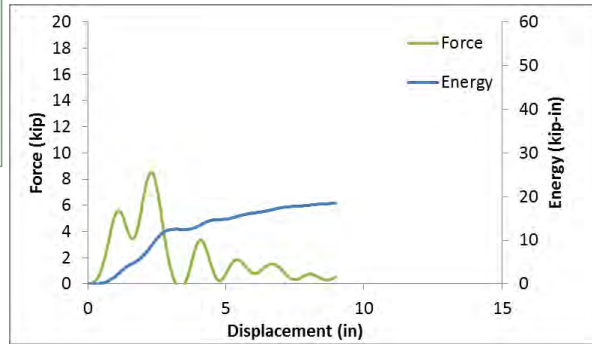
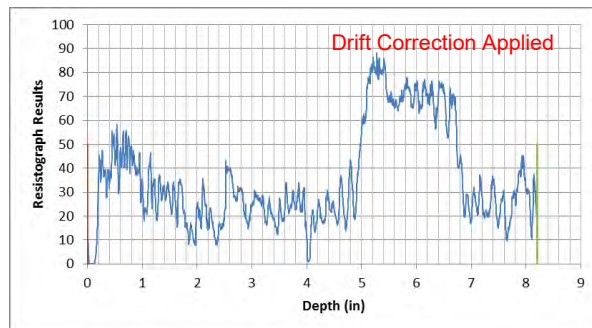
Figure 128. Test Summary Sheet for Test 13009S1.

Test Information	
Test Number:	13009S1
Test Date:	03-Oct-2013
Post Properties	
Post Number:	21
Post Type:	Round SYP
Post Length:	66 inches
Post Diameter:	7.96 inches
Moisture Content:	< 50%
Ring Density (avg.):	12.2 per inch
Resi Score S_{MOR} :	0.82
Resi Score S_U :	0.77
Pendulum Properties	
Weight:	2,372 lb
Impact Speed:	10 mph
Impact Height:	21.5 inches

Fractured Post

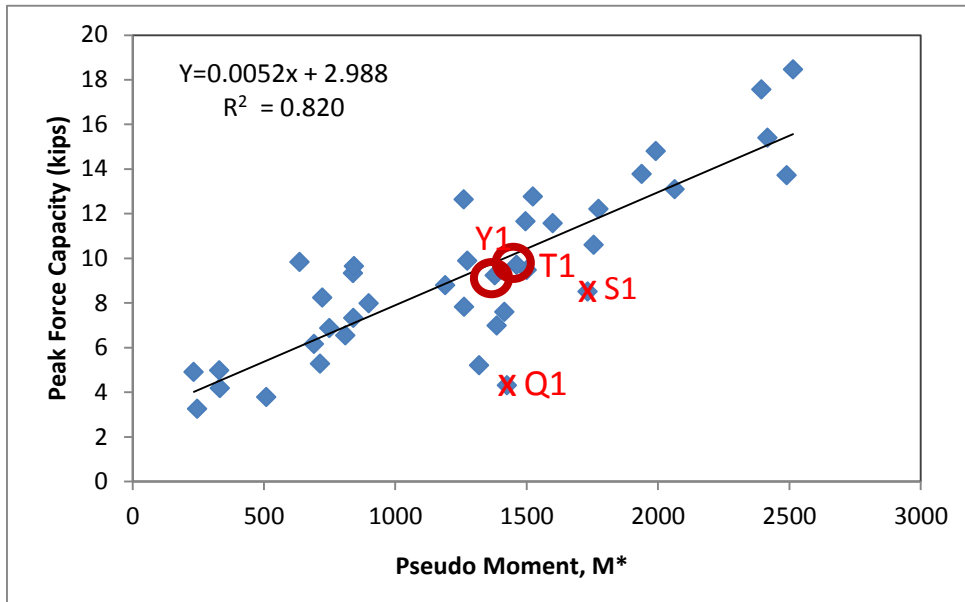
Figure 129. Peak Force vs. M^* for Test Series 13009 Group 2 (revised data set).

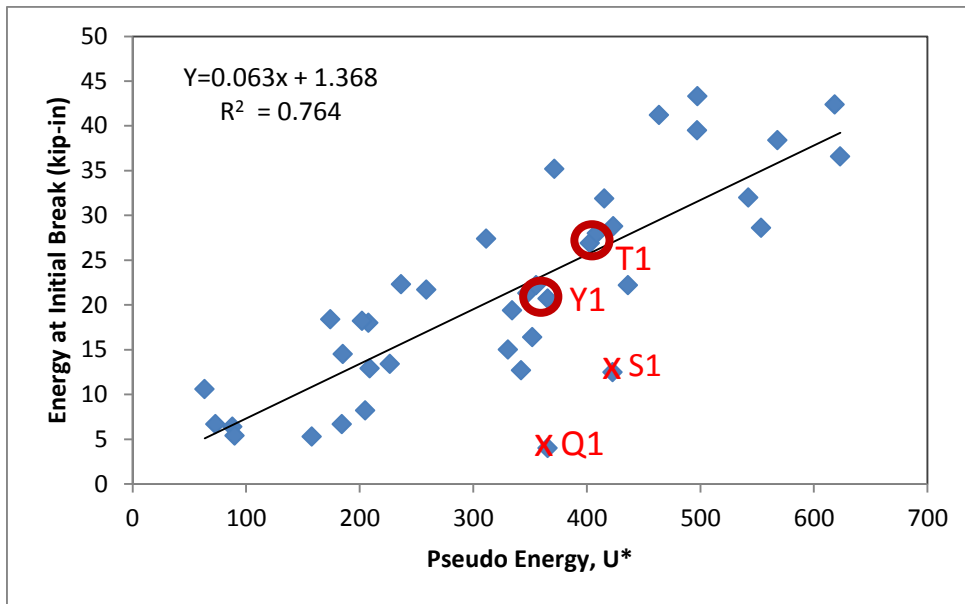
Figure 130. Energy at Initial Break vs. U^* for Test Series 13009 Group 2 (revised data set).

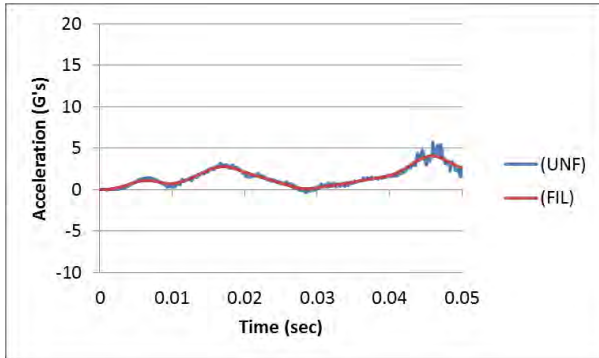
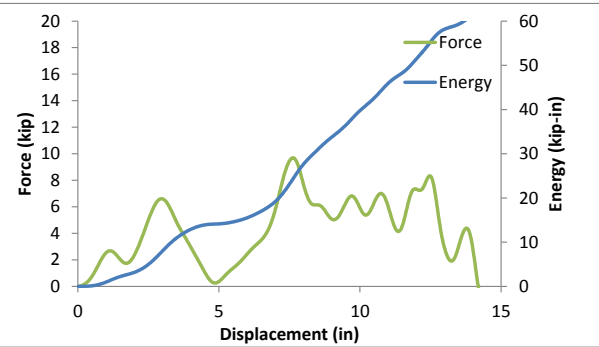
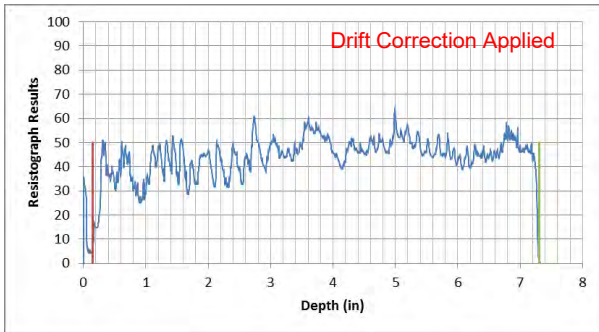
Figure 131. Test Summary Sheet for Test 13009T1.

Test Information	
Test Number:	13009T1
Test Date:	03-Oct-2013
Post Properties	
Post Number:	63
Post Type:	Round SYP
Post Length:	66 inches
Post Diameter:	7.48 inches
Moisture Content:	37.26%
Ring Density (avg.):	8.0 per inch
Resi Score S_{MOR} :	0.69
Resi Score S_U :	0.75
Pendulum Properties	
Weight:	2,372 lb
Impact Speed:	10 mph
Impact Height:	21.5 inches

Fractured Post

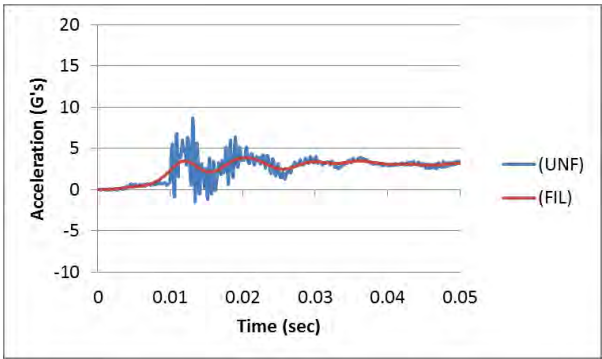
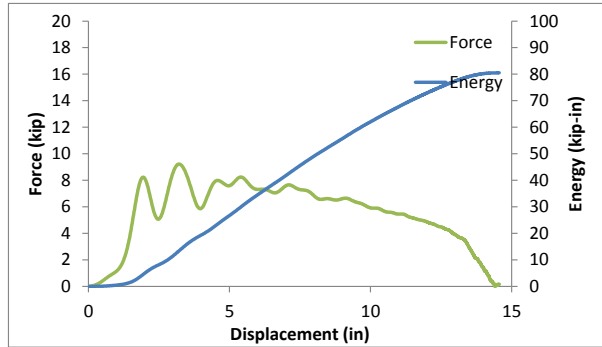
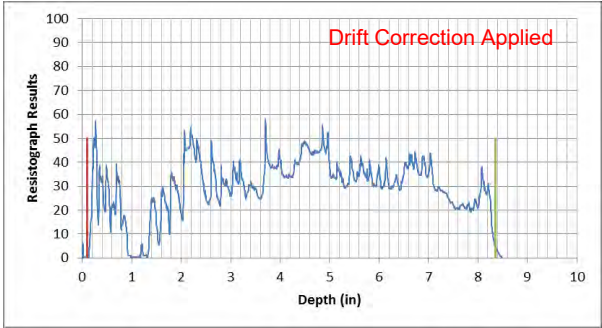
Figure 132. Test summary sheet for Test 13009Y1.

Test Information	
Test Number:	13009Y1
Test Date:	08-Oct-2013
Post Properties	
Post Number:	123
Post Type:	Round SYP
Post Length:	66 inches
Post Diameter:	8.28 inches
Moisture Content:	< 50%
Ring Density (avg.):	4.6 per inch
Resi Score S_{MOR} :	0.66
Resi Score S_U :	0.61
Pendulum Properties	
Weight:	2,372 lb
Impact Speed:	10 mph
Impact Height:	21.5 inches

Fractured Post

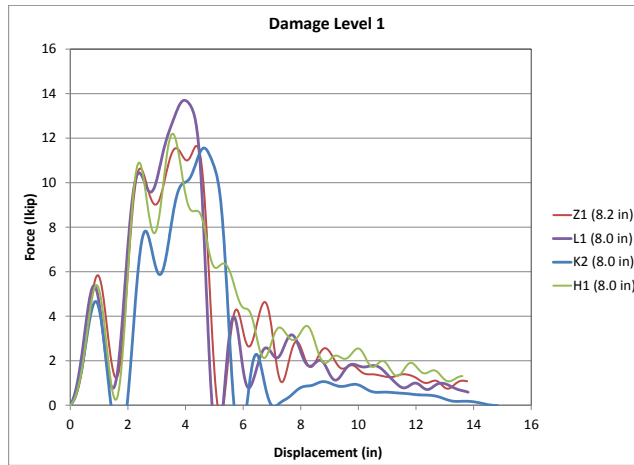
Figure 133. Pendulum impact tests from Series 13009 corresponding to deterioration damage level 1 (DL1).

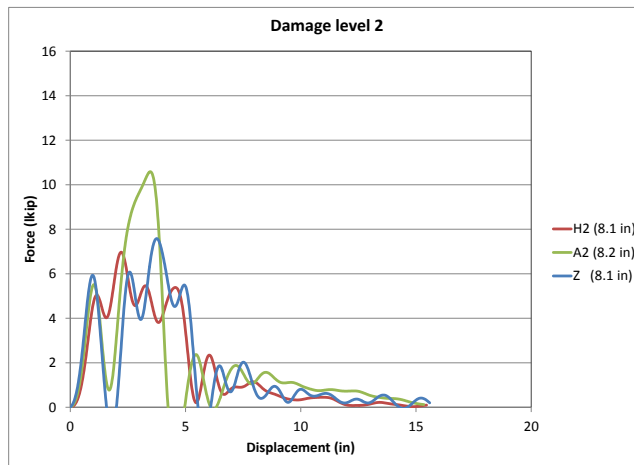
Figure 134. Pendulum impact tests from Series 13009 corresponding to deterioration damage level 2 (DL2).

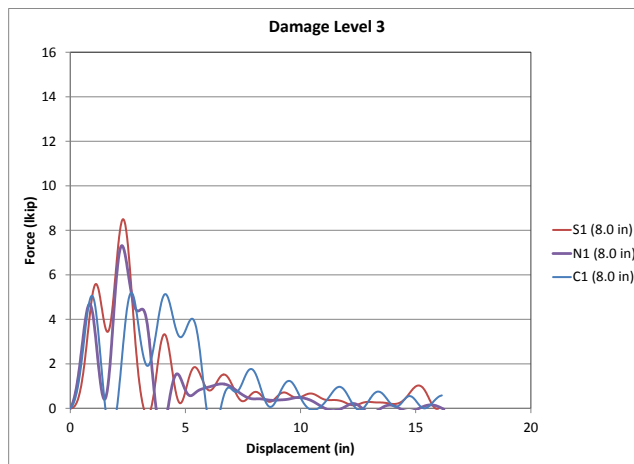
Figure 135. Pendulum impact tests from Series 13009 corresponding to deterioration damage level 3 (DL3).

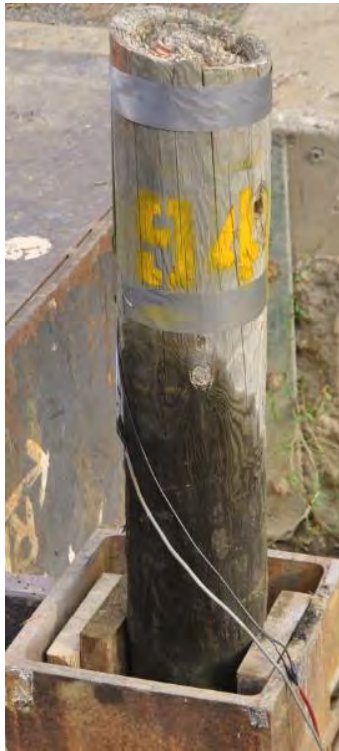
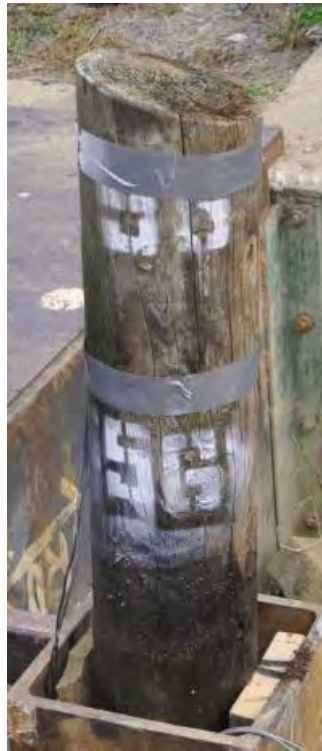
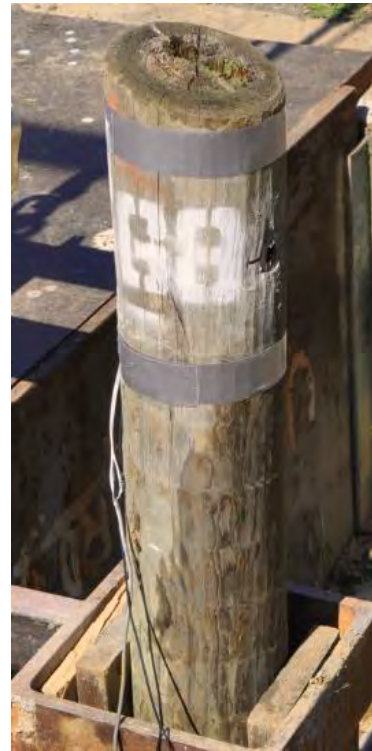
DL3		DL2		DL1	
	<u>Score</u>	<u>Criteria</u>	<u>Score</u>	<u>Criteria</u>	<u>Score</u>	<u>Criteria</u>
Force (k):	3.8	< 9	7.6	7-13	14.8	12-15
Energy (k-in):	5.3	< 20	21.3	20-30	32	26-40
Resi:	0.24	< 0.57	0.67	0.57 - 0.83	0.95	0.83 - 1.0

Figure 136. Examples of aged posts corresponding to deterioration levels DL1 through DL3.

The pendulum impact tests conducted in Test Series 13009 were used to establish four levels of damage for deteriorated guardrail posts. For the assessment, only those tests with post diameters ranging from 8.0 to 8.2 inches were selected in order to eliminate the effects of post size. There were a total of 10 tests that met this criterion. These tests were then sorted based on strain energy absorbed by the post at the time of fracture initiation. The results are shown in Table 44 and in Figures 133 - 135. The four deterioration levels are summarized in Table 45 in terms of force capacity and energy capacity. Figure 136 shows examples of aged posts corresponding to deterioration levels DL1 through DL3.

If strength and/or deterioration measurement tools are not available, then visual inspection and “sounding” procedures should be utilized by experienced maintenance personnel to assess the soundness of the posts. Refer to Figure 136 in regard to the following damage assessment cues.

DL3: Significant deterioration at top of post is usually evident. Deterioration is often deep (>1”) and covers the full cross-section of the post. Mildew or mold is often present on the side of the post near the ground line; and the post is audibly very soft (punky) when struck with a hammer near the groundline.

DL2: Often marked by shallow deterioration at top of post (<1”), extending over most if not all the cross-section. Post is audibly soft but not punky when struck by a hammer.

DL1: Generally there is no deterioration evident at the top of the post. In some cases, however, signs of deterioration may exist near the top-center of post, but will not extend to the outer shell. The post is relatively sound when struck with a hammer.

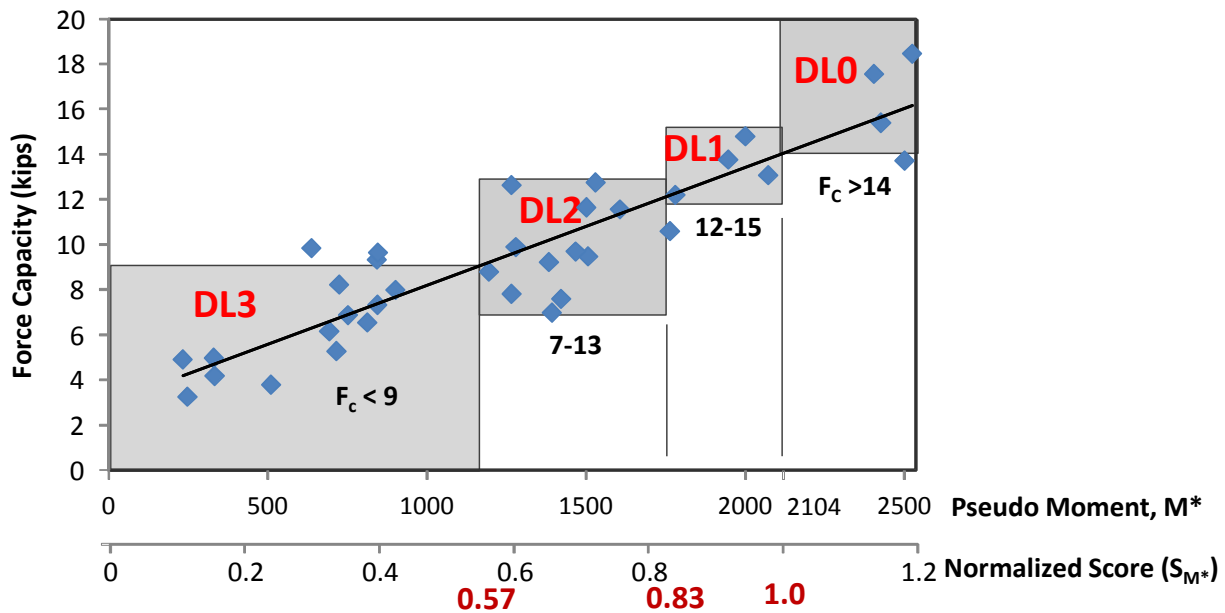
Figure 137. Graphical representation of damage levels with respect to resi-score, S_M , and load capacity.

For convenience the values for pseudo moment M^* and the pseudo energy U^* were normalized based on their values at the threshold of Damage Level 1 (DL1), such that for scores greater than 1 the post is considered undamaged. Figure 137 shows a graphical representation of damage levels with respect to resi-score S_{M^*} and load capacity; and Figure 138 shows a graphical representation of the damage levels with respect to resi-score, S_U , and strain energy capacity. The values for M^* and U^* are computed slightly differently, but when normalized the resulting scores corresponding to each of the damage levels are essentially identical; thus, either score may be used. The fourth column of Table 45 shows the damage level in terms of resistograph scores and the last column of Table 45 presents the damage levels in terms of relative capacity. Therefore, if post strength is measured or otherwise determined in the field via alternative means (e.g., stress wave techniques, force-deflection techniques, etc.) then the relative capacity may be used to identify damage level.

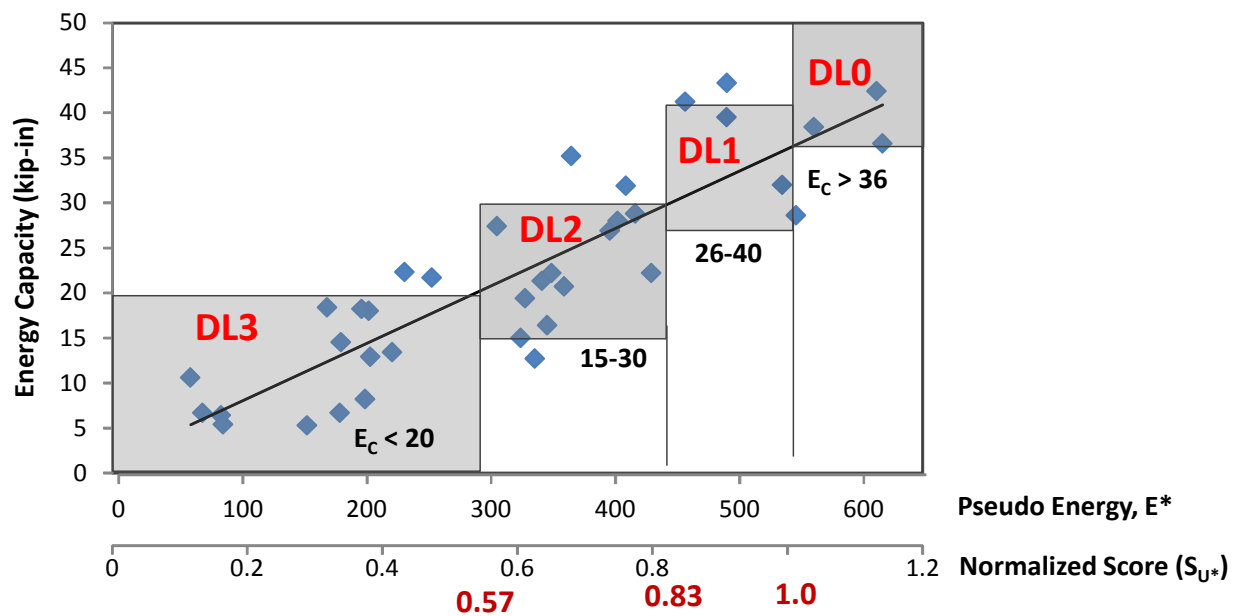
Figure 138. Graphical representation of damage levels with respect to resi-score, S_U , and strain energy capacity.

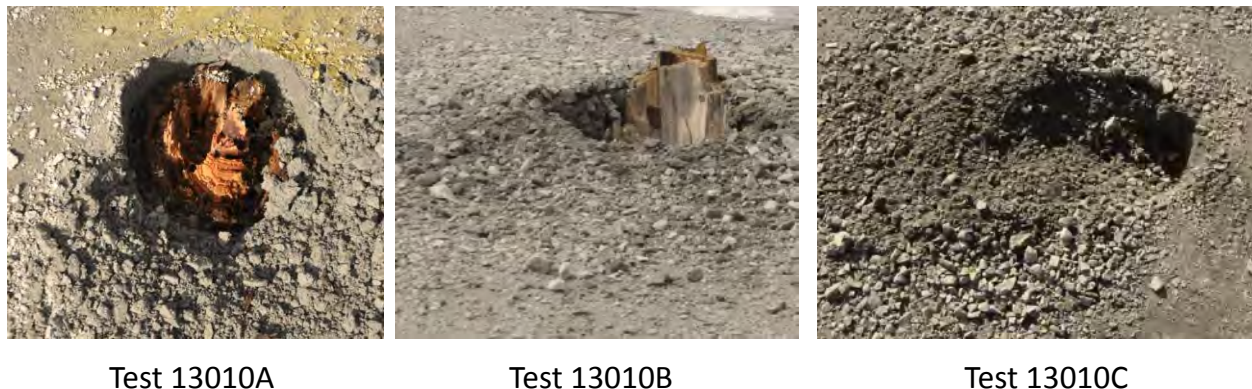
Figure 139. Tests 13010A, B and C resulted in relatively little soil displacement.

All the tests, however, resulted in complete rupture of the posts with relatively little disturbance of the soil, as illustrated in Figure 139. Additional results can be found in Appendix F. The soil for these tests was compacted to a dry density of 142-148 pcf, corresponding to 95-99 percent soil compaction. It was apparent from these results that the soil was considerably stronger than the standard soil conditions recommended in MASH. It was then decided that soil stiffness tests would be carried out using the recommended procedures in *MASH* (which involves a rigid W6x16 steel post) to establish the baseline soil conditions to be used in the remainder of the study.

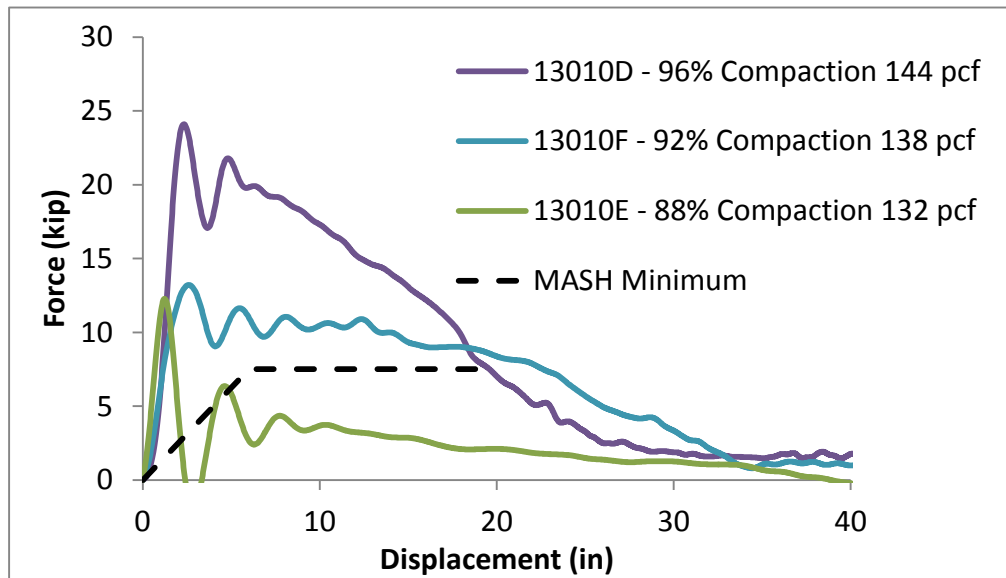
Figure 140. Force vs. deflection results for soil strength tests.

The results of these tests are shown in Figure 140 and Figure 141. The dashed line in Figure 140 represents the minimum strength requirements for the soil. The soil test with 96 percent compaction resulted in a peak impact force of 24 kips with total energy absorption of 317 kip-in. The soil test with 92 percent compaction resulted in a peak impact force of 13.2 kips with total energy absorption of 244 kip-in. The soil test with 88 percent compaction resulted in a peak

impact force of 12.3 kips with total energy absorption of 86.6 kip-in. The results clearly show that for 96 percent soil compaction (i.e., soil conditions used in the preliminary tests) the soil strength greatly exceeded the minimum strength conditions specified in *MASH*; at 92 percent soil compaction, the soil strength exceeded the minimum strength conditions by approximately 30 percent; and at 88 percent soil compaction the resulting strength was significantly less than *MASH* specifications. The soil conditions corresponding to 92 percent compaction were selected as the baseline for the remainder of the study.

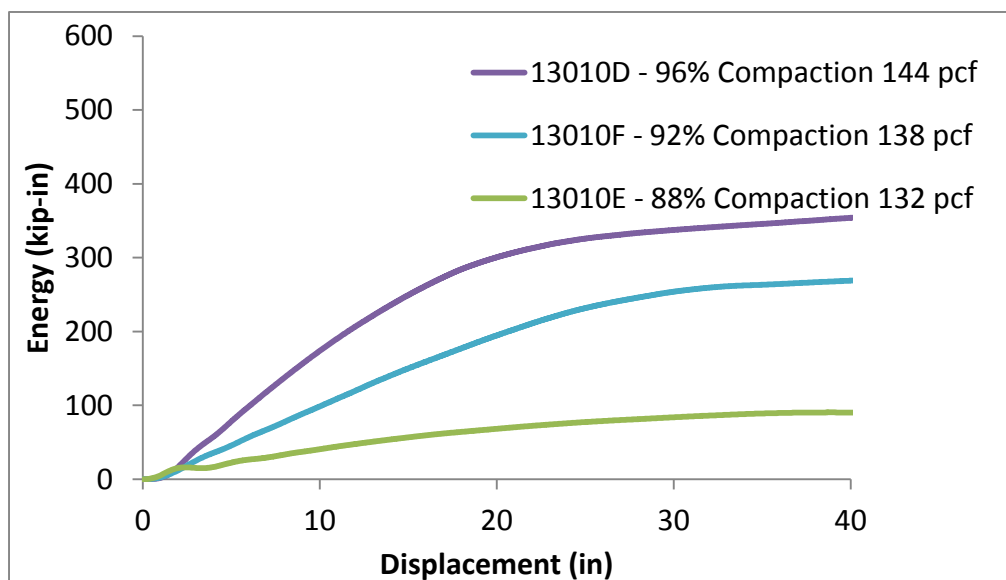
Figure 141. Energy vs. deflection results for soil strength tests.

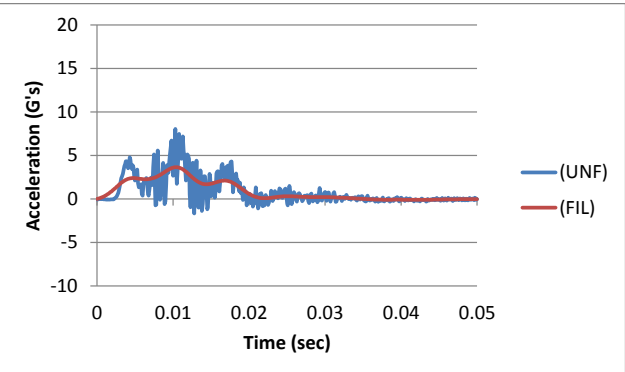
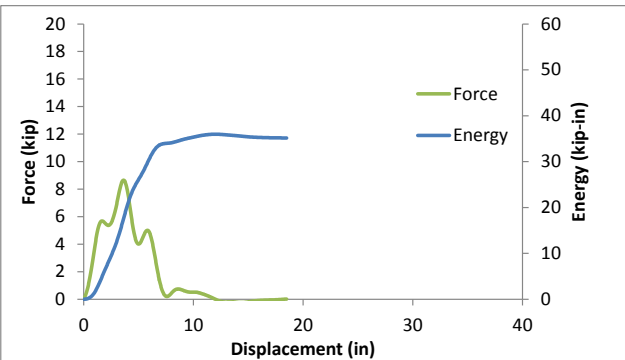
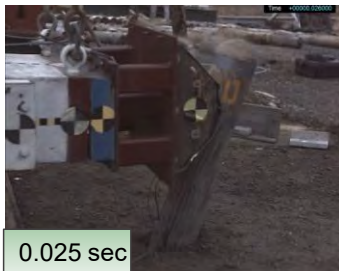
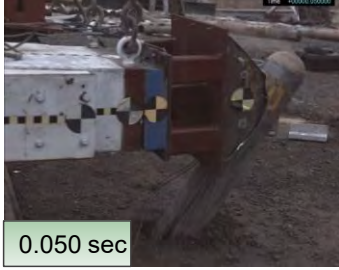
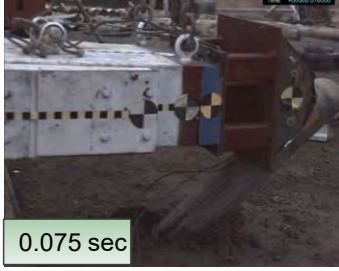
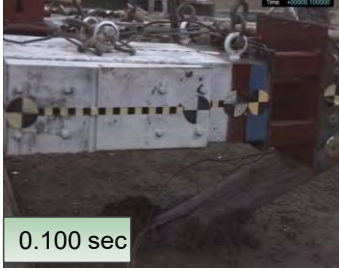
Figure 143. Summary sheet for Test 13010H.

Test Information	
Test Number:	13010H
Test Date:	16-Dec-2013
Post Properties	
Post Number:	D
Post Type:	Round SYP
Post Length:	72 inches
Post Diameter:	7.5 inches
Embedment Depth:	40 inches
Moisture Content:	35 percent
Ring Density (avg.):	6.4 per inch
Resi Score S_M :	
Resi Score S_U :	
Soil Properties	
Dry Density:	142.4 pcf
Moisture Content:	6.2 percent
Compaction:	94.8 percent
Pendulum Properties	
Weight:	2,372 lb
Impact Speed:	20 mph
Impact Height:	24.8 inches

Fractured Post

In Tests 13010G and 13010H, the 2,372-lb pendulum struck the posts at 24.8 inches above ground at an impact speed of 20 mph. For Test 13010I, the impact speed was reduced to 10 mph. The results of these tests are shown in Figure 142 through Figure 144. The posts ruptured in each of the three tests. The peak force at rupture was 9.8 kips, 8.6 kips and 10.7 kips for Tests G, H, and I, respectively, compared to a maximum resistive force of 13.2 kips for the soil (refer to Figure 140). Based on the results of these tests, it appears that the round wood post with nominal diameter of 8 inches does not have sufficient strength to properly rotate through the soil, for this baseline soil strength. Further, it should be noted that these tests were conducted with an embedment depth of 40 inches, whereas the construction drawings in the AASHTO-AGC-ARTBA Barrier Hardware Guide show the standard embedment depth for the G4(2W) guardrail system to be 44 inches.[AASHTO04]

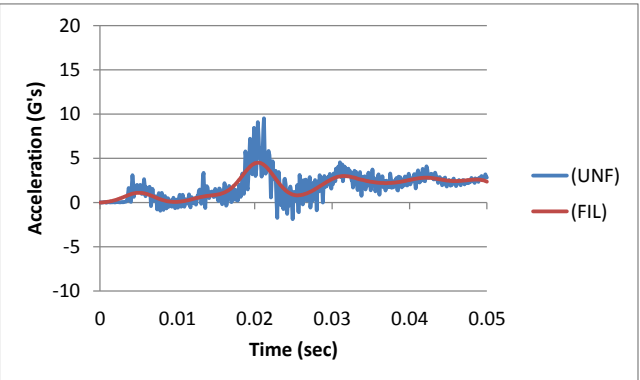
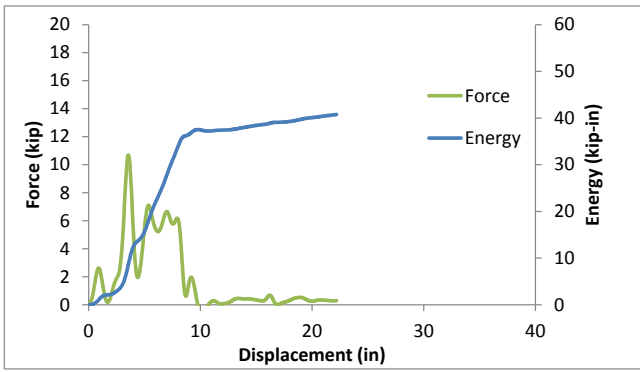
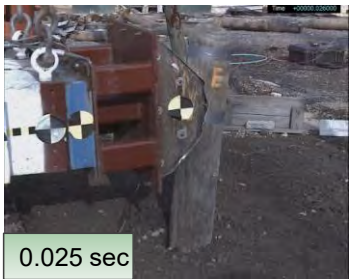
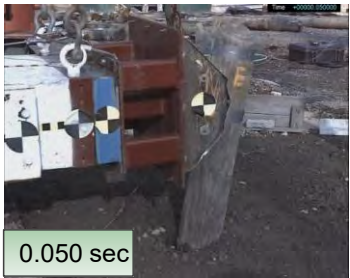
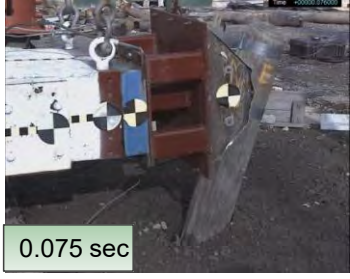
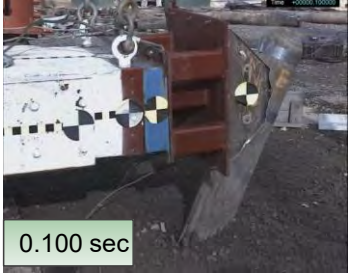
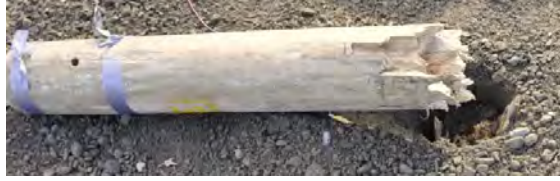
Figure 144. Summary sheet for Test 13010I.

Test Information	
Test Number:	13010I
Test Date:	18-Dec-2013
Post Properties	
Post Number:	E
Post Type:	Round SYP
Post Length:	72 inches
Post Diameter:	7.4 inches
Embedment Depth:	40 inches
Moisture Content:	19 percent
Ring Density (avg.):	4.1 per inch
Resi Score S_M :	
Resi Score S_U :	
Soil Properties	
Dry Density:	- pcf
Moisture Content:	- percent
Compaction:	- percent
Pendulum Properties	
Weight:	2,372 lb
Impact Speed:	10 mph
Impact Height:	24.8 inches

Based on the results of Tests 13010G, 13010H and 13010I, which involved two new posts and one used (but very sound) post, it was decided that it would not be meaningful to perform the second group of tests. Over 85 percent of the posts tested in Test Series 13009 resulted in peak impact forces that were less than 13.2 kips (e.g., peak resistance of baseline soil), as shown in Figure 120; and those that exceeded this strength had very low deterioration and/or relatively large cross-section diameters.
