Criteria for Restoration of Longitudinal Barriers, Phase II (2021)

Criteria for Restoration of Longitudinal Barriers, Phase II

Contractor's Final Report for NCHRP Project 22-28
Submitted June 2015

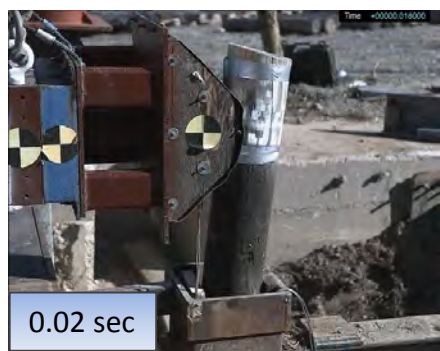
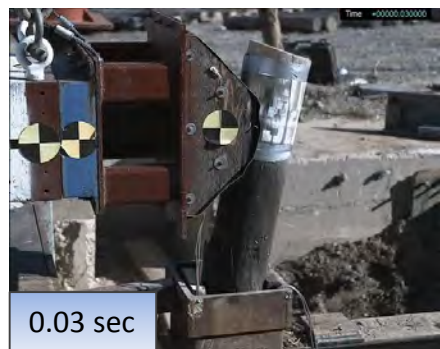
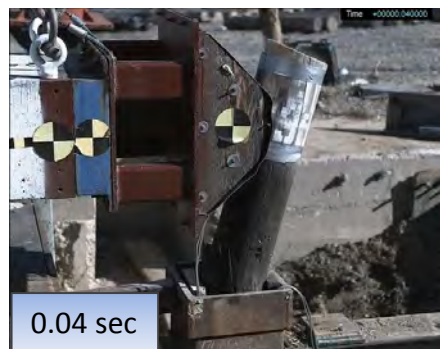
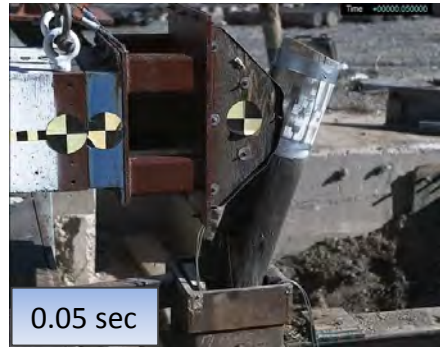
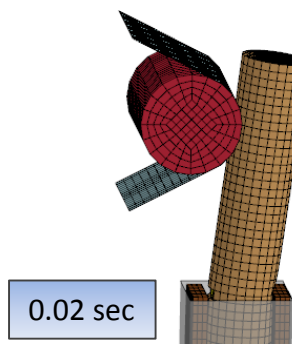
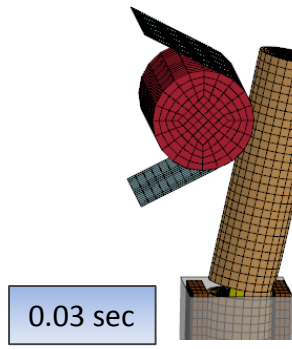
Figure 151. Sequential views of Test 13009H1 and FE analysis DL1(a).

13009H1

FEA DL1(a)

The results of the model are compared to the full-scale impact tests in Figure 147 through Figure 150. Figures 147 and 148 show the force vs. deflection and energy vs. deflection results, respectively, for the FE model compared to Test 13009H1. The peak impact force from the analysis was 13 kips compared to 12.2 kips in the test. The total energy absorbed in the analysis at 13 inches displacement was 57 kip-inches compared to 56 kip-inches in the test. Figure 149 and Figure 150 show the force vs. deflection and energy vs. deflection response for the FE model compared to Test 13009L1. In this case the FE model resulted in a peak force of 17.3 kips compared to 13.6 kips in the test. The total energy absorbed in the analysis at 13 inches displacement was 46.5 kip-inches compared to 49.7 kip-inches in the test. Figure 151 and Figure 152 show sequential views comparing analysis results to dynamic impact tests 13009H1 and 13009L1, respectively.

An important point to consider regarding the differences between the tests and simulations is that the analyses and the tests have essentially the same number of peaks leading up to initiation of rupture, but the distance between peaks is considerably different. The reason for the differences is not well understood. From a review of the test video, the impact speed was confirmed to be 10 mph, which is the same as the impact speed that was simulated in the models. The most logical explanation is that the boundary conditions for the tests were effectively less “rigid” than those of the model. Thus, the test specimens were allowed greater movement upon impact at, and below, groundline, which consequently resulted in a greater distance between the initial inertial spike (i.e., first peak) and the start of the actual loading on the post (i.e., second peak). For comparison of the analysis results with the tests, the test data was shifted such that the initial loading of the second peak was coincident with that of the analysis.

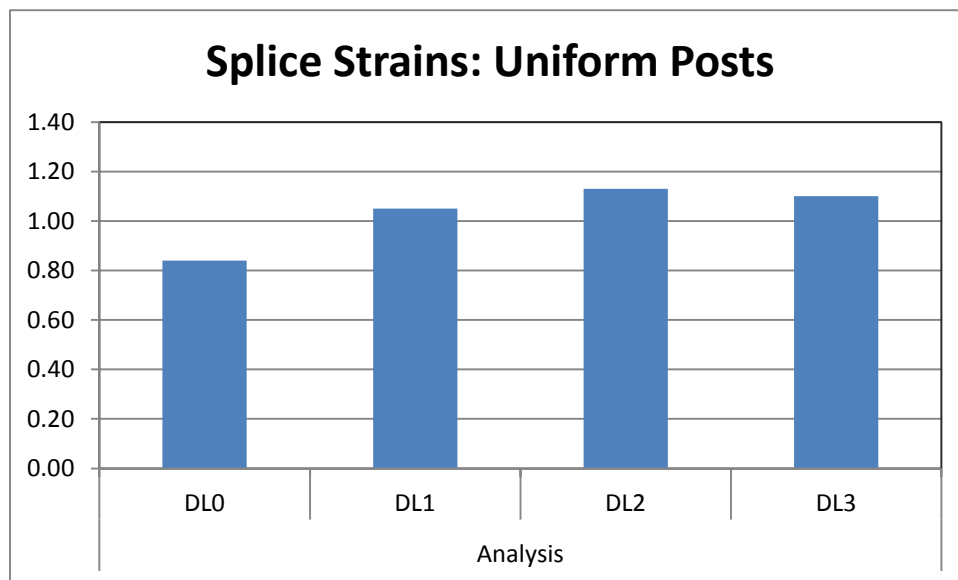
Figure 166. Summary of maximum effective plastic strains occurring at the splice-bolt locations at Post 16.

For analysis case DL2 and DL3 the plastic strains were slightly higher than the DL1 case. It is possible, although not confirmed, that the splice damage for cases DL2 and DL3 may be higher if evaluated at their critical impact points.

A summary of the maximum effective plastic strains around the splice-bolt holes in the w-beam is shown in Figure 166. The results indicate that the plastic strain values were relatively high even for the baseline case with a magnitude of 0.84, while for analysis Case DL1, the plastic strain values were 25 percent higher with a magnitude of 1.05. It is assumed that the baseline G4(2W) guardrail case is near its performance capacity under these impact conditions, thus as the plastic strains increase beyond those of the baseline case, the potential for rupture increases accordingly.

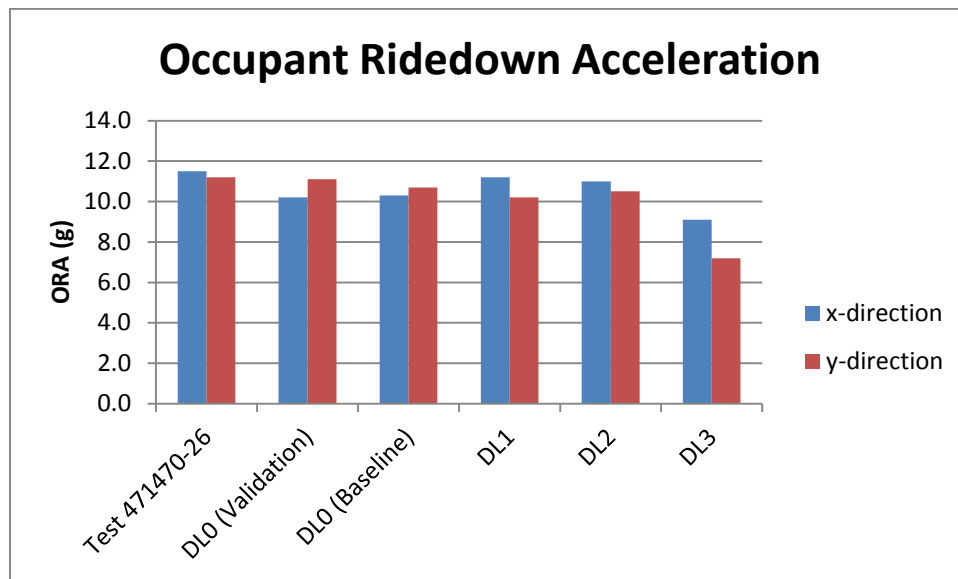
Figure 171. Summary of maximum occupant ridedown acceleration evaluation of uniform post deterioration.

A summary of occupant risk measures computed from the acceleration and angular rate time-histories at the vehicle's center of gravity is provided in Table 53. This data is also presented graphically in Figures 170 through 172. The results indicate that the vehicle decelerations were very similar for all cases, with a slight trend toward decreasing values as post deterioration increased. These results seem counter intuitive and should be reassessed using a more appropriate impact point for the analyses.

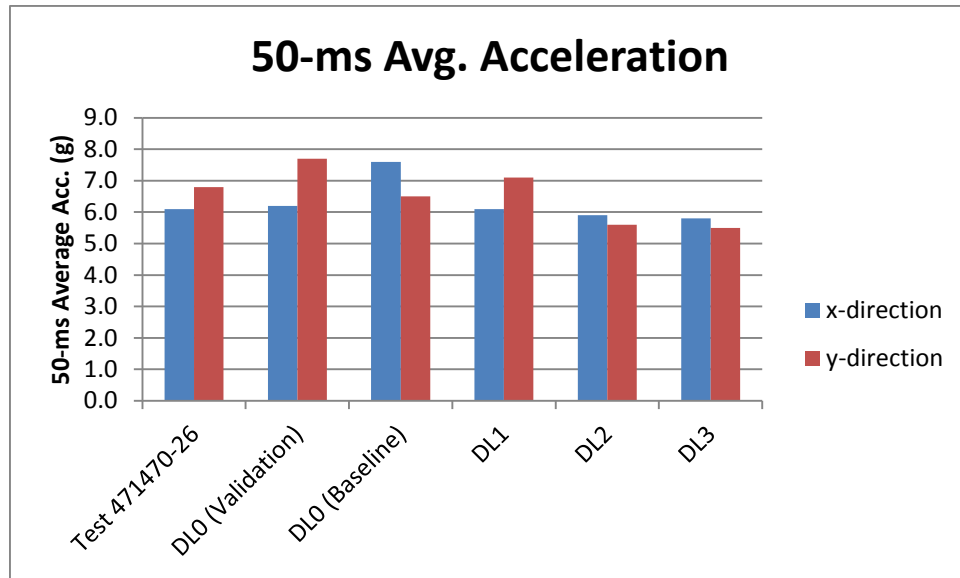
Figure 172. Summary of 50-ms running average acceleration evaluation of uniform post deterioration.

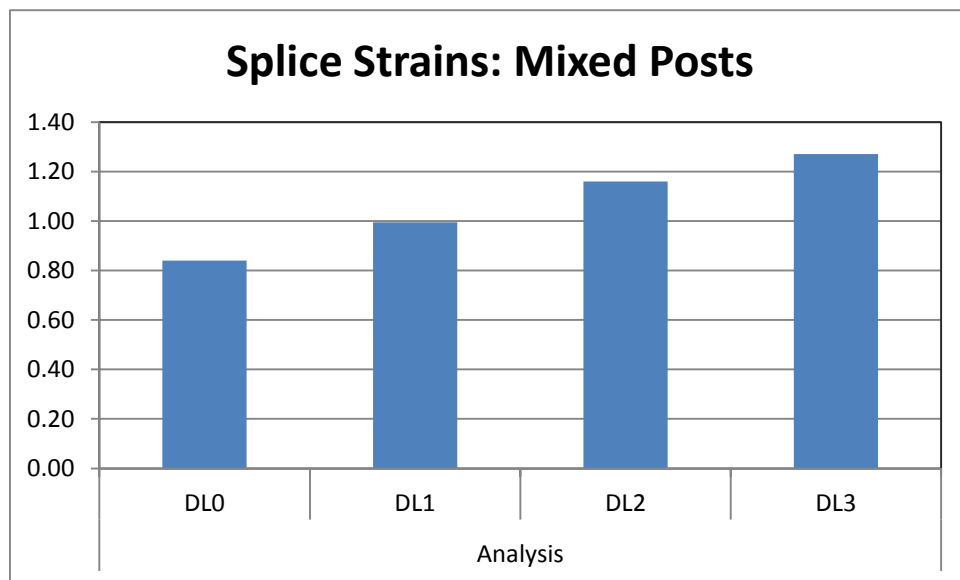
Figure 173. Summary of maximum effective plastic strains occurring at the splice-bolt locations at Post 16.

A summary of the maximum effective plastic strains around the splice-bolt holes in the w-beam for each analysis case is shown in Figure 173. The results indicated that the potential for splice rupture increased as post deterioration increased. For example, the plastic strains at the splice-bolt holes reached magnitudes of 1.0, 1.2 and 1.3 for cases DL1, DL2 and DL3, respectively. It is assumed that the results for cases DL1 and DL2 actually under-predict the maximum strain values, since the critical impact point for these two cases was not evaluated.

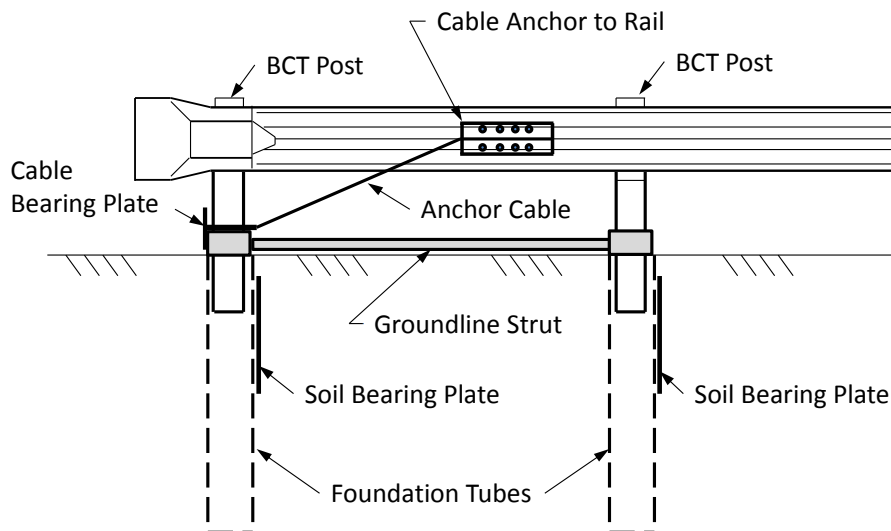
Figure 174. Sketch of typical guardrail anchor system.

(MELT). The basic design of the anchor mechanism, illustrated in Figure 55, entails an anchor cable (3/4-inch diameter) with one end fastened to the rail element and the other fastened to the end-post near the groundline. A bearing plate is used to prevent the cable from pulling through the hole in the end-post and to distribute the load to the foundation tube (i.e., the bearing plate overlaps the top of the foundation tube). The end-post and the adjacent post are both installed in 5-foot long steel foundation tubes with a soil-bearing-plate (18 inches long by 24 inches wide) attached to provide additional resistance from the soil. A steel strut is then laid at the groundline which connects the two foundation tubes together making them work as a system. When the guardrail is struck, the anchor cable transfers the load to the foundation tubes to resist axial movement of the rail; the resulting tension in the rail helps to limit lateral deflections of the guardrail in the impact zone. Figure 56 shows a photo of a generic end-anchor for the modified G4(1S) with wood blockouts that was used in full-scale crash test 2214-WB1.[*Polivka06a*]

Most guardrail end-terminals use the same basic arrangement that is illustrated in Figure 55. When the guardrail is struck, the anchor cable transfers the load to the foundation tubes to resist axial movement of the rail; the resulting tension in the rail helps to limit lateral deflections of the guardrail in the impact zone. Figure 56 shows a photo of the generic end-anchor for the modified G4(1S) with wood blockouts that was used in full-scale crash test 2214-WB1.[Polivka06a]

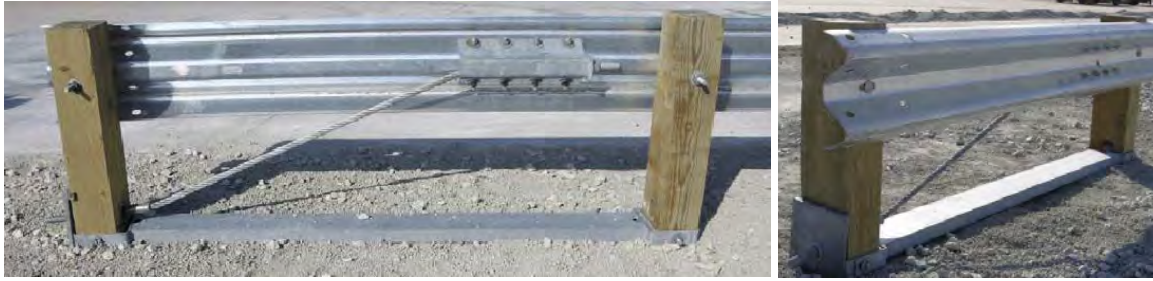
Figure 175. Generic end-terminal used in full-scale crash test 2214-WB1 of a strong-post guardrail system.[Polivka06a]

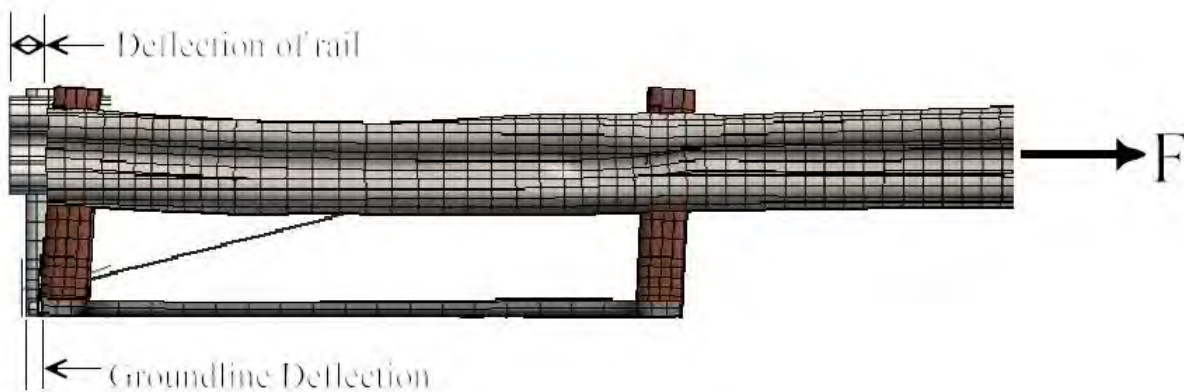
Figure 176. Example – finite element model for computing force-deflection response of the standard two-post guardrail anchor system.[Plaxico03]

The baseline anchor strength was determined through physical testing by measuring the force-deflection response of a standard two-post end-terminal anchor subjected to tensile loading, as illustrated in Figure 176. Ideally, the loading on the end of the rail would be applied dynamically with a loading rate similar to real-world vehicular collisions. However, there are many difficulties involved in designing a pendulum test experiment to “pull” on the end of the system. In general pendulums (and bogie vehicles) are used to strike and “push” an object rather than “pull”. Although it should be possible to construct a fixture (e.g., using pulleys or levers) to convert the compressive load of the pendulum to a tensile load on the rail, it would probably be difficult to separate out the dynamic effects of the mass, stiffness, energy absorption, etc. of the fixture from the test results. Also, the rail tension, which results from the lateral deflection of the guardrail during vehicular collisions, develops at a relatively low rate. For example, the maximum deflection of a guardrail in a TL3 event typically occurs over a period of approximately 0.2 to 0.3 seconds. If the resulting maximum rail deflection at the anchor is, say, 3 inches and assuming that the rail displaces at a constant rate, then the resulting deflection rate would be in the range of 10 in/s (0.6 mph) to 15 in/s (0.9 mph). To use a pendulum (or bogie) to achieve sufficient energy to displace the anchor system at such a low rate would require a very large mass and/or a fixture with significant mechanical advantage. Based on these facts and issues, it was decided that a more appropriate approach would be to perform a quasi-static test using a cable and winch system. The loading rate for the quasi-static tests was 1.0 to 1.5 in/s.

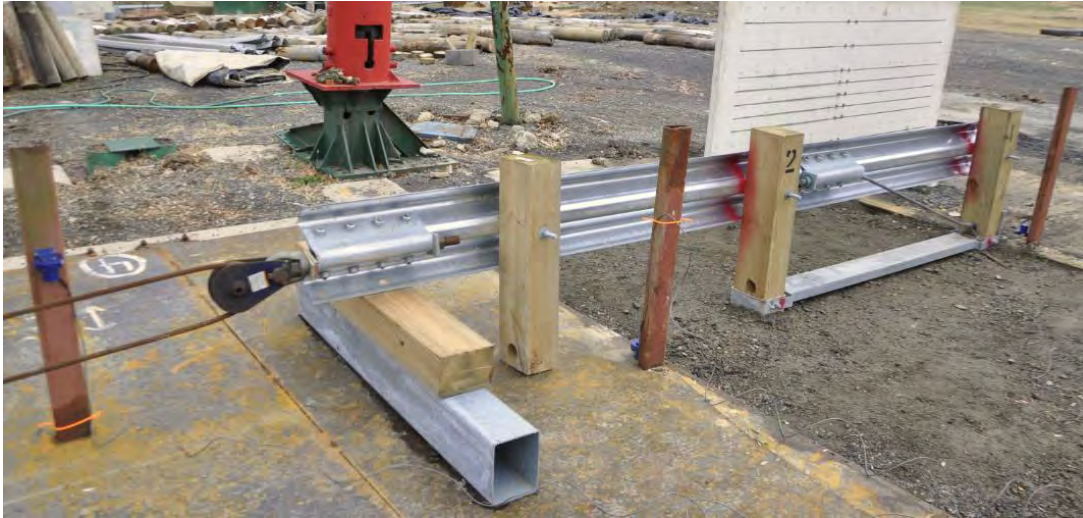
Figure 177. Test set-up for measuring force-deflection response of a standard two-post guardrail end-terminal anchor.

A quasi-static test was performed to measure the force-deflection response of a standard two-post guardrail anchor system, shown in Figure 177. The components of the test article were donated to the study by three guardrail distributors: Trinity Industries, Gregory Industries, Inc. and Road Systems, Inc. The test was performed on December 16, 2013 by the staff of the Federal Outdoor Impact Laboratory (FOIL) at the Federal Highway Administration's Turner Fairbank Highway Research Center in McLean, Virginia. Since the purpose of the test was to measure the

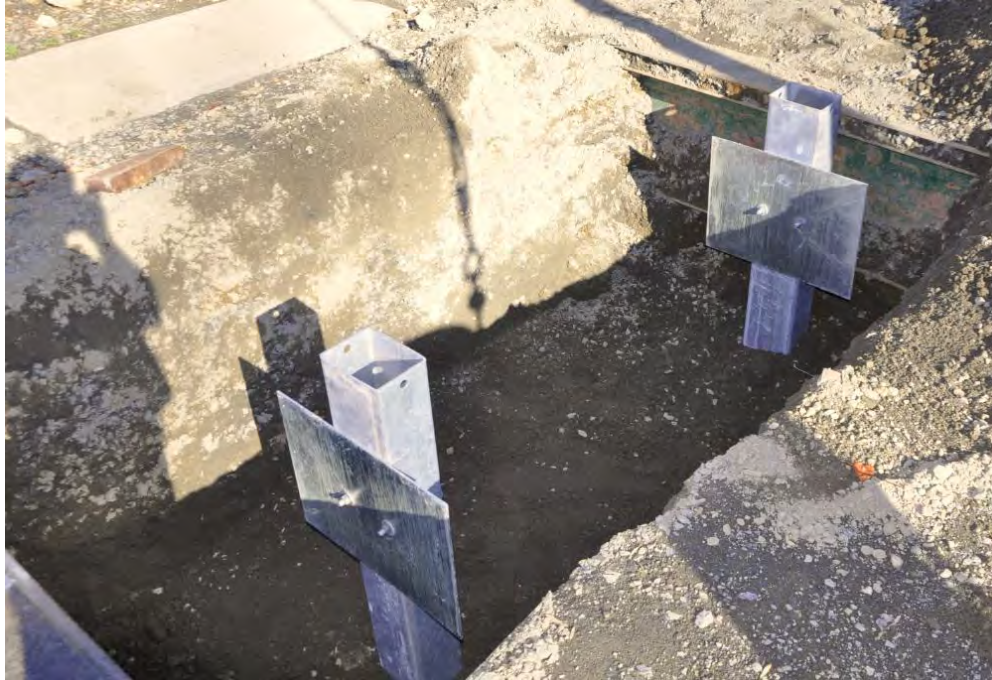
Figure 178. Photograph of anchor tubes with soil plates during installation.

Figure 178 shows a photo of the two foundation tubes with soil plates taken during the installation process. Because of the limited size of the soil pit at the test site, the test article was placed as far back as possible in the pit in order to minimize the influence of the rigid steel wall at the front of the soil pit. The distance from the front of the foundation tube at Post 2 to the front wall was approximately 30 inches; and the distance from the back of the foundation tube at Post 1 to the back of the soil pit was approximately 6 inches. It was not clear from the test results if the response of the system was influenced by the size limitation of the soil pit area.

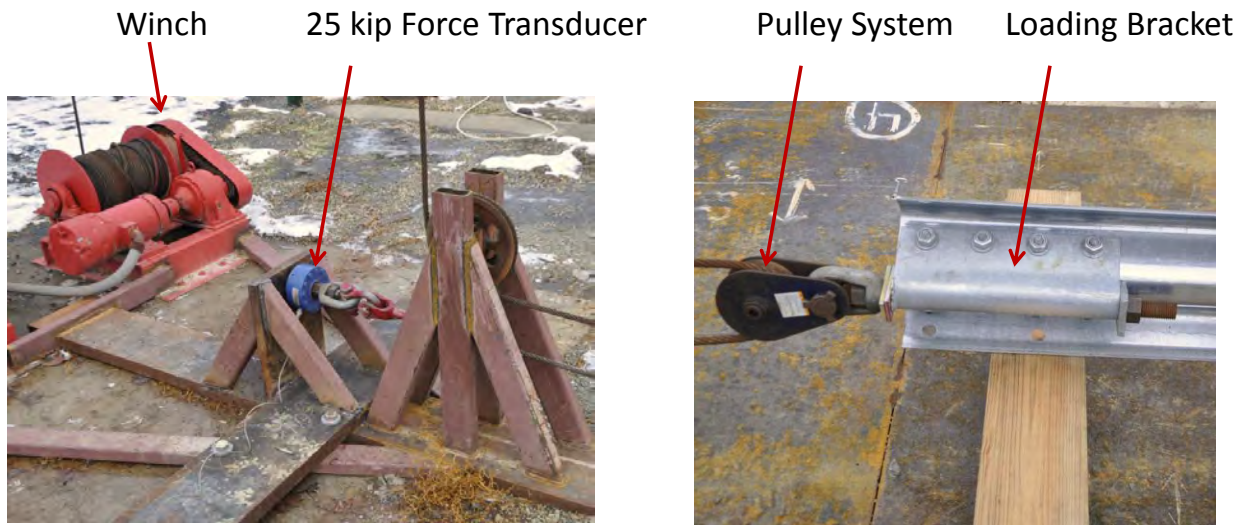
Figure 179. Cable and pulley system used to apply tensile loading on end-terminal anchor.

The load was applied to the end of the test article using a winch and a cable-pulley system with a 2:1 mechanical advantage, as shown in Figure 179. The winch system used for the quasi-static test was an existing component of the pendulum test device – used primarily to hoist the pendulum into position for dynamic tests. For the test, the winch cable was run through a stationary pulley bracket aligned with the test article, then around another pulley that was attached to the end of the test article, and then back to a fixed anchor point near the stationary pulley bracket. This arrangement resulted in a 2:1 mechanical advantage for the winch. For the pulley located at the end of the test article, a 1-inch diameter steel rod was attached to the pulley and then fastened onto the end of the w-beam rail using a standard cable-anchor-bracket (i.e., RWE02), as shown in Figure 179.

An additional wood post was fastened onto the rail near the load-point in order to maintain the proper height of the rail during the test. Recall that for most end-terminals a CRT post is fastened to the rail at this location. As a further precaution, additional materials were stacked underneath the end of the w-beam near the load point to ensure that the rail height did not drop during the test. The three vertical steel posts shown in the test set-up in Figure 177 were used for mounting (anchoring) the string-pot displacement transducers and were not part of the test article.

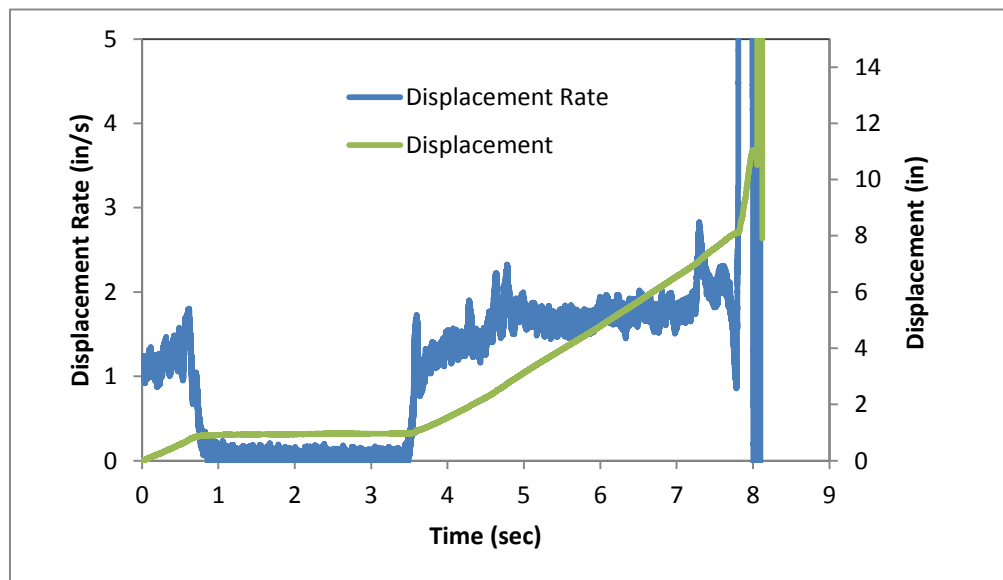
Figure 181. Displacement- and displacement rate-time histories measured at the load point on the end of the rail.

The loading on the anchor system was applied in two steps. In the first step, a displacement of 1 inch was applied to the end of the rail at a displacement rate of approximately 1 inch per second. The displacement was then held constant for 2.8 seconds. The test then proceeded at a displacement rate of approximately 1.5 inches per second until failure of the anchor system. Figure 181 shows the displacement- and displacement rate-time histories measured at the load point; Figure 182 shows the resulting force-deflection response. The displacement at the end of the rail and the displacement at the groundline of Post 2 are shown in Figure 183. The displacement at Post 1 was not measured due to the displacement transducer malfunctioning.

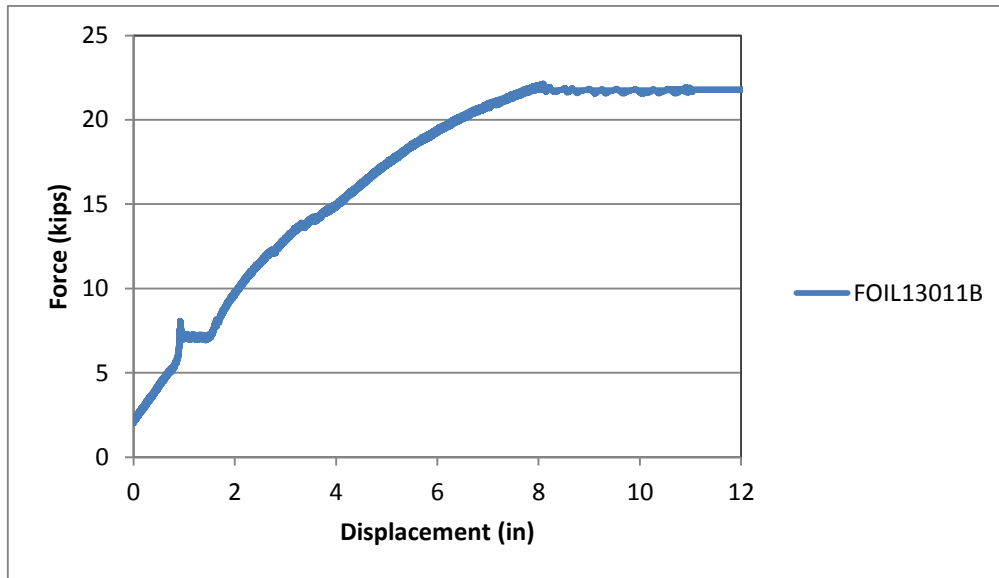
Figure 182. Force-displacement response of the anchor system measured at the load point on the end of the rail.

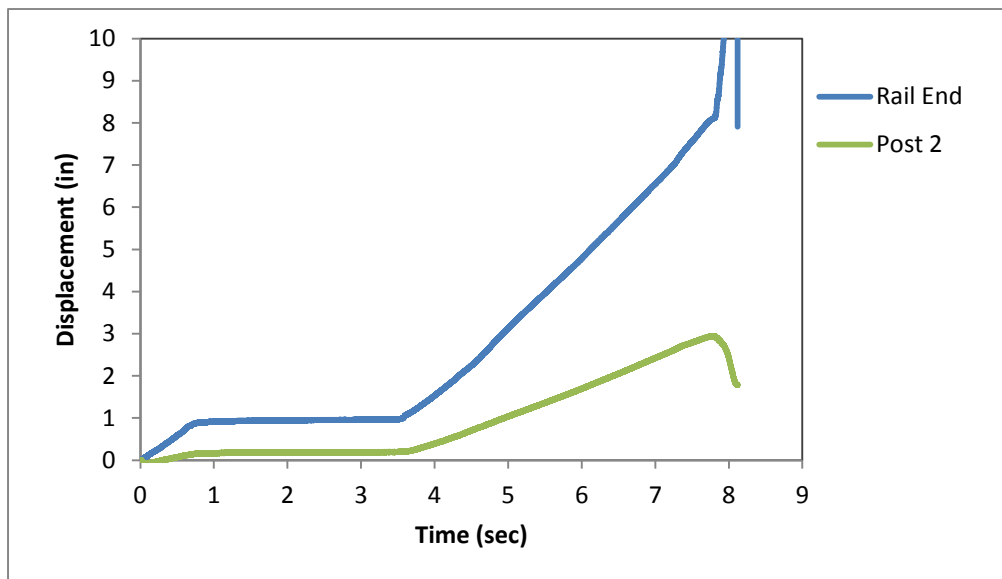
Figure 183. Displacement-time history at the end-of-the rail and at the groundline of Post 2.

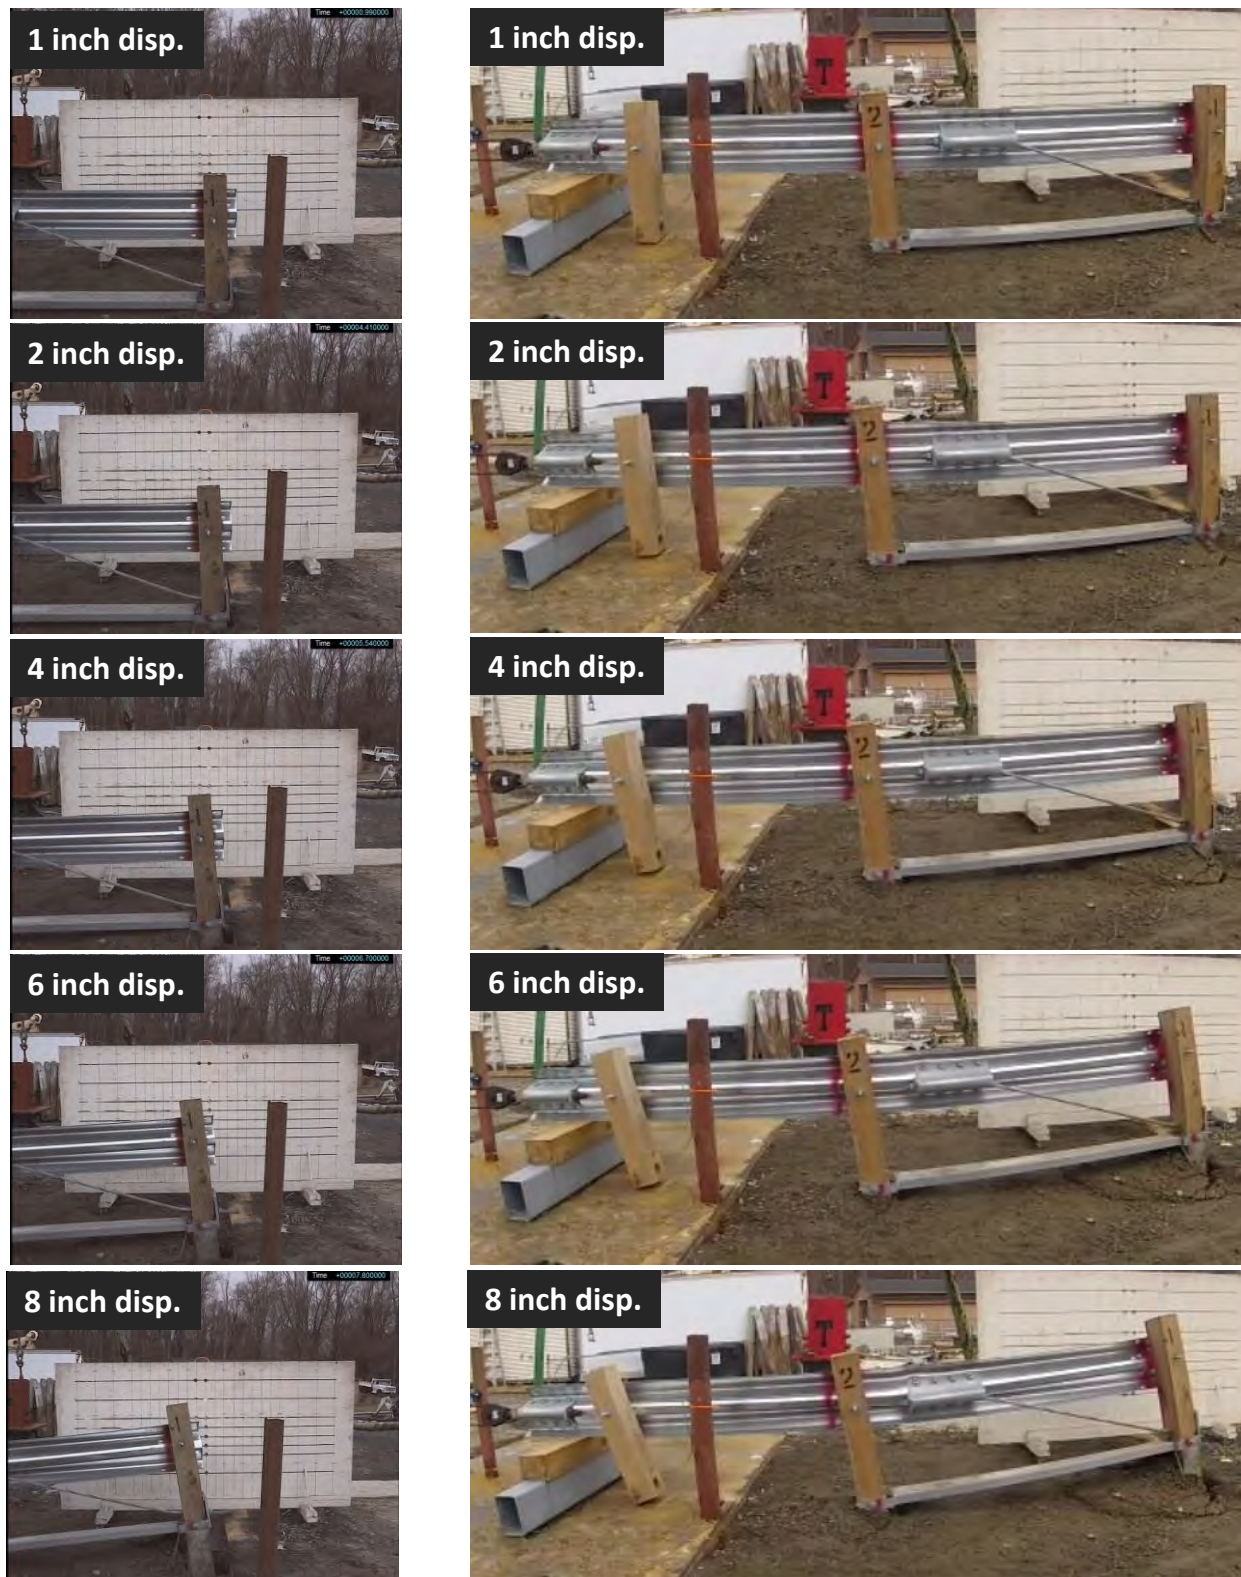
Figure 184. Sequential views of Test 13011B.

Sequential views of the test from two view-points are shown in Figure 184. The foundation tube at Post 1 began to displace vertically almost immediately at the start of the second loading step. The vertical component of displacement was not measured in the test; however, at 2 inches horizontal deflection of the rail element, the vertical displacement of Post 1 was estimated from the test videos to be 0.5 inches. At approximately 8.1 inches horizontal displacement of the rail element, the foundation tube fully extracted from the ground.

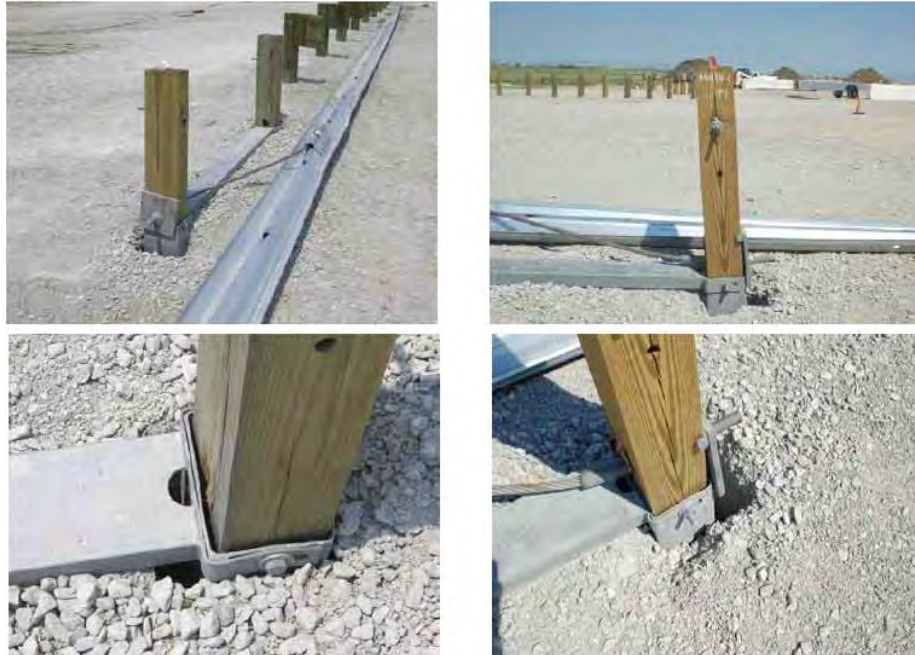
Figure 185. Damage to end-terminal anchor in full-scale crash Test MGSDF-1.[Hascal07]

As the rail element was pulled during the test, the vertical force on the foundation tube (resulting from the vertical component of force of the anchor cable) was greater than the friction forces between the ground and foundation tube. This behavior, however, was not expected based on the results of previous full-scale crash tests in which vertical displacement of the foundation tube was generally negligible. For example, Figure 185 shows the damage to the upstream anchor system in full-scale crash Test MGSDF-1 conducted by the Midwest Roadside Safety Facility (MwRSF). The horizontal groundline displacement of the foundation tube in the crash test appears to be greater than that of quasi-static Test 13011B, and yet there was no measurable vertical deflection in the dynamic test.

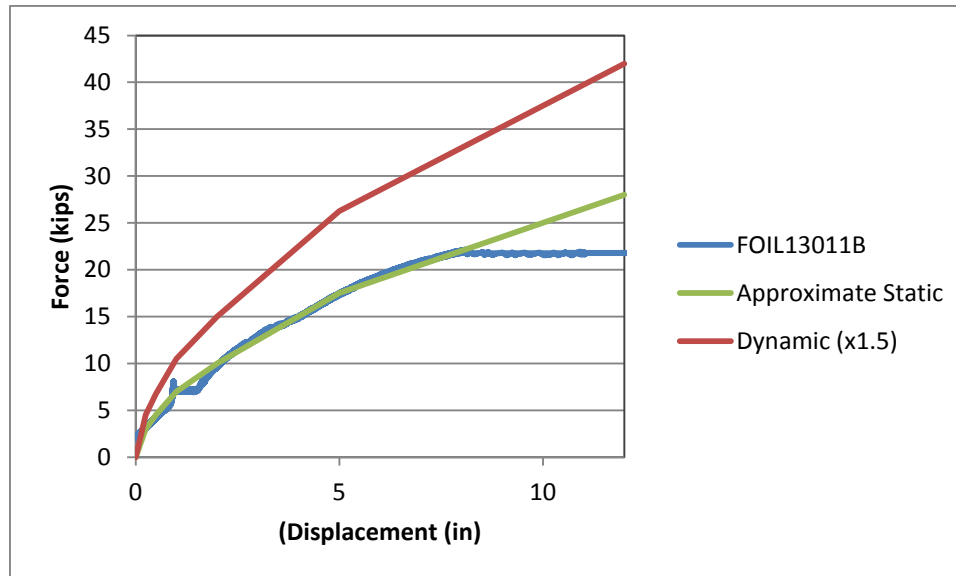
Figure 186. Measured and approximated force-deflection response for the end-anchor.

Due to the abnormal behavior of the anchor system in Test 13011B, the test results were considered to represent a lower bound for the force-deflection response of the system. Further, if the foundation tube had not extracted suddenly at 8 inches rail deflection, then it was assumed that the force would have continued to increase. Based on these assumptions, the effective static force-deflection response of the system was approximated, as shown in Figure 186. The effect of loading rate on the anchor response was accounted for in the finite element model using a dynamic magnification factor of 1.5 to scale the quasi-static force-deflection curve.

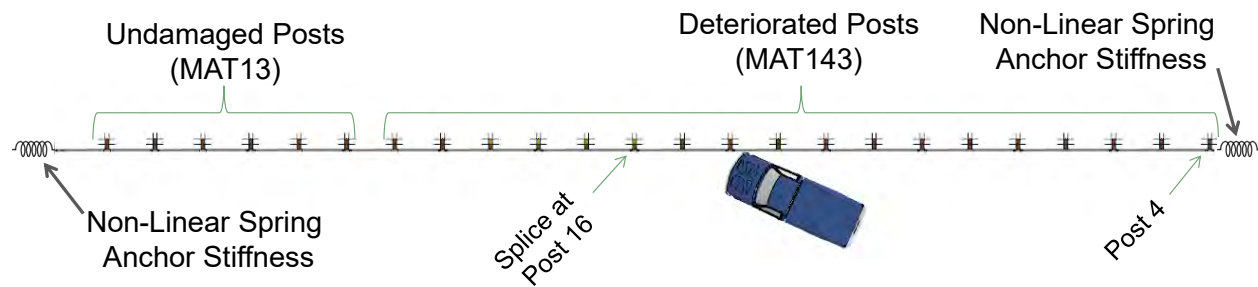
Figure 187. Analysis setup for evaluating effects of anchor strength on the performance of the G4(2W).

The analysis model used for the evaluations is shown in Figure 187. Post 4 through Post 21 were modeled using MAT143; while the posts located upstream of the impact zone were modeled using a less computationally demanding material model, MAT13. The material parameters for MAT143 were defined according to deterioration level as described in Chapter 8. MAT13, however, was not calibrated for the various levels of post deterioration. Instead, the material parameters used for MAT13 were adopted from the earlier work by Plaxico, et.al.[Plaxico98] In effect, the line of posts near the downstream anchor should be considered undamaged, or new.

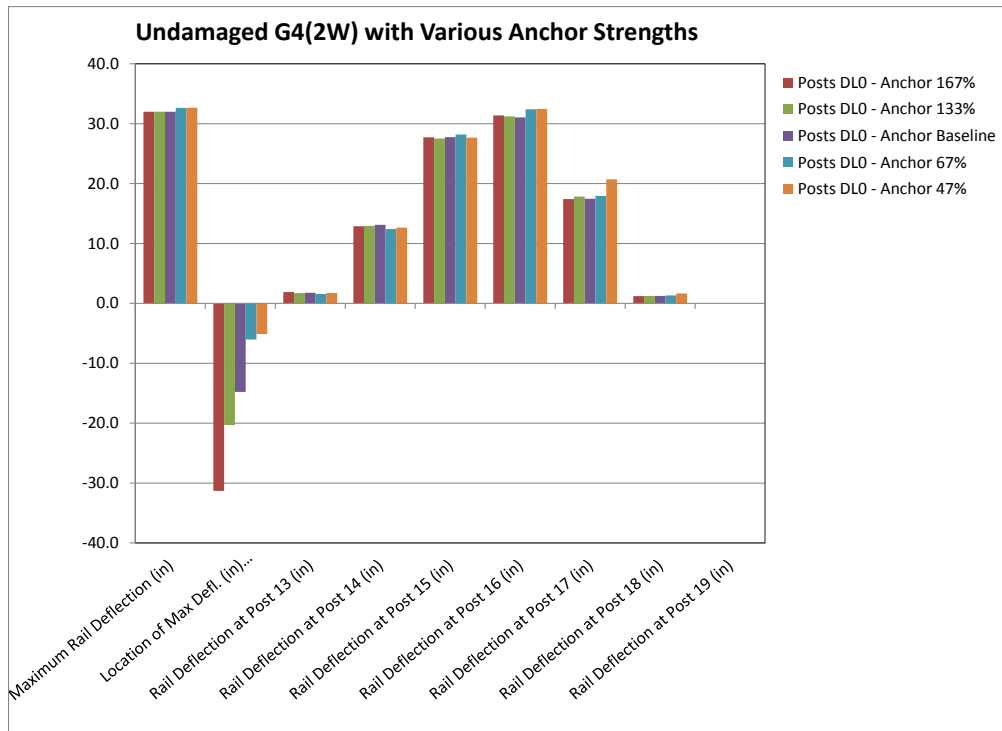
Figure 188. Summary of barrier damage evaluation from analyses of undamaged G4(2W) guardrail with various anchor strengths.

The following is an evaluation of the G4(2W) guardrail with various levels of anchor strengths. Sequential views of the FE analysis results for each case are provided in Appendix I. Table 56 provides a summary of barrier damage from the analyses related to rail deflections, anchor movement and splice damage. This information is also presented graphically in Figure 188 and Figure 189. The maximum lateral rail deflection was essentially the same for all cases. This result was not expected, however, and was interpreted to indicate that the tension in the w-beam rail was carried primarily by the line-posts leading up to the end-terminals, resulting in minimal force on the anchor systems. Likewise, the maximum longitudinal deflection of the w-beam rail at the anchor was very similar for each case as well and ranged from 1.3 to 1.8 inches.

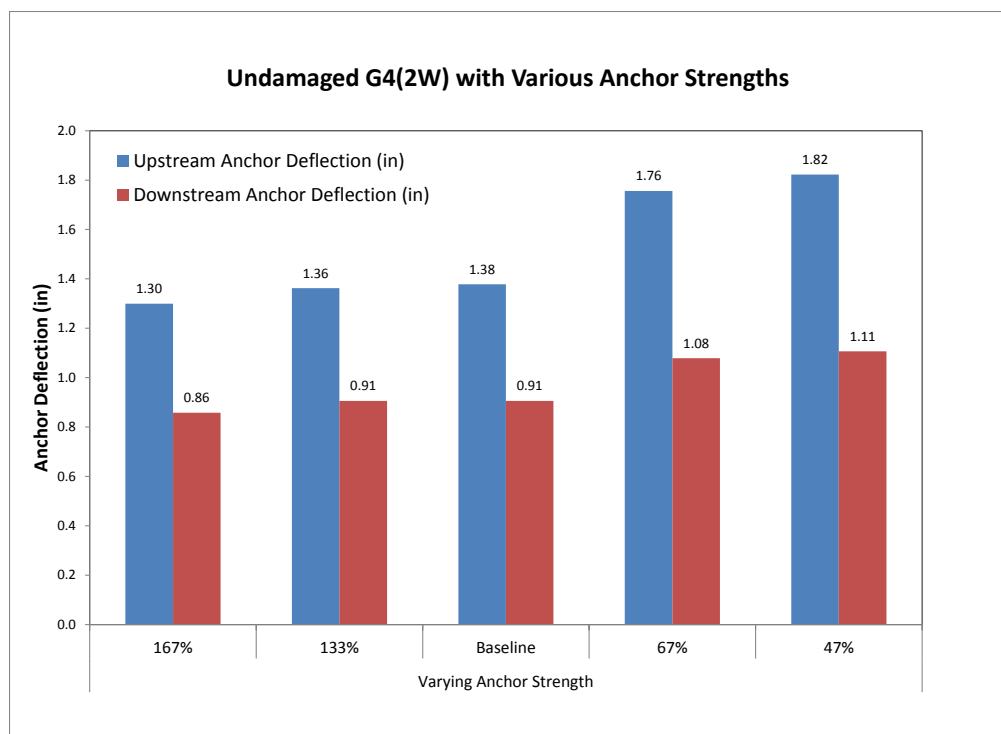
Figure 189. Summary of anchor displacement at rail height from analyses of undamaged G4(2W) guardrail with various anchor strengths.

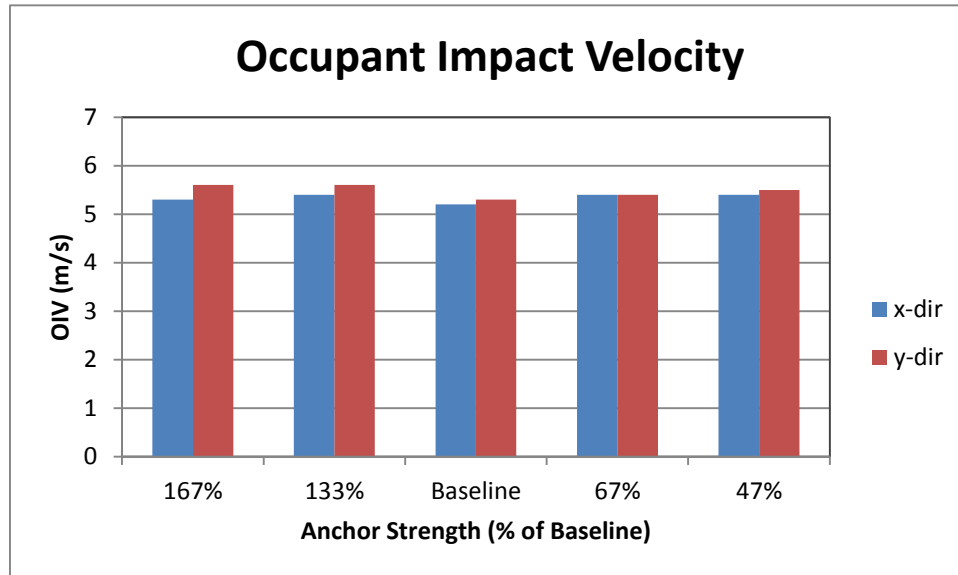
Figure 190. Summary of occupant impact velocity (OIV) from analyses of undamaged G4(2W) guardrail with various anchor strengths.

A summary of occupant risk measures computed from the acceleration and angular rate time-histories at the vehicle's center of gravity is provided in Table 57. This data is also presented graphically in Figures 190 through 192. The results indicate that reduced anchor strength does not significantly affect occupant risk as the magnitude of maximum vehicle decelerations was very similar for all cases.

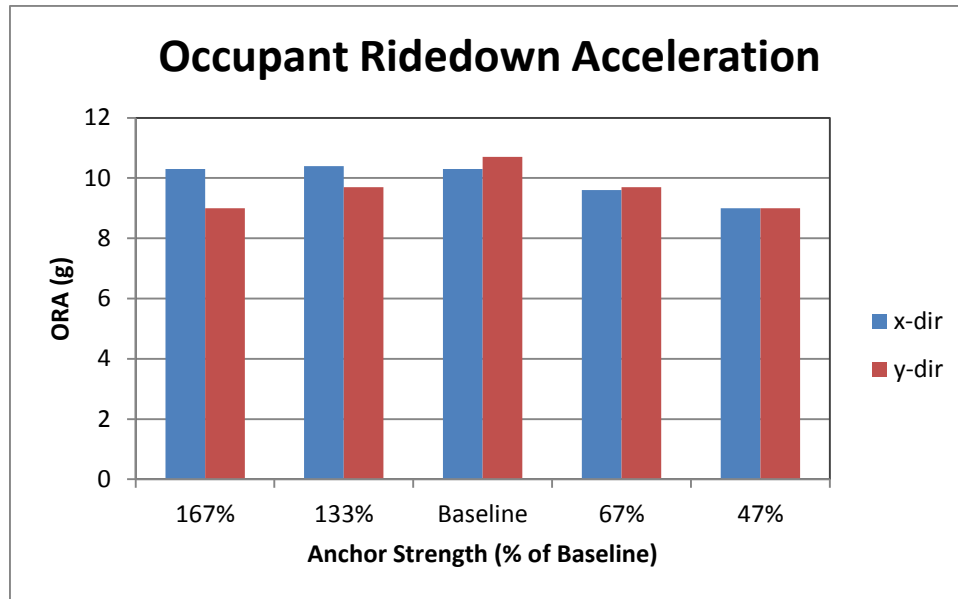
Figure 191. Summary of occupant ridedown accelerations (ORA) from analyses of undamaged G4(2W) guardrail with various anchor strengths.

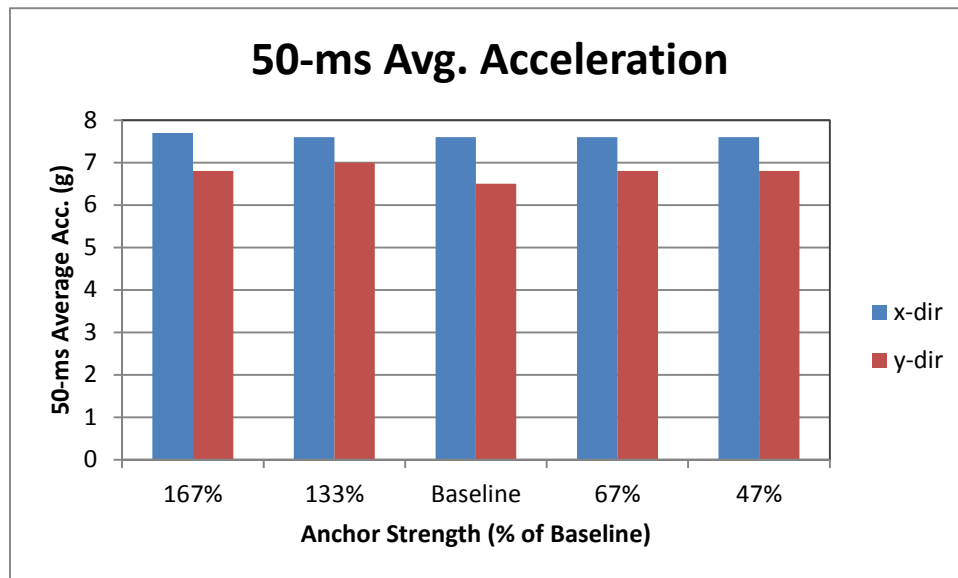
Figure 192. Summary of occupant risk measures from analyses of undamaged G4(2W) guardrail with various anchor strengths.

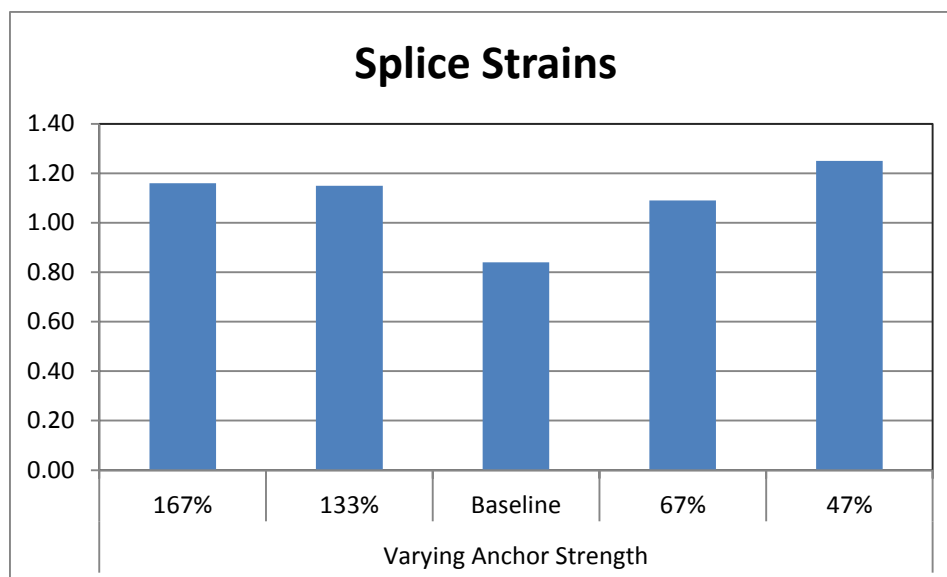
Figure 193. Summary of maximum effective plastic strains occurring at the splice-bolt locations at Post 16.

A summary of the maximum effective plastic strains around the splice-bolt holes in the w-beam for each analysis case is shown in Figure 193. The results showed that the potential for splice rupture increased as anchor strength increased or decreased from the baseline anchor strength case.

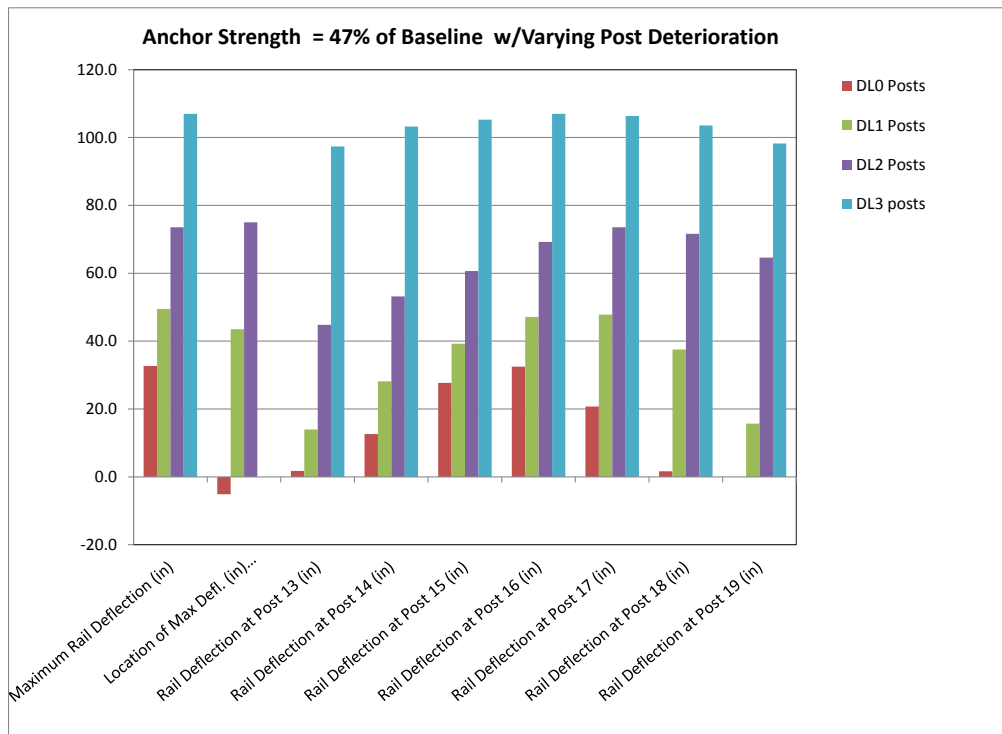
Figure 194. Summary of barrier damage evaluation from analyses of G4(2W) with combination of weak anchor and deteriorated posts.

The following is an evaluation of the G4(2W) guardrail for the combination damage mode of reduced anchor stiffness and deteriorated guardrail posts. The anchor stiffness for this analysis was set to 47 percent of the baseline anchor strength and four different post deterioration levels were evaluated. Sequential views of the FEA results for each case are provided in Appendix J. Table 56 provides a summary of barrier damage from the analyses related to rail deflections, anchor movement and splice damage. This information is also presented graphically in Figures 188 and 189.

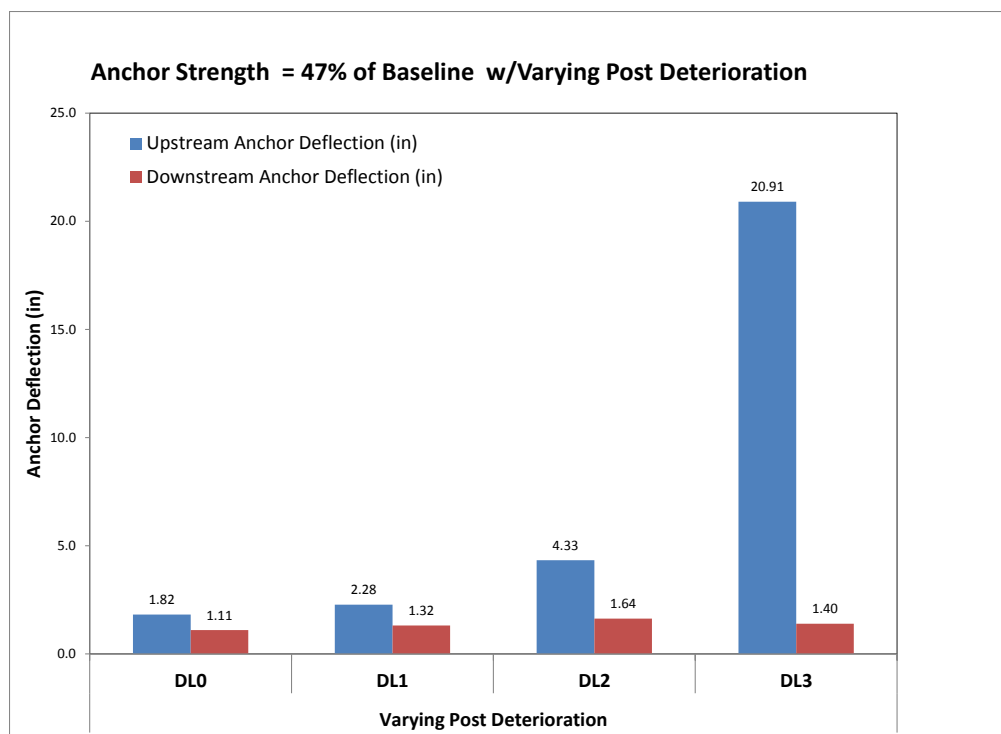
Figure 195. Summary of anchor displacement at rail height from analyses of G4(2W) with combination of weak anchor and deteriorated posts.

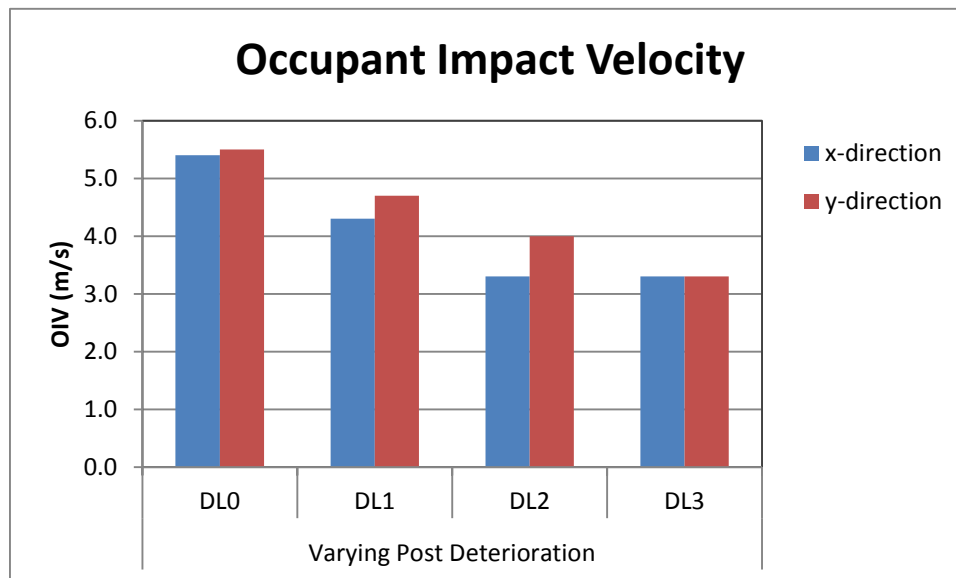
Figure 196. Summary of occupant impact velocity (OIV) from analyses of G4(2W) with combination of weak anchor and deteriorated posts.

A summary of occupant risk measures computed from the acceleration and angular rate time-histories at the vehicle's center of gravity is provided in Table 59. This data is also presented graphically in Figures 196 through 198. The results indicated that reduced anchor strength did not significantly affect occupant risk; however there was a slight trend toward decreasing values as post deterioration levels increased.
