Criteria for Restoration of Longitudinal Barriers, Phase II (2021)

Criteria for Restoration of Longitudinal Barriers, Phase II

Contractor's Final Report for NCHRP Project 22-28
Submitted June 2015

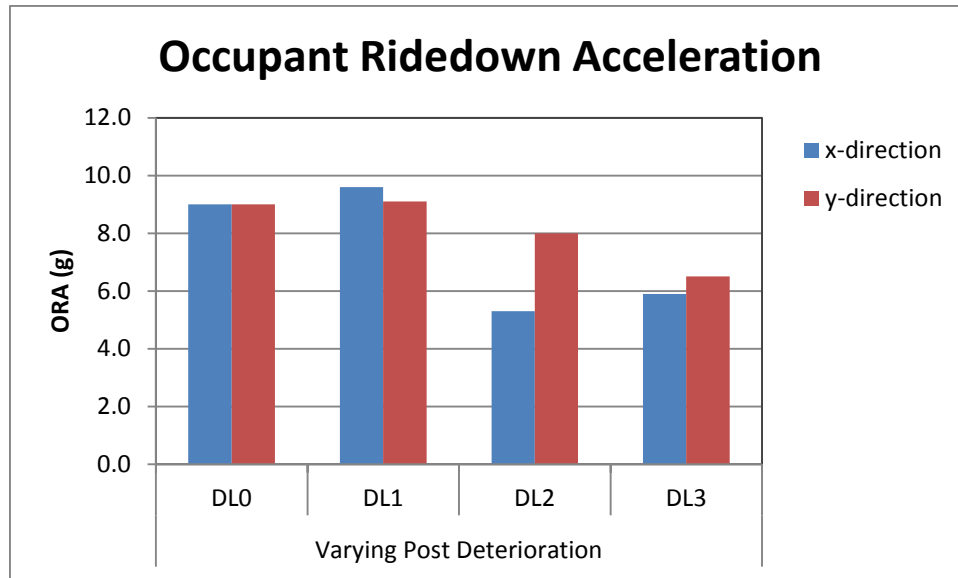
Figure 197. Summary of occupant ridedown accelerations (ORA) from analyses of G4(2W) with combination of weak anchor and deteriorated posts.

A summary of occupant risk measures computed from the acceleration and angular rate time-histories at the vehicle's center of gravity is provided in Table 59. This data is also presented graphically in Figures 196 through 198. The results indicated that reduced anchor strength did not significantly affect occupant risk; however there was a slight trend toward decreasing values as post deterioration levels increased.

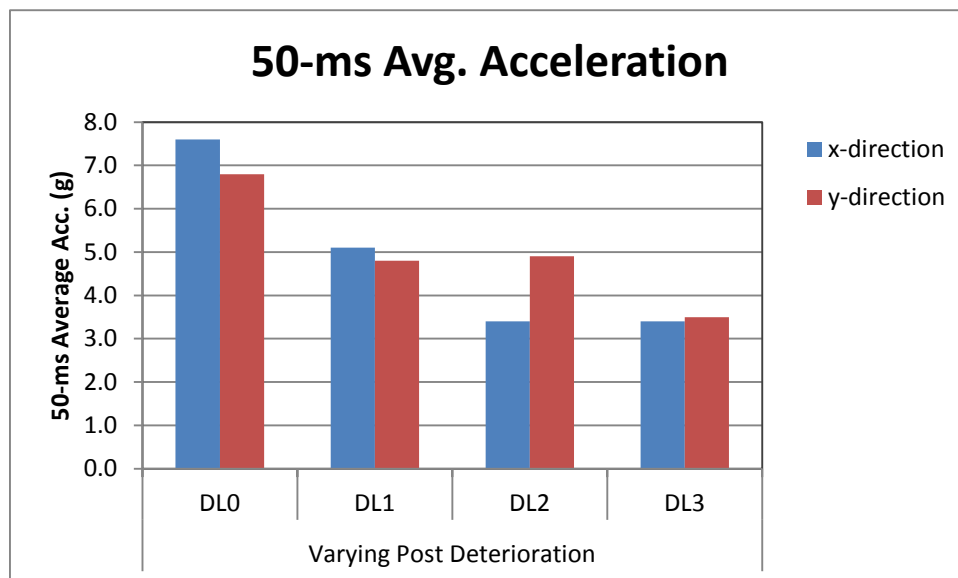
Figure 198. Summary of occupant risk measures from analyses of G4(2W) with combination of weak anchor and deteriorated posts.

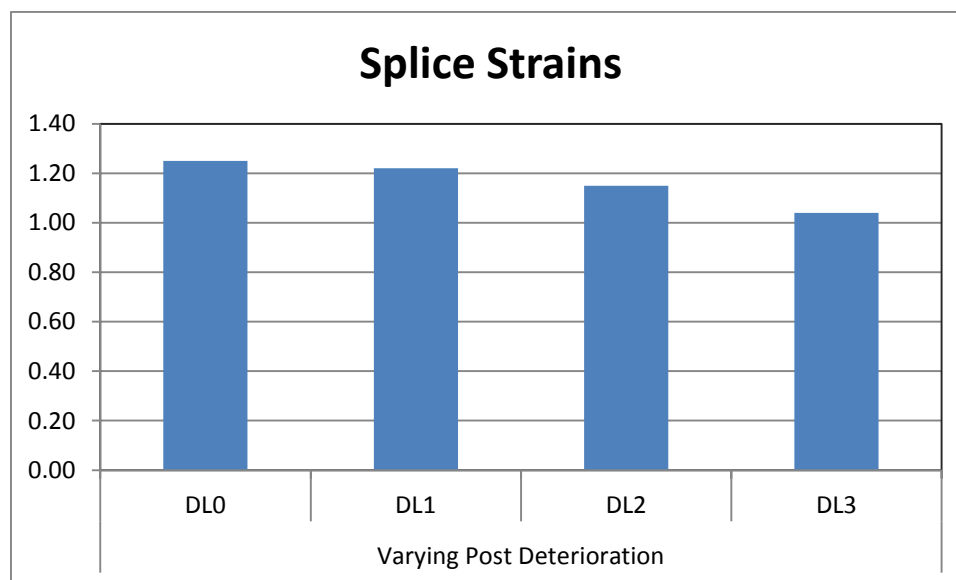
Figure 199. Summary of maximum effective plastic strains occurring at the splice-bolt locations at Post 16.

A summary of the maximum effective plastic strains around the splice-bolt holes in the w-beam for each analysis case is shown in Figure 199. The results showed that the potential for splice rupture decreased slightly as post deterioration levels increased; this information may not be reliable, however, since the CIP was not used in the analyses. It is assumed that the results for Cases DL2 and DL3 would likely have been more severe had critical impact conditions been used. The CIP for these cases can be estimated based on the deflection data from Table 58 and assuming that the maximum potential for rail rupture occurs when maximum rail deflection is located at approximately 20 inches upstream of a splice connection. Future work should include analysis cases using the CIP (as estimated here or otherwise determined) for each damage case.

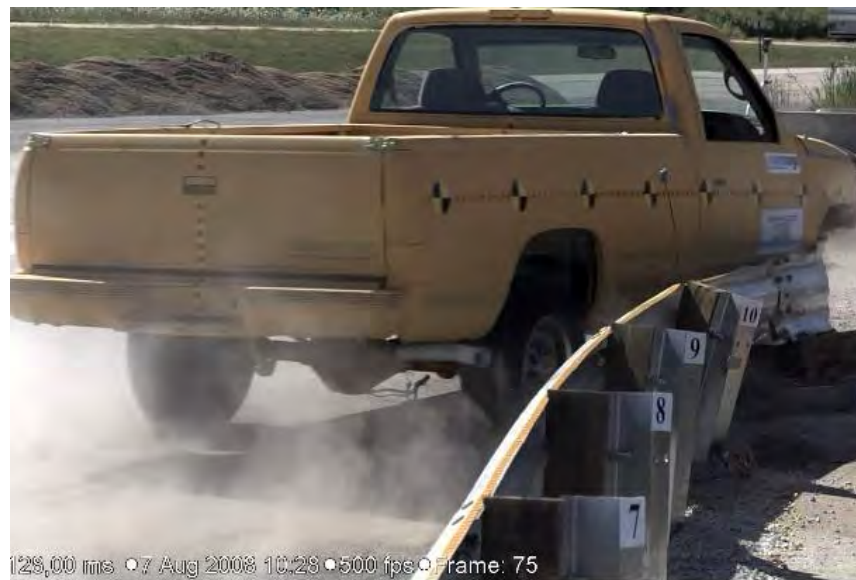
Figure 200. Snapshot from Test C08C3-2 illustrating torsion behavior of posts upstream of impact on the G4(1S).[Fleck08b]

This result may differ for the G4(1S) guardrail. The wood post (6x8-inch rectangular or 8-inch round cross-section) has a much higher torsional rigidity than the steel W6x9 steel post, and thus the posts of the G4(2W) guardrail do not experience torsional deflections like the posts of the G4(1S). For example, Figure 200 shows a snapshot from full-scale crash test C08C3-2 on the G4(1S) conducted by MGA Research Corporation on August 6, 2008, illustrating the relatively large torsional deflections of the guardrail posts upstream of the impact resulting from the tensile forces in the rail.[Fleck08] This test also resulted in relatively high deflection of the upstream anchor. Figure 201, on the other hand, shows a snapshot from full-scale crash test 471470-26 on the G4(2W) conducted by TTI on May 25, 1994.[Mak99a] In this test, the torsional deflection of the posts upstream of the impact was negligible and there was relatively low deflection of the anchor system.

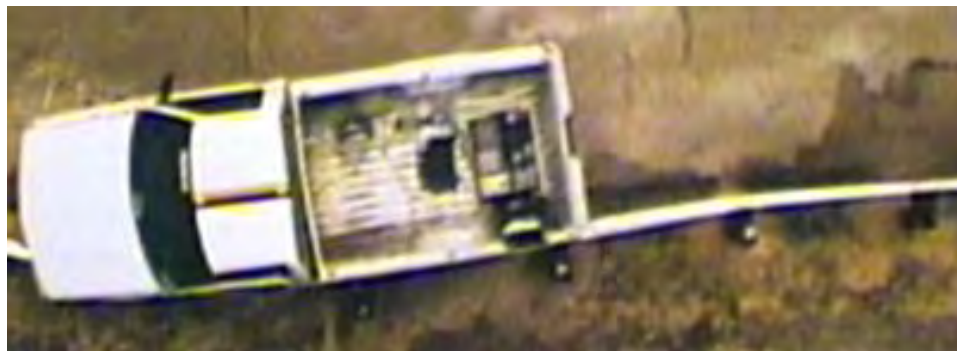
Figure 201. Snapshot from 471470-26 illustrating torsion behavior of posts upstream of impact on the G4(2W).[Mak99a]

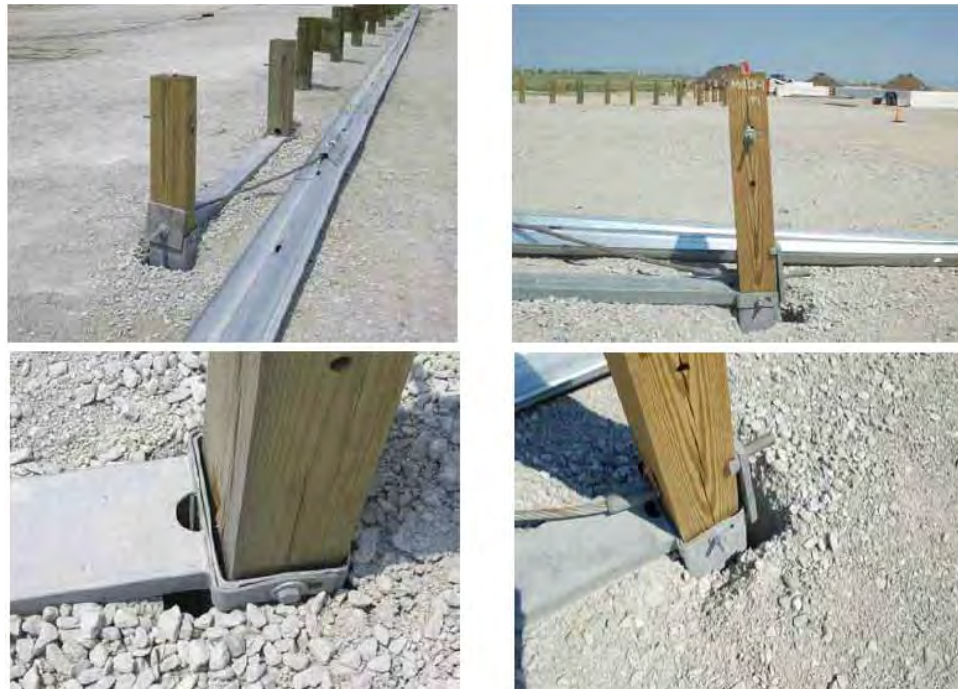
Figure 202. System damage at upstream anchor resulting from Test MGSDF-1.[Hascall07]

posts upstream of the impact point carrying the tensile load of the rail such that the loading on the anchor was negligible. However, consideration should be given to the possibility of impact occurring at a point nearer to the anchor which would significantly increase the loading on the anchor. Also, if the w-beam rail detaches from the upstream posts during impact, or if posts upstream of the impact point fracture under the tensile loading of the w-beam, then anchor loads may increase significantly. For example, in full-scale crash test MGSDF-1 conducted by the MwRSF on a reduced-diameter wood post version of the MGS (i.e., 7.2-inch diameter Douglas Fir posts), the rail separated from all the posts upstream of the impact point to the anchor, as illustrated Figure 202, resulting in notable displacement of the anchor. This was, however, a successful test.

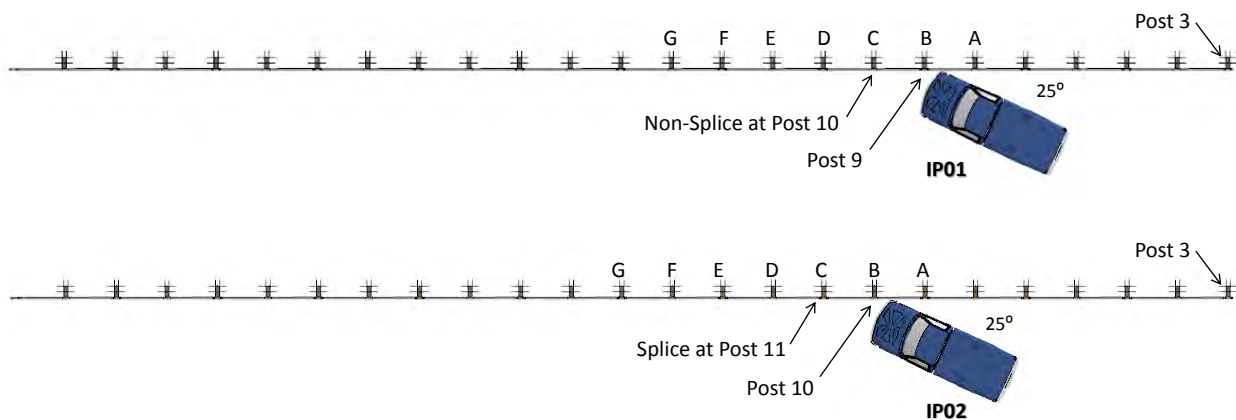
Figure 203. Impact locations, IP01 and IP02, for low-speed impact cases.

A total of six low severity, crash-induced damage cases were created by simulating the impact of a 4568-lb $\frac{3}{4}$ -ton pickup into the G4(2W) guardrail at an impact angle of 25 degrees using LS-DYNA. The simulation matrix is shown in Table 61 and includes three impact speeds (i.e., 30 mph, 35 mph and 40 mph) and two impact locations. The FEA models for these analysis cases are shown in Figure 203.

alternative reference system was used for labeling the posts within the impact region of the guardrail. This section of posts was labeled A through G, with Post A being the first post upstream of the impact point, as illustrated in Figure 203. This labeling system resulted in the rail-post connections at Posts C and D being the most critical for evaluating proper release of the rail from the posts for all impact scenarios. Recall that the greatest potential for vehicle override occurs when the rail is pulled down by the posts during deflection.

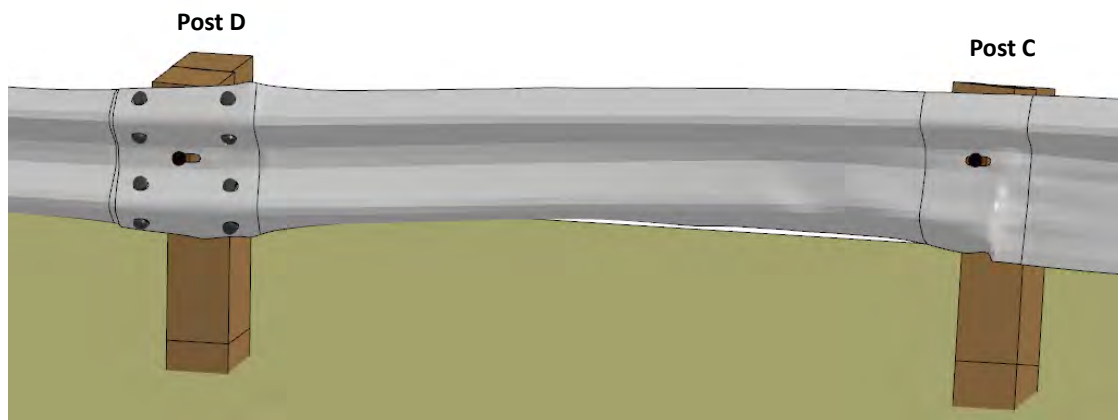
Figure 204. Example of low-severity impact damage illustrating final position of post-bolts relative to the slotted hole in w-beam.

At the start of the analyses, the post-bolts were positioned at the center of the slotted hole in the w-beam at all rail-to-post connections points. Due to the tension in the rail during impact, the post-bolts located upstream of the impact point tended to pull toward the upstream end of the slot, while the post-bolts downstream of the impact tended to pull toward the downstream end of the slot. At Post C, however, the post-bolt was first pulled to the downstream end of the slot as the vehicle approaches from the upstream direction; then as the vehicle passed by the post during redirection, the tension in the rail tended to pull the post-bolt back toward the center. In some cases, however, the bolt remained at, or very near to, the downstream end of the slot. The post-bolt positioned at the ends of the slotted hole result in a stronger, more critical connection for the study, since it results in a higher probability of the rail to remain attached to, and be pulled down with, the posts as they deflect.

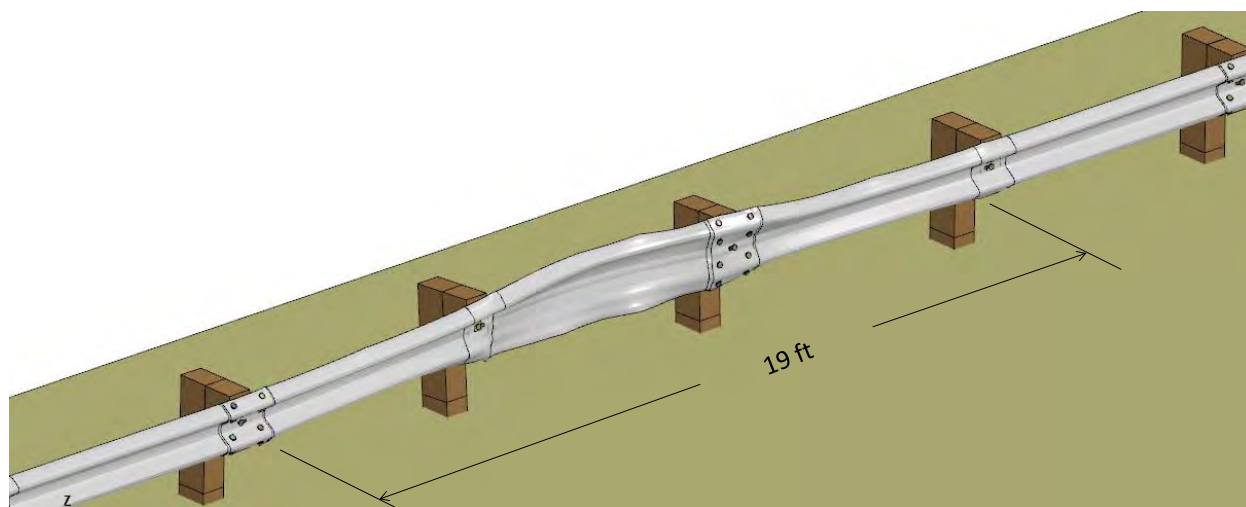
Figure 205. Extent of damage resulting from impact on G4(2W) at 30 mph at Impact Point.

The low-severity impact cases performed in this study involved low speeds and a high impact angle which resulted in damages to a relatively localized section of the guardrail, as illustrated in Figure 205. The length of damage shown in the figure includes only the section of rail with visually discernable lateral deflection. The full extent of damage actually involved a much longer section of the system and included low levels of permanent anchor deflections. It may be possible to achieve similar magnitudes of lateral deflection, spread over a greater length of guardrail, by using higher impact speeds and smaller impact angles. In such cases, the resulting capacity of the damaged guardrail may differ from those presented herein and should be considered in future evaluations of damage modes related to guardrail deflections.

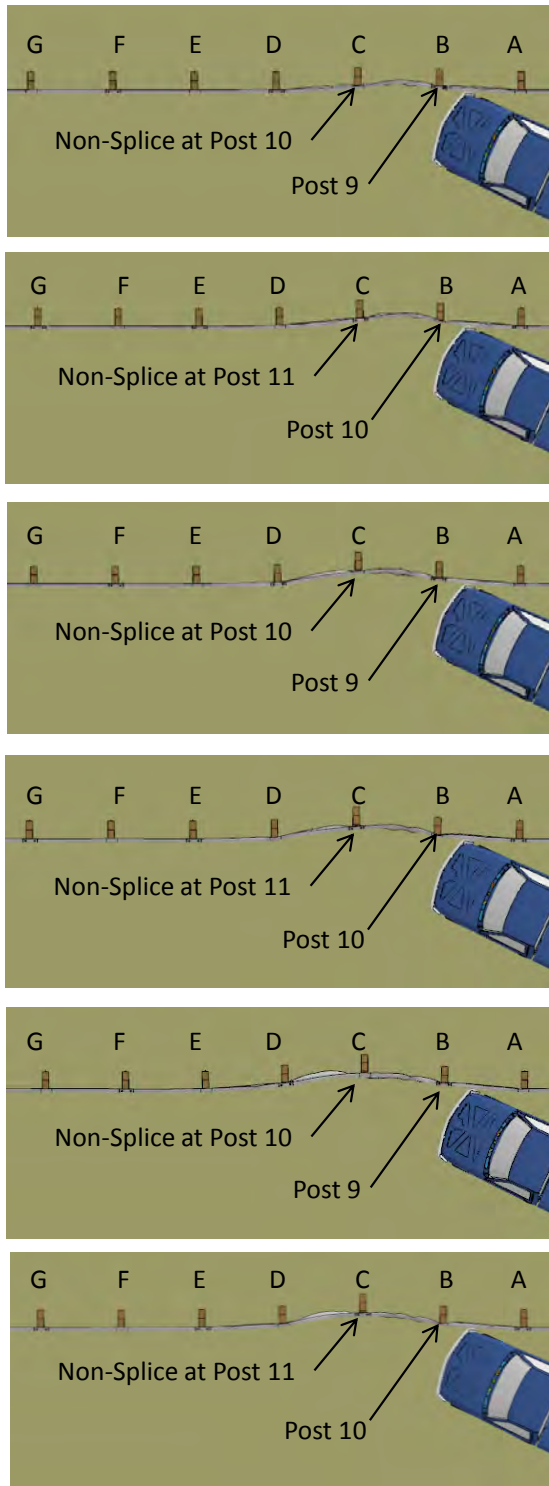
Case 1: Impact Point - IP01
Critical post-bolt connection at non-splice

- Pre-Damage:
- Speed / angle = 30 mph / 25 deg.
 - Deflection = 8.7 in.
 - Length of damage = 19 ft.

- Pre-Damage:
- Speed / angle = 30 mph / 25 deg.
 - Deflection = 8.7 in. (estimated)
 - Length of damage = 20 ft.

- Pre-Damage:
- Speed / angle = 35 mph / 25 deg.
 - Deflection = 13.5 in.
 - Length of damage = 20 ft.

- Pre-Damage:
- Speed / angle = 35 mph / 25 deg.
 - Deflection = 13.3 in.
 - Length of damage = 24.5 ft.

- Pre-Damage:
- Speed / angle = 40 mph / 25 deg.
 - Deflection = 13.9 in.
 - Length of damage = 26 ft.

- Pre-Damage:
- Speed / angle = 40 mph / 25 deg.
 - Deflection = 13.3 in.
 - Length of damage = 28 ft.

Figure 206. Initial conditions used in evaluating effects of low-level guardrail deflection on the performance of the G4(2W).

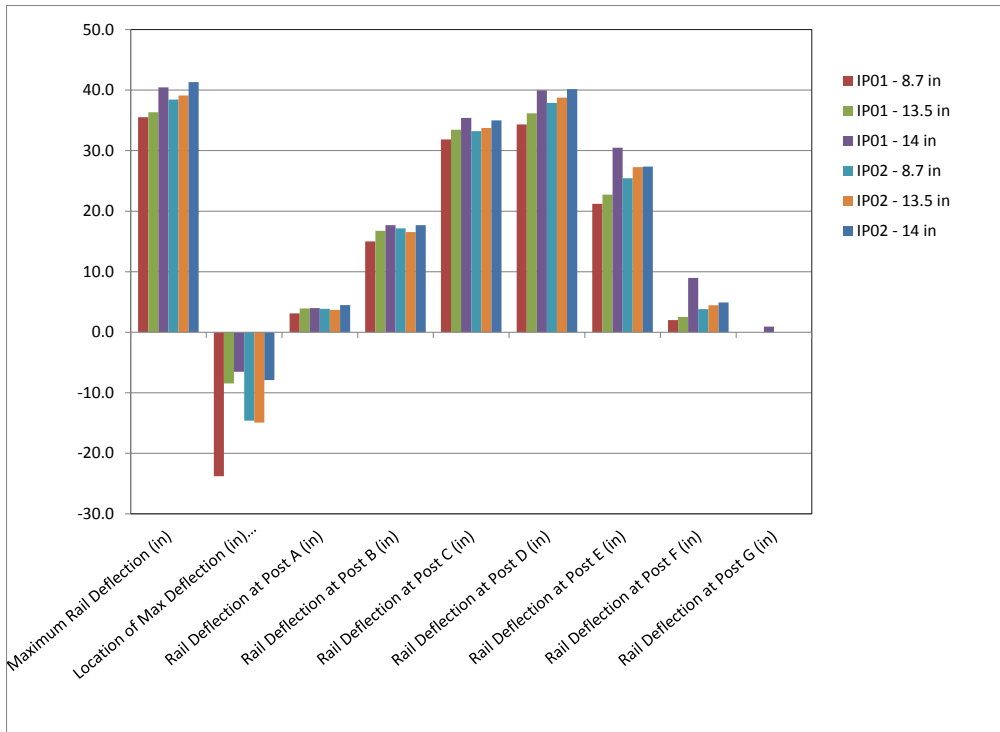
Figure 207. Summary of barrier damage resulting from analysis of high-speed impact into the G4(2W) with pre-existing low-severity rail deflection.

The movement of the anchors and the maximum tensile forces in the rail tended to increase as the severity of the pre-existing crash-induced rail deflections increased. The anchor deflections also tended to be higher for cases involving Impact Point 1, which was in part attributed to the fact that Impact Point 1 was closer to the downstream end-terminal (e.g., tensile force in rail were distributed to fewer upstream posts for IP01 cases). A summary of the maximum effective plastic strains around the splice-bolt holes in the w-beam is shown in Figure 209 for each analysis case. The results show that the potential for splice rupture tended to increase as the severity of the pre-existing crash-induced rail deflections increased. For all cases, the maximum splice damage occurred at Post 11; which, for those analysis cases involving Impact Point 2, was at Post C located upstream of point of maximum deflection. For reference, the maximum effective plastic strains in the splice for the undamaged baseline case was 0.84 (see Chapter 8).

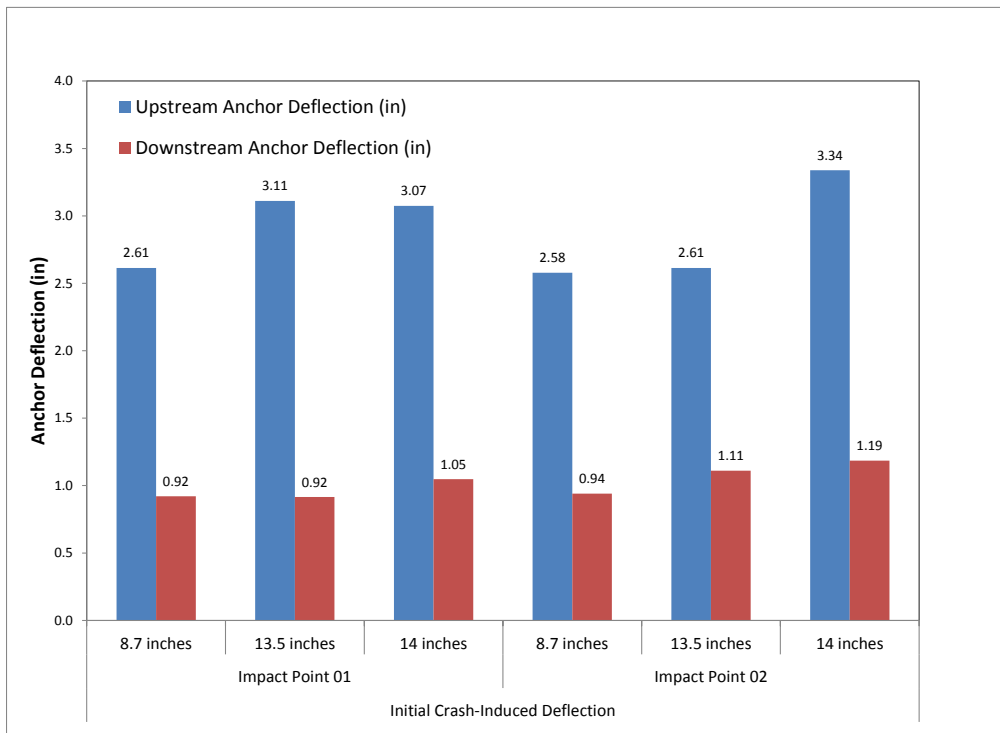
Figure 208. Summary of anchor displacement at rail height from analysis of high-speed impact into the G4(2W) with pre-existing low-severity rail deflection.

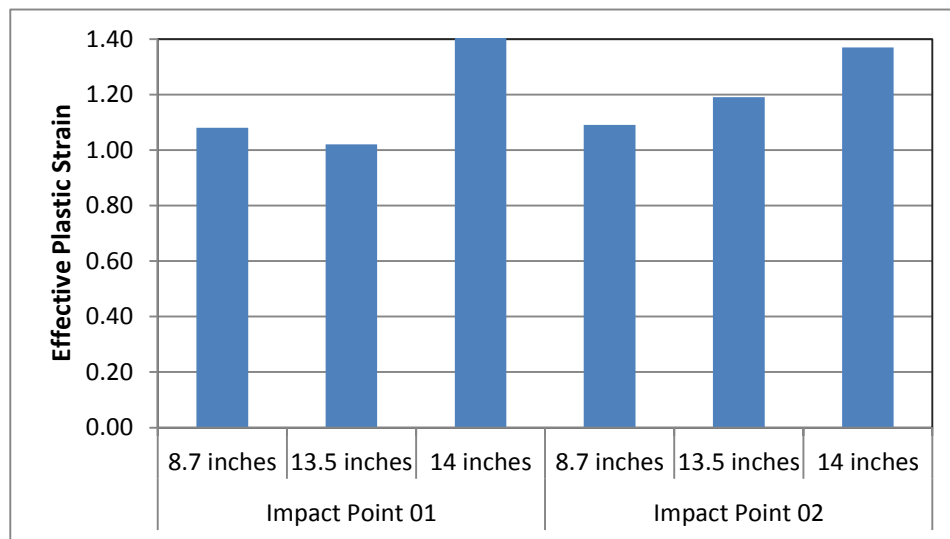
Figure 209. Summary of maximum effective plastic strains occurring at splice-bolt locations.

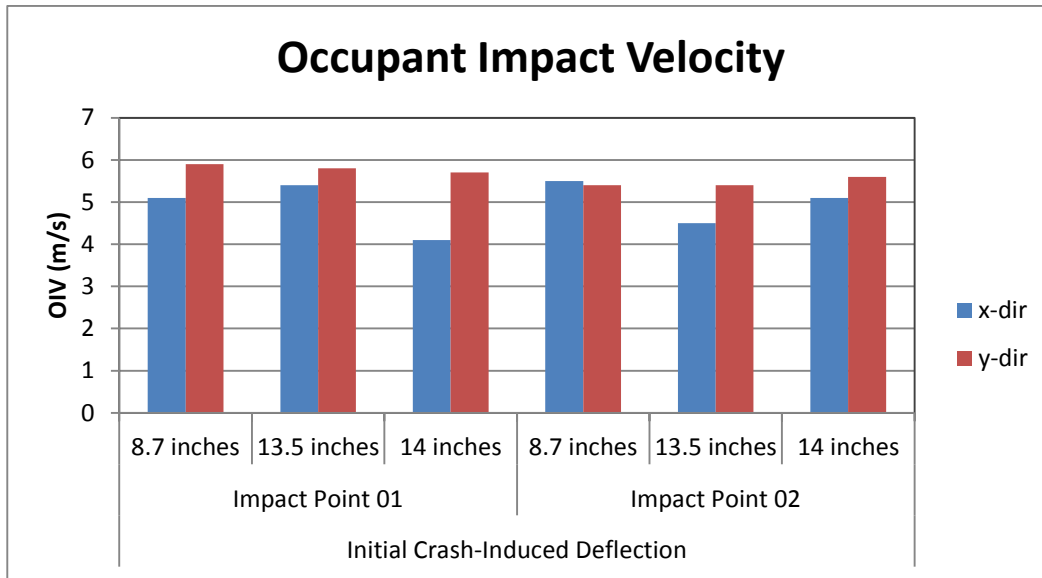
Figure 210. Summary of occupant impact velocity (OIV) from analysis of high-speed impact into the G4(2W) with pre-existing low-severity rail deflection.

A summary of occupant risk measures computed from the acceleration and angular rate time-histories at the vehicle's center of gravity is provided in Table 64. This data is also presented graphically in Figures 190 through 192. The results indicate that occupant impact velocity (OIV) is not significantly affected by pre-existing low-level guardrail deflections. The maximum 10-millisecond occupant ridedown accelerations (ORA) in the longitudinal direction tended to increase as pre-existing guardrail deflections increased; however, they remained below critical limits of 20 g's for all cases. The ORA values in the lateral directions were less affected.

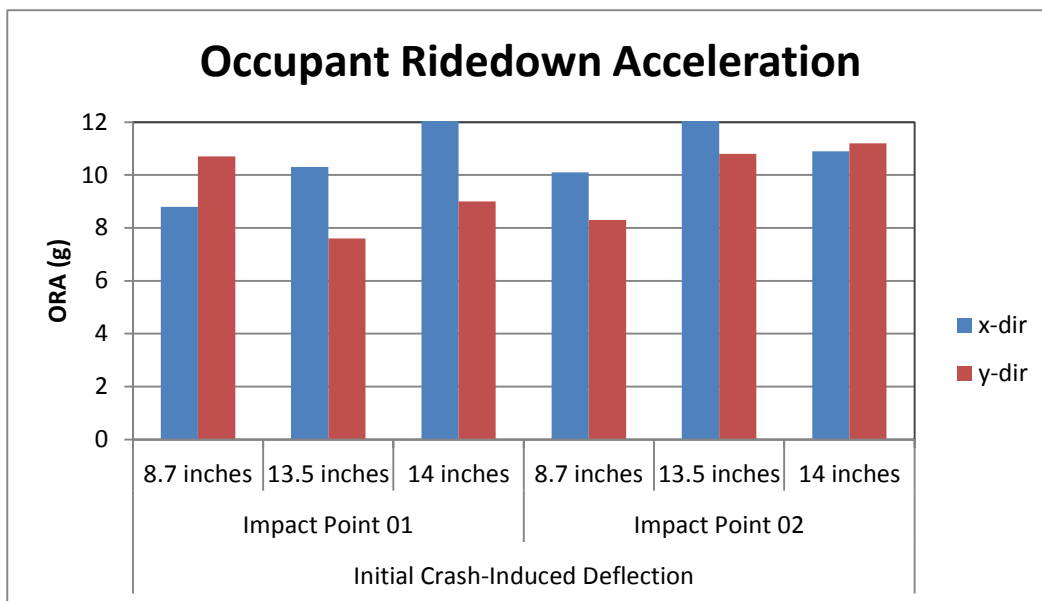
Figure 211. Summary of occupant ridedown accelerations (ORA) from analysis of high-speed impact into the G4(2W) with pre-existing low-severity rail deflection.

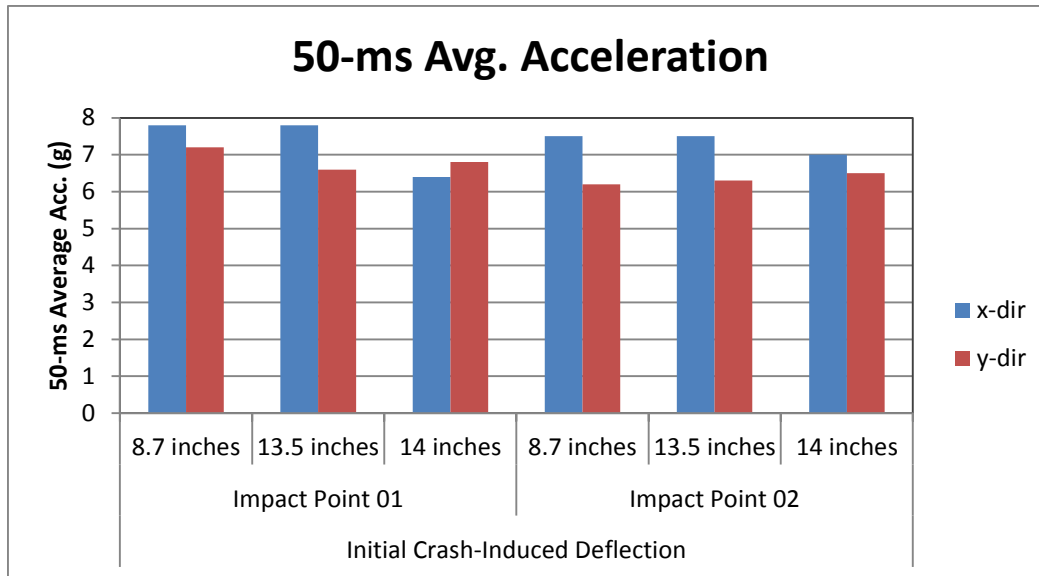
Figure 212. Summary of 50-ms average acceleration from analysis of high-speed impact into the G4(2W) with pre-existing low-severity rail deflection.

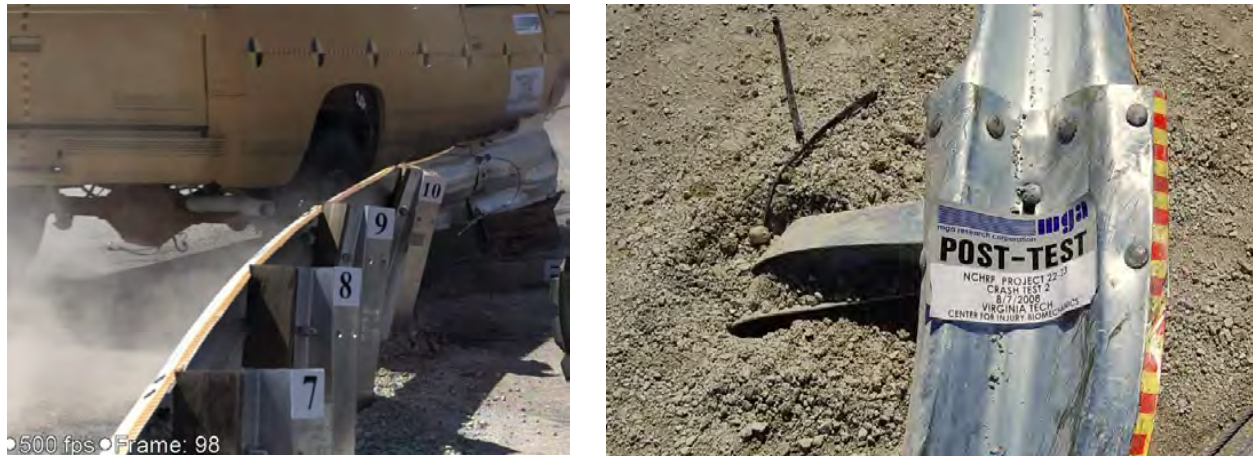
Figure 213. Results of Test MGA C08C3-027.2 illustrating torsional deformation of the W6x8 steel guardrail posts during vehicle collision.[Fleck08b]

In order to understand the differences in the performance of these two seemingly identical systems, it is first important to understand the differences in the response of the two different types of posts under loading conditions typical of real-world collisions. In particular, guardrail posts generally experience both lateral and torsional loads during vehicle collisions – whereas bogie impact tests induce only lateral loads onto the post. The lateral load from vehicle collision arises directly from the lateral deflection of the w-beam rail against the posts. The torsional loads on the posts result from the tensile load in the w-beam rail acting at the front of the blockouts; the blockouts are offset 8 inches from the front face of the posts, thus creating a torsional moment about the vertical axis of the posts. The wood posts tend to resist this torsion, while the W6x9 steel posts do not. The torsion of the steel posts not only reduces the breakout distance between the rail and the post, but also significantly reduces its resistance to lateral deflection. Figure 213 shows the results of full-scale Test C08C3-027.2 on the G4(1S) guardrail system conducted by the MGA Research Corporation in Gabler's study, illustrating the torsional deformation of the posts.[*Fleck08b*] The photo on the right in Figure 213 further illustrates the apparent reduction in lateral stiffness of the “twisted” post, where the post buckled at the groundline rather than displacing the soil. The combined effects of (1) reduced breakout

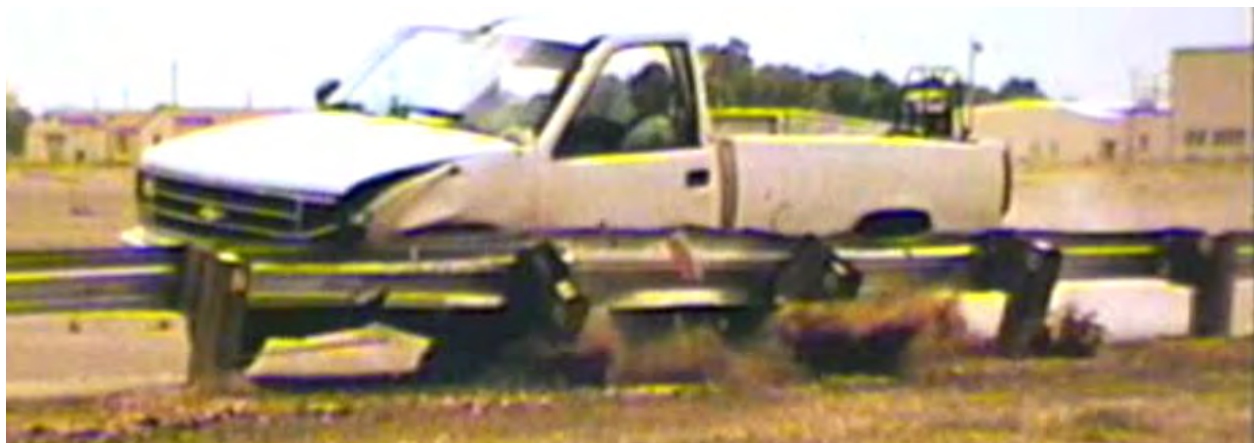
Figure 214. Results of Test 471470-26 illustrating the response of the wooden guardrail posts during vehicle collision.[Mak99]

distance, (2) the post buckling at the groundline, and (3) loss of rail tension as the anchor failed resulted in the rail being pulled down with the post rather than releasing from the post as it was intended. In contrast, Figure 214 shows the results of full-scale Test 471470-26 on the G4(2W) guardrail conducted by TTI showing the general deformation mode of the posts during vehicle collision. In this case the posts do not show any apparent torsional deflections and tend to deflect only in the lateral direction. When wood posts fail under the torsional load, it is usually a brittle failure in which the posts split or fracture, as illustrated in Figure 215.

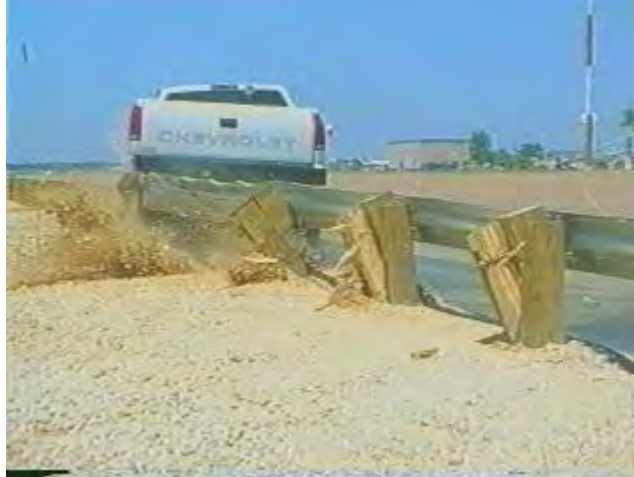
Figure 215. Results of Test 404201-1 illustrating brittle fracture of wood posts due to tensile forces in the w-beam rail.[Bullard00]

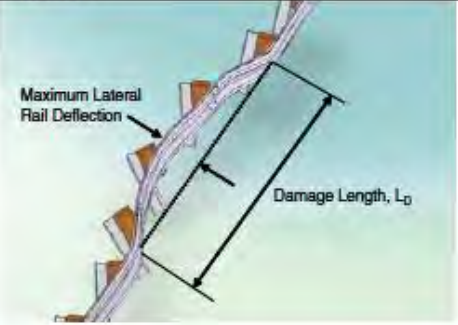
Damage Mode	Repair Threshold	Relative Priority	Measurement
Post and Rail Deflection	One or more of the following thresholds: <ul style="list-style-type: none"> • More than 9 in. of lateral deflection anywhere over a 25-ft length of rail • Top of rail height 2 or more inches lower than original top of rail height 	High

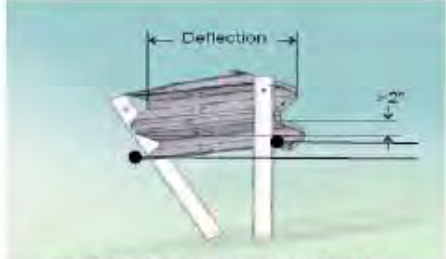
6-9 in. lateral deflection anywhere over a 25-ft length of rail	Medium

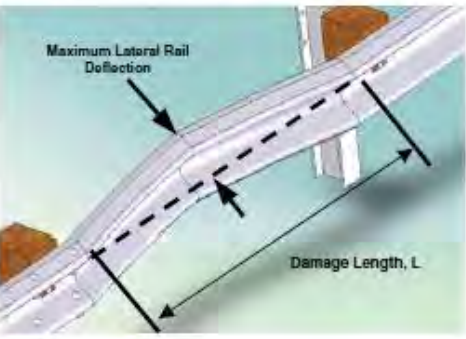
(Weak Post W-Beam Shown Only for Clarity. Each measurement taken at the rail's middle fold)
	Less than 6 in. of lateral deflection over a 25-ft length of rail	Low	
Rail Deflection Only	6-9 in. of lateral deflection between any two adjacent posts <u>Note:</u> For deflection over 9 in., use post/rail deflection guidelines.	Medium

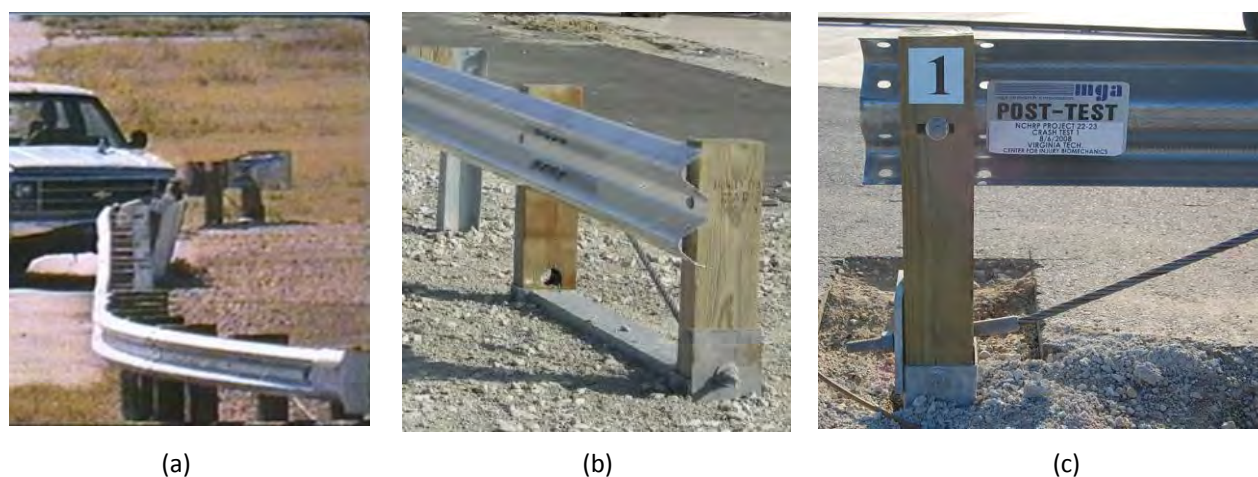
Figure 216. Anchor used in evaluation of the modified G4(1S) with wood blockouts in tests (a) 405421-1 [Bullard96], (b) 2214-WB2 [Polivka06b] and (c) C08C3-027 [Fleck08a;08b].

The undetached post-rail connection in Test C08C3-027.2 that led to the vehicle overriding the barrier was suspected by the authors to be a *symptom of low rail tension* resulting from the excessive movement of the anchor during the test. The focus of this chapter is to reevaluate the G4(1S) installation of Test C08C3-027.2 and investigate the cause for the improper rail detachment. The anchor system used in Test C08C3-027, shown in Figure 216(c) included only a single foundation tube, and was therefore not as stiff nor as strong as the standard anchor system used in the earlier tests of the G4(1S) (i.e., Figure 216 (a) and Figure 216 (b)), which included two foundation tubes connected via a groundline strut.

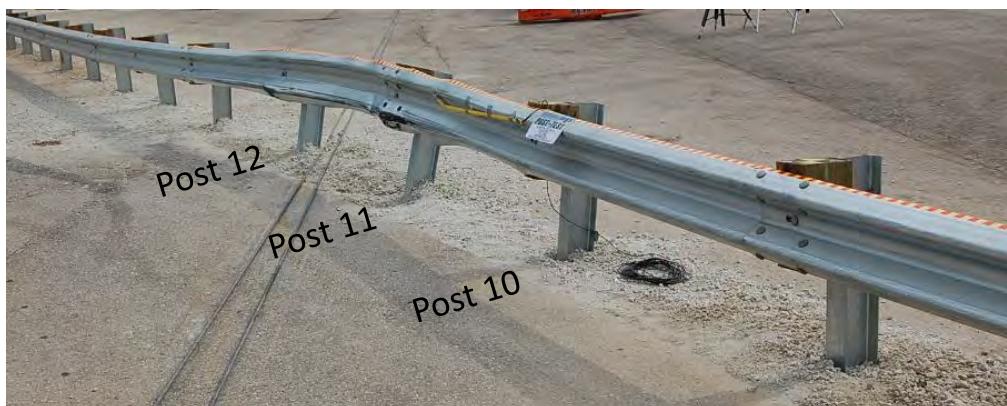
Figure 217. Damage to guardrail in low-speed impact test C08C3-027-1. [Fleck08a]

Full-scale test C08C3-027-1 involved a 1997 Chevrolet 2500 pickup impacting the G4(1S) guardrail at 30.0 mph and at an impact angle of 26 degrees; the impact point was at 45.8 inches upstream of the splice connection at Post 11. The gross static mass of the test vehicle was 4,632 lb. The damage to the test installation is shown in Figures 217 and 218. The maximum deflection of the rail was 14.5 inches and occurred at the midspan between Post 11 and Post 12.

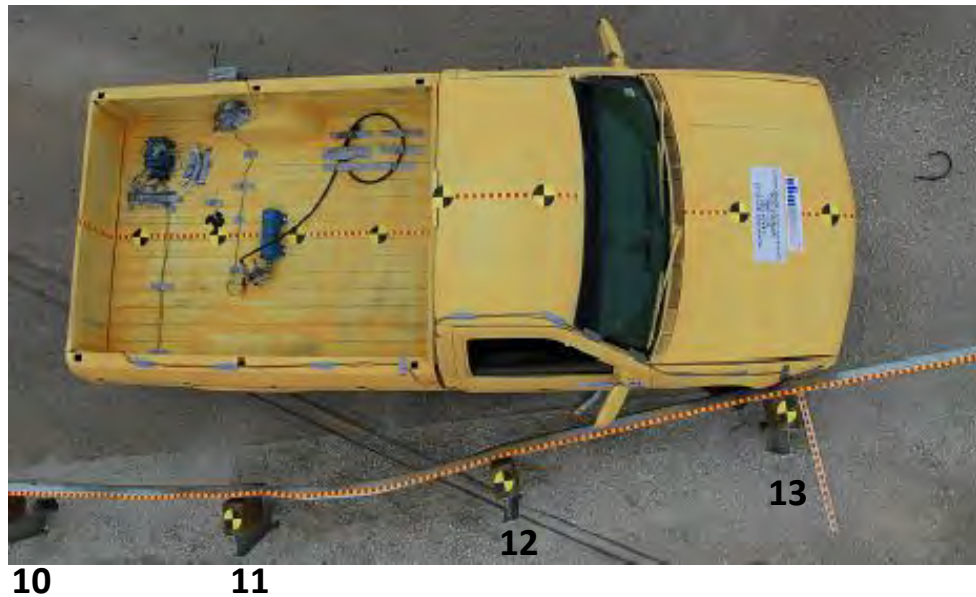
Figure 218. Damage to guardrail in low-speed test C08C3-027-1 (overhead view).[Fleck08a]

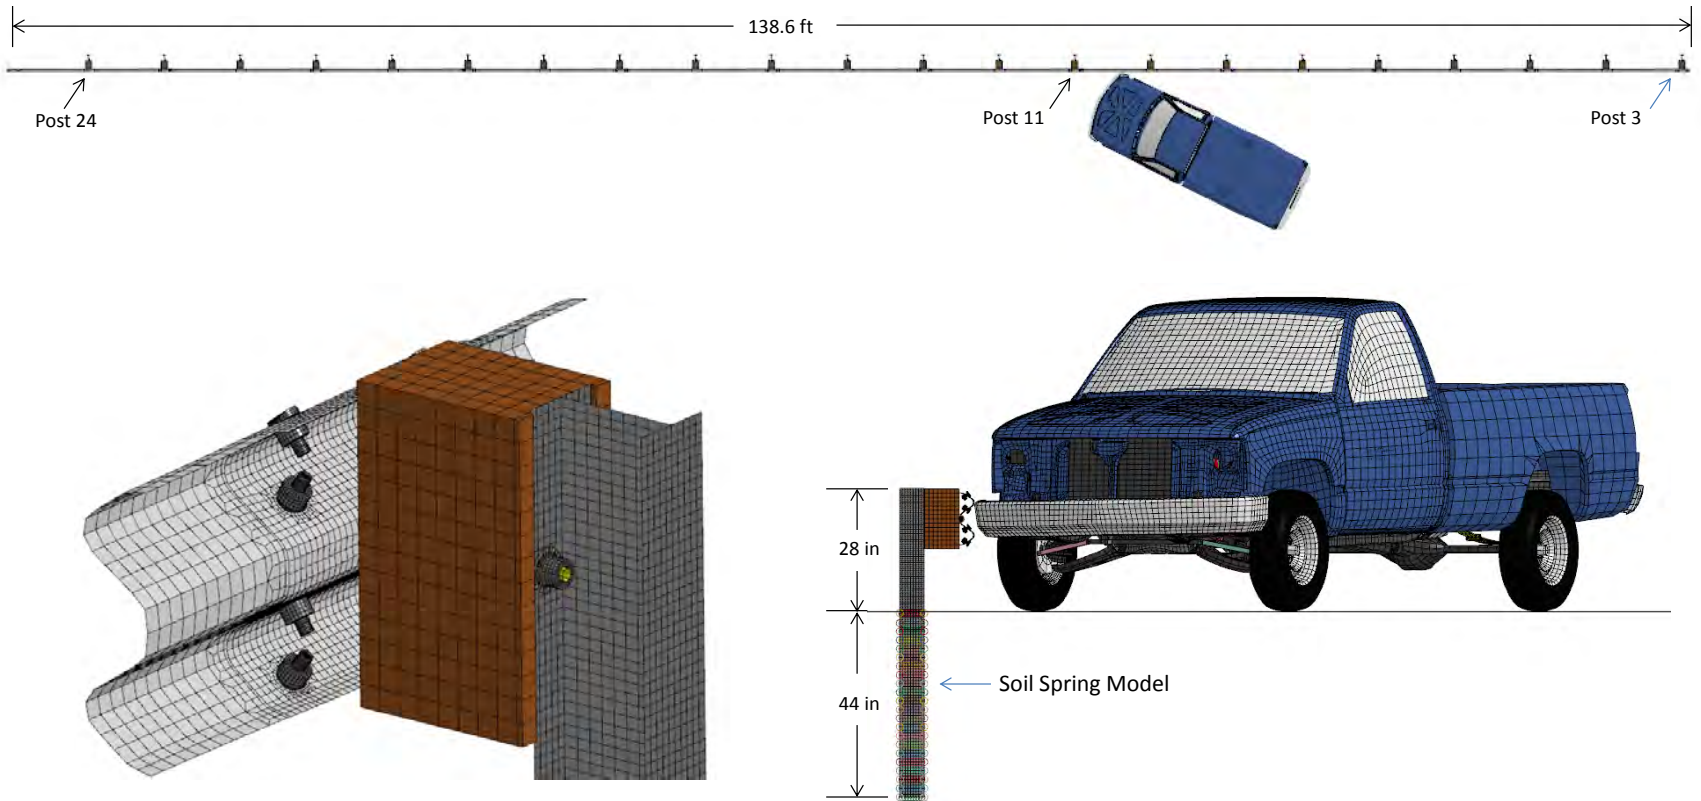
Figure 219. Finite element model of G4(1S) for simulation of Test C08C3-027-1.

The finite element model of the G4(1S) guardrail is shown in Figure 219. The guardrail model consisted of eleven 13.5 foot lengths of 12-gauge w-beam rail, twenty-two W6x9 structural steel posts, and twenty-two 6x8x13 inch routed wood blockouts. The center-to-center distance between rail splices was 12.5 feet. The posts were spaced at 75 inches on center and the w-beam rail was positioned such that the top of rail was 27-5/8 inches above ground. The posts were embedded 44 inches in the ground. The model included 138.6 feet of the guardrail including Post 3 through Post 24. The boundary conditions at the ends of the rail were modeled using nonlinear springs with properties corresponding to 47 percent of the baseline anchor stiffness; this was based on the assumption that the single-foundation tube anchor would have approximately half the stiffness of the baseline two-foundation tube anchor system. The overall *effective* length of the model (including the simulated end-terminals) was 162.4 feet.

The finite element model for the rail element, the blockouts and the connection hardware were adopted from the G4(2W) guardrail model developed in Chapter 7. The blockout was modified by including the “routed” section that fits over the flange of the W6x9 steel posts. The finite element model of the W6x9 posts were modeled with the fully-integrated Type 16 shell elements in LS-DYNA with warping stiffness. The nominal element size was 0.4 x 0.5 inches for the post flange and 0.6 x 0.5 inches for the post web. The material properties for the post were characterized based on the properties determined in an earlier study by Wright and Ray.[Wright96] This material model has been used in numerous analyses and has been validated in simulations of full-scale crash tests.[Plaxico02] For consistency with the G4(2W) model, the soil response was modeled using the non-linear spring concept with the springs attached directly to the post. The properties of the spring elements were defined according to [Plaxico98] using a soil density of 134 pcf and no moisture content (refer to Chapter 7 for more details).

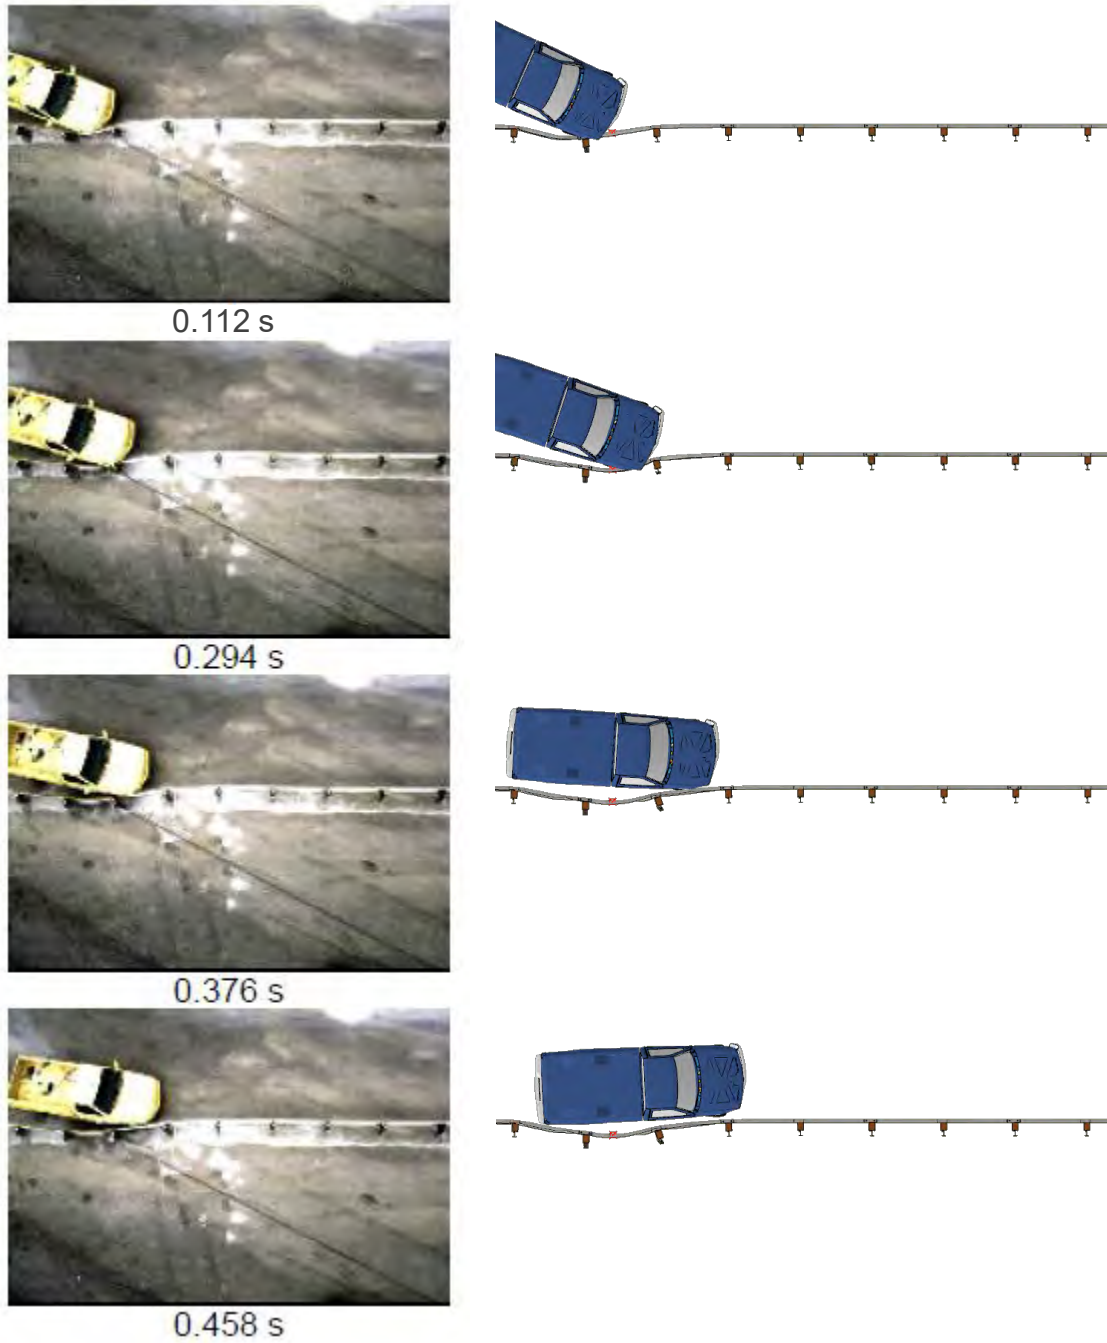
Figure 220. Sequential views of FEA results compared with Test C08C3-027-1.

The analysis was conducted with a time-step of 1.26 microseconds for a time period of 0.6 seconds. Figure 220 shows sequential snapshots of the impact event from an overhead viewpoint comparing the results from the FE analysis with the full-scale test. The yaw angle of the model was greater than that of the test, due primarily to the difference in the response of the wheel assemblies during impact, as illustrated in Figure 221. In the full-scale test the wheel snagged on Post 11 causing the front wheels to turn “full-steer” toward the barrier; whereas in the simulation the wheel’s contact with the post was not sufficient to significantly alter the steer angle. In the full-scale test, the steer angle of the wheels resulted in higher deceleration of the vehicle and also altered the trajectory during the impact event, compared to the results of the FE analysis.

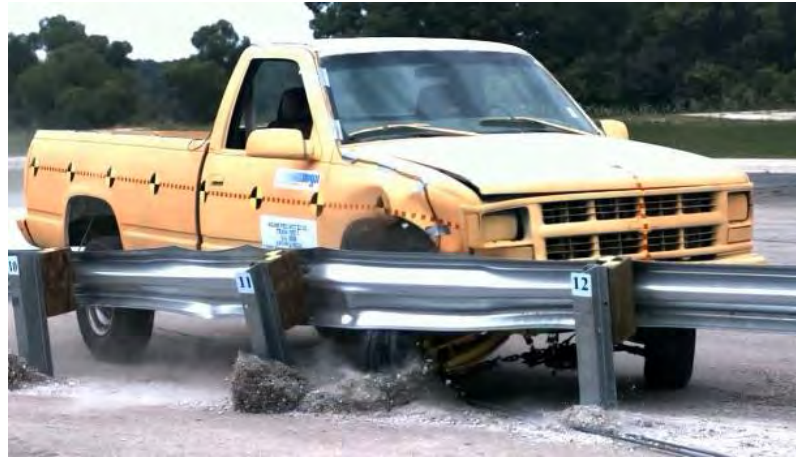
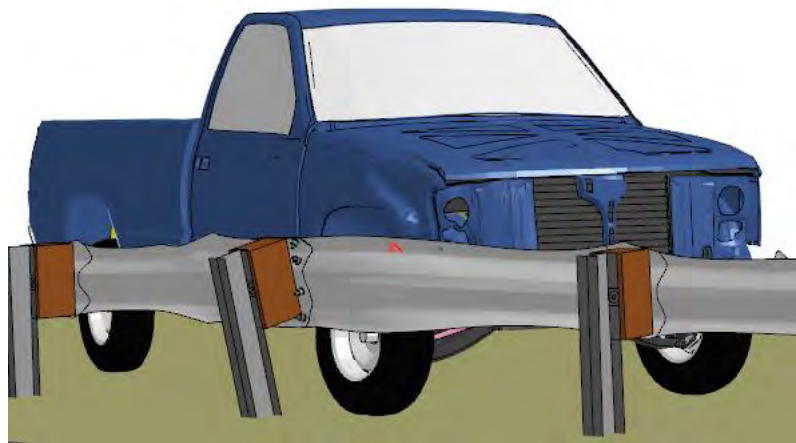
Figure 221. Impact response at 0.18 seconds for (a) full-scale test and (b) FEA illustrating wheel orientation.

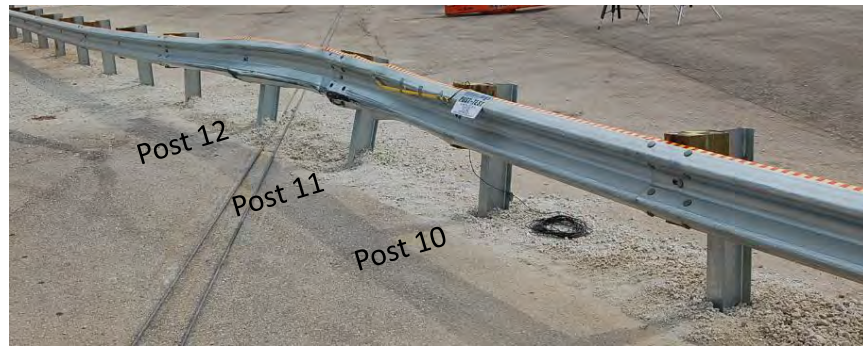
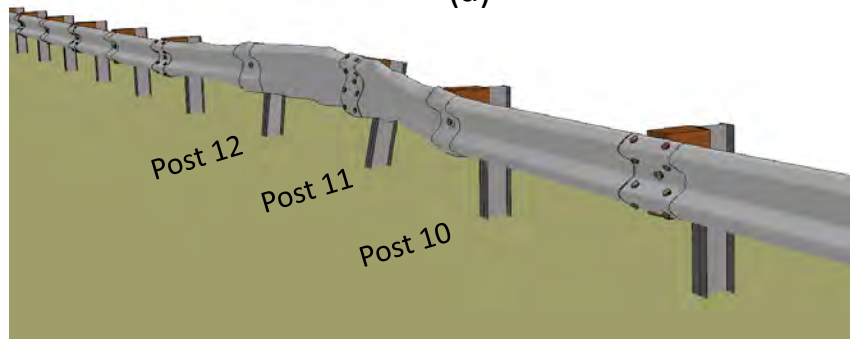
Figure 222. Comparison of guardrail damage for (a) Test C08C3-027-1 and (b) FEA model.

The W-Beam rail element was deformed from Posts 9 through 14 as shown Figure 222. The maximum permanent deflection of the rail in the FE analysis was 15.5 inches and occurred at 47 inches upstream of Post 12 (compared to 14.5 inches deflection at 37.5 inches upstream of Post 12 in the full-scale test). All the post-bolt connections remained attached throughout the impact for both the full-scale test and the FE analysis. The maximum permanent groundline deflections of Posts 10 through 13 in the FE analysis were 0.7 inches, 7 inches, 4.2 inches and 0.24 inches, respectively. Although it cannot be confirmed, it appears from visual inspection of the damaged test article that the deflections of the posts are of similar magnitude. The maximum deflection of the rail at the upstream boundary was 1.2 inches. Figure 223 shows the post-test photograph of the upstream anchor after Test C08C3-027-1. The separation between the back of the post and the soil in the photo is evidence of upstream anchor movement, but the actual amount of displacement was not included in the test report. Overall, the barrier damages resulting from the simulated impact were reasonably representative of that observed in the full-scale test.
