Criteria for Restoration of Longitudinal Barriers, Phase II (2021)

Criteria for Restoration of Longitudinal Barriers, Phase II

Contractor's Final Report for NCHRP Project 22-28
Submitted June 2015

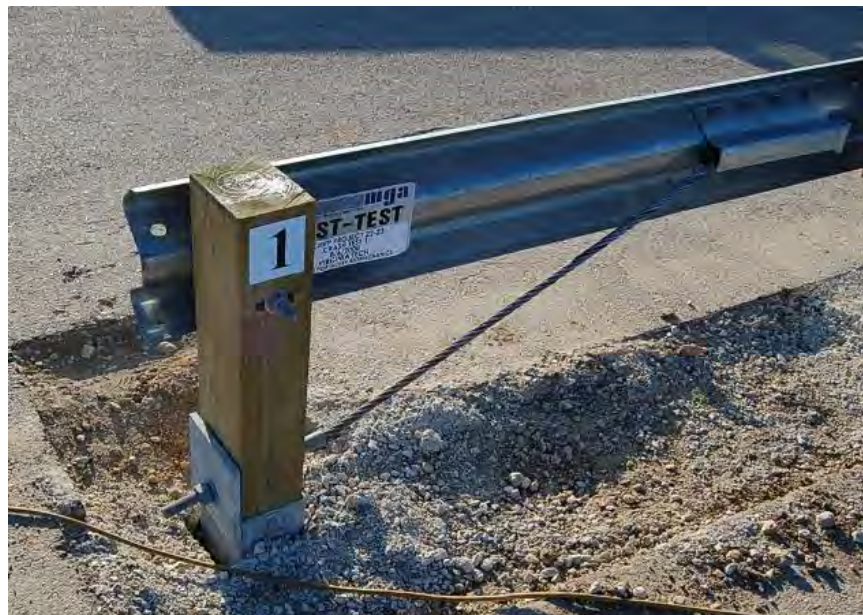
Figure 223. Photo of upstream anchor after Test C08C3-027-1. [Fleck08a]

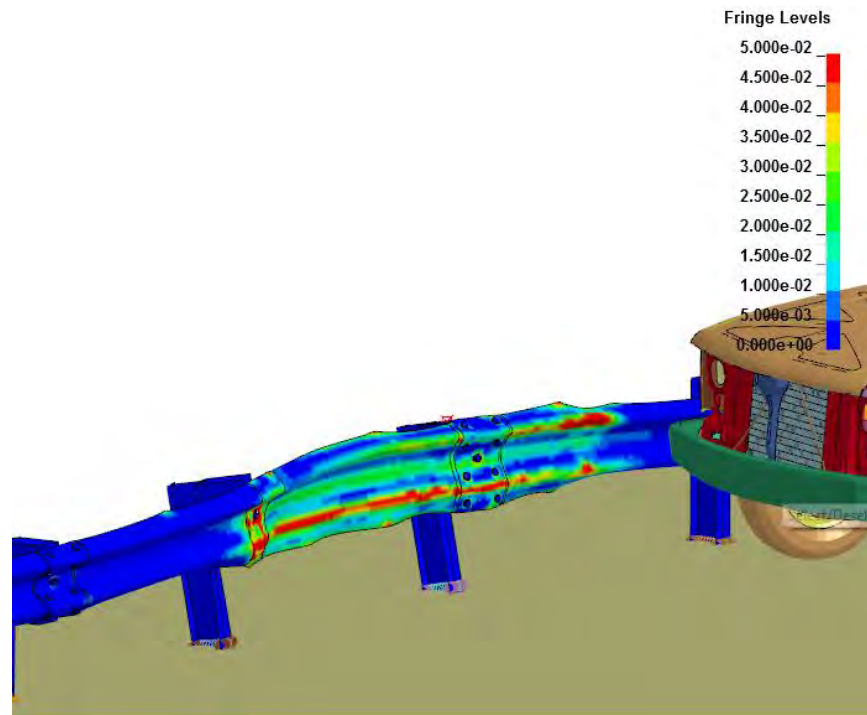
Figure 224. Contours of effective plastic strain for the initial state of the guardrail model for simulation of Test C08C3-027-2.

The results from the low-speed impact case were used as initial conditions in a secondary high-speed impact simulation of full-scale crash test C08C3-027-2. The initial conditions for the pre-damaged guardrail included component deformations and residual stresses. These values were recorded for all shell, solid and beam elements in the model via the SPRINGBACK option in LS-DYNA. The residual forces for discrete elements (e.g., non-linear spring elements for the soil and rail end-boundaries), however, could not be recorded and saved with this option. For initialization of all the spring elements in the model, LS-PrePost was used to determine the final displacements of the spring nodes; these displacement values were then used to define the *initial* offset for each spring element in the FE model. This methodology directly imposed the force-deflection response of the spring elements for the soil and the end-anchor from the low-speed analysis onto the model for the high-speed impact case. Figure 224 shows a contour plot of effective plastic strain for the *initial* state of the guardrail model used in the simulation of Test C08C3-027-2.

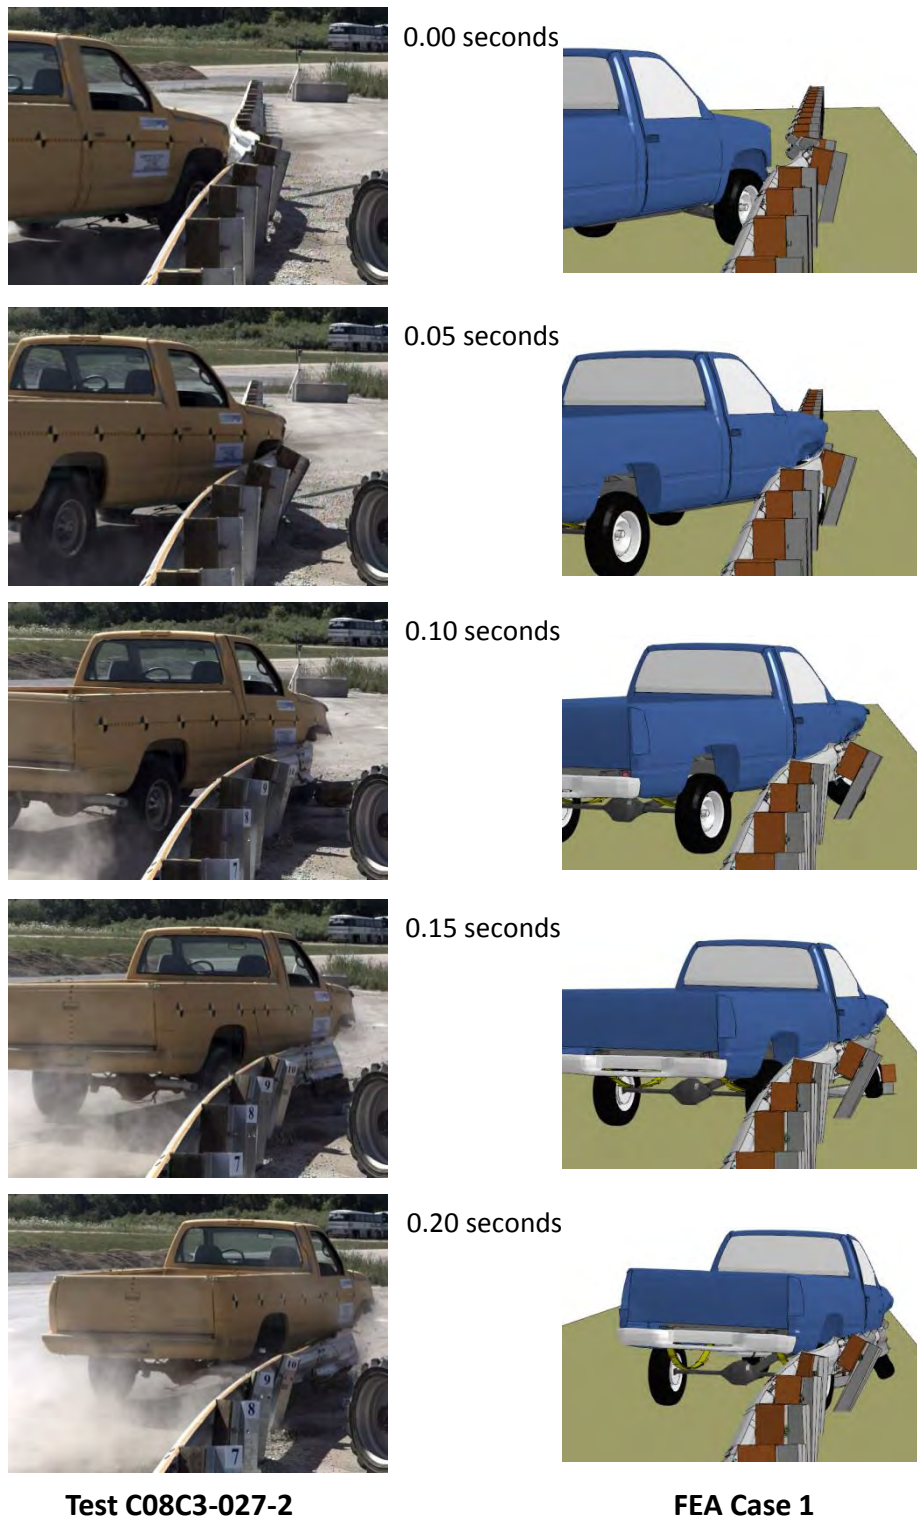
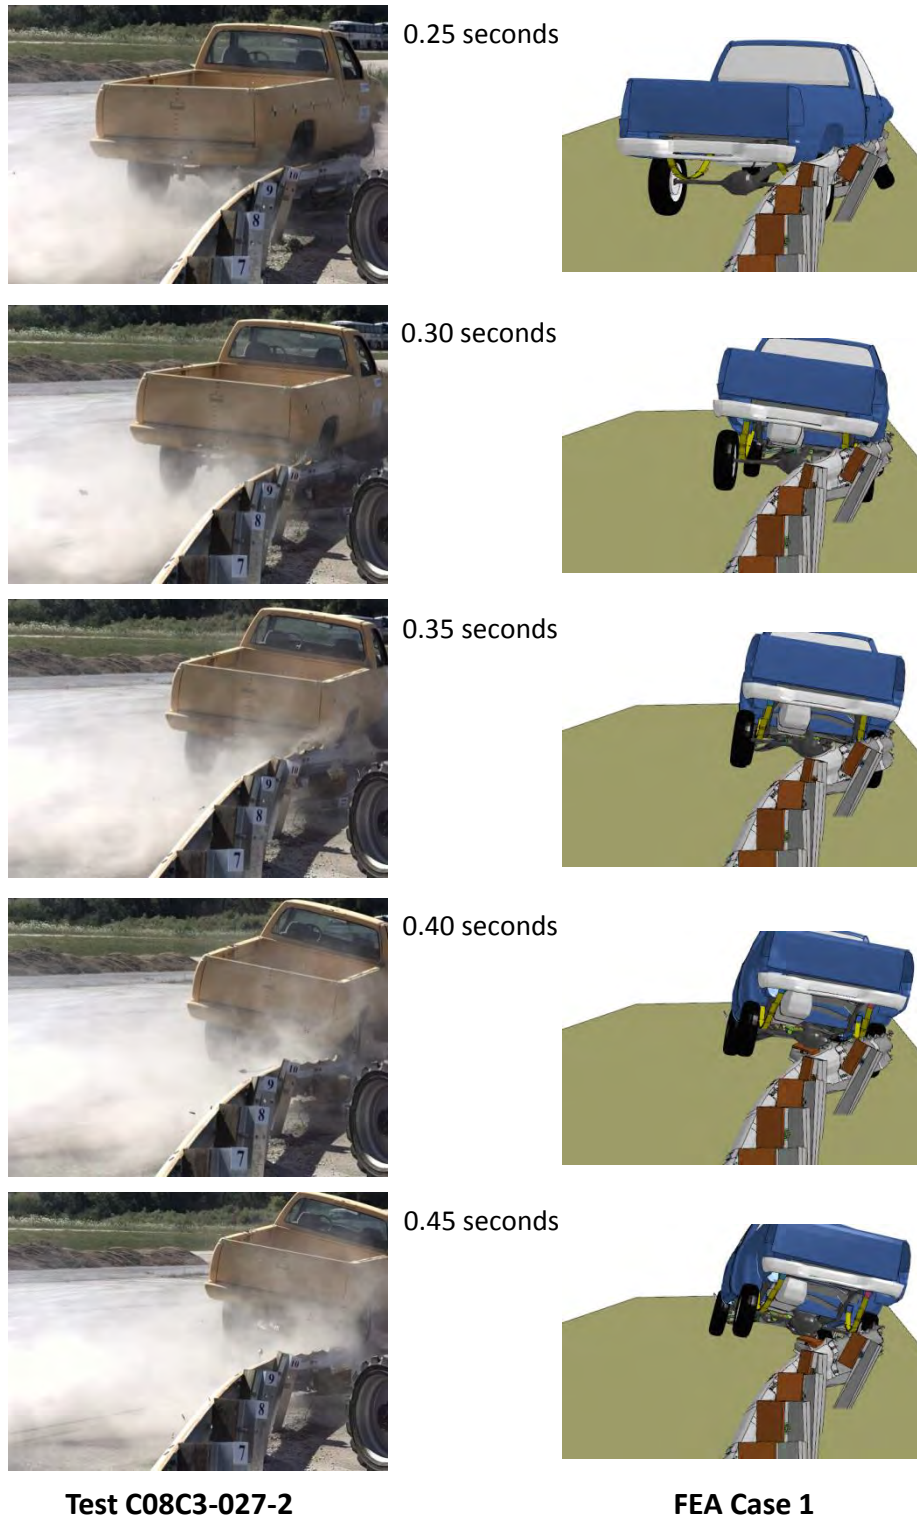
Figure 226. Sequential Views of Test C08C3-027-2 and FE analysis Case 1 from an upstream view perspective.

Figure 226. [CONTINUED] Sequential Views of Test C08C3-027-2 and FE analysis Case 1 from an upstream view perspective.

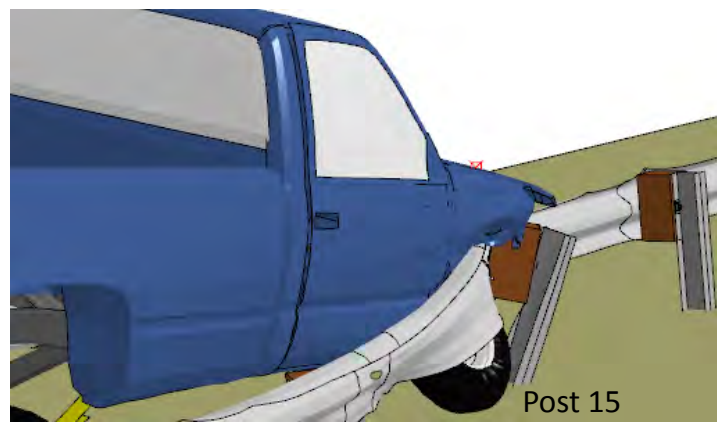
Figure 227. Vehicle impacts against Post 15 in analysis Case 1.

In the longitudinal direction, the occupant impact velocity was 16.4 ft/s (5.0 m/s) at 0.1584 seconds, the highest 0.010-second occupant ridedown acceleration was -8.5 g from 0.4146 and 0.4246 seconds, and the maximum 0.050-second average acceleration was -5.6 g between 0.3404 and 0.3904 seconds. The sudden drop in acceleration at times 0.13 seconds, 0.21 seconds, 0.27 seconds and 0.32 seconds corresponded to the release of post-bolts and buckling of posts. The maximum 0.010-second acceleration occurred when the vehicle impacted against Post 15, as shown in Figure 227.

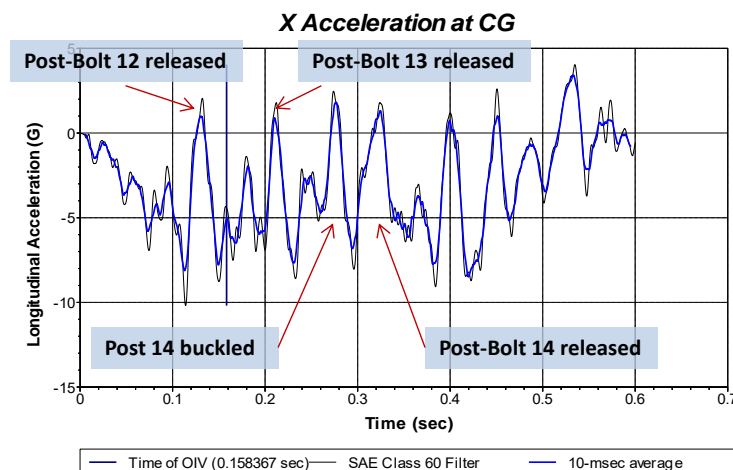
Figure 228. Longitudinal acceleration-time history at C.G. of pickup truck model in local coordinates for analysis Case 1.

The acceleration time-histories of the vehicle during the event are shown in Figure 228 through Figure 230 and the angular displacement-time histories are shown in Figure 231. Data from the accelerometer located at the center of gravity of the vehicle were collected and input into the Test Risk Assessment Program (TRAP) Version 2.3.2 to determine occupant risk factors. The data as provided directly from TRAP is presented in Figure 232.

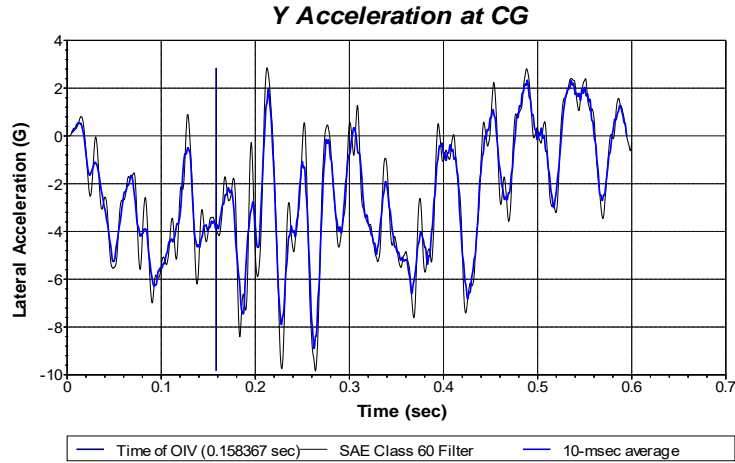
Figure 229. Lateral acceleration-time history at C.G. of pickup truck model in local coordinates for analysis Case 1.

In the lateral direction, the occupant impact velocity was 15.4 ft/s (4.7 m/s) at 0.1584 seconds, the highest 0.010-second occupant ridedown acceleration was -8.9 g from 0.2575 and 0.2675 seconds, and the maximum 0.050-second average acceleration was -5.2 g between 0.2203 - 0.2703 seconds.

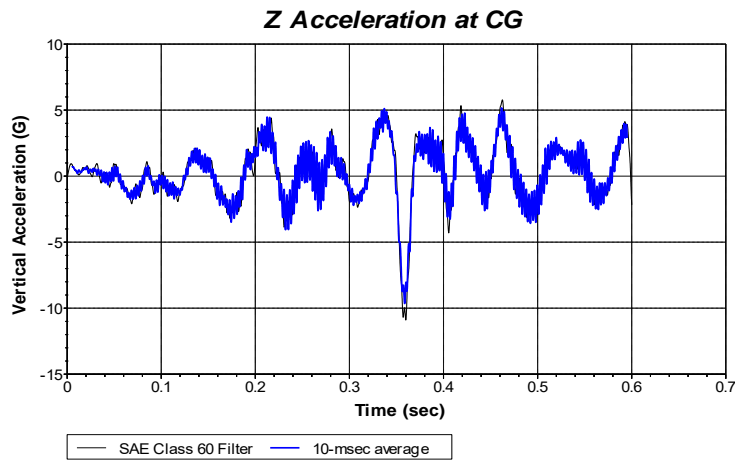
Figure 230. Vertical acceleration-time history at C.G. of pickup truck model in local coordinates for analysis Case 1.

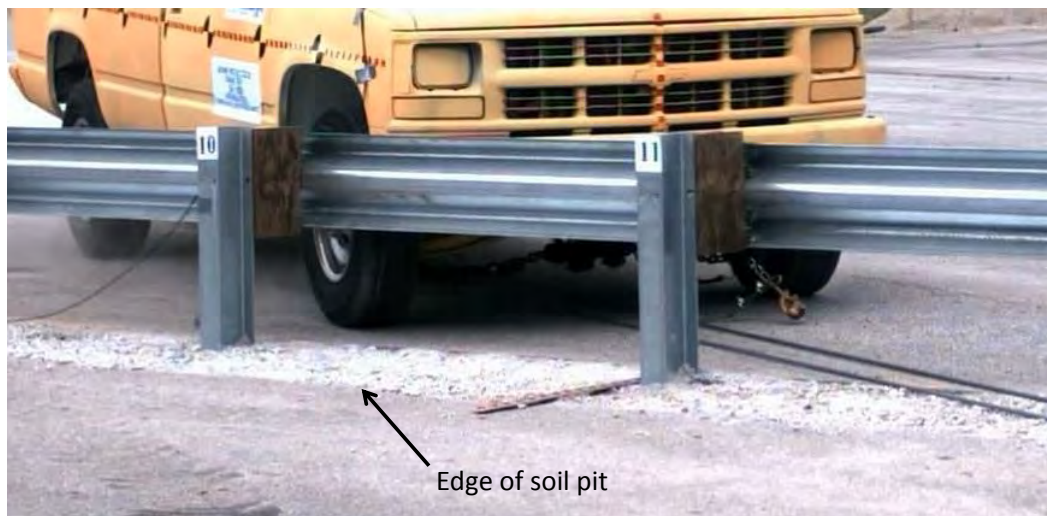
Figure 233. Test setup for low-speed test C08C3-027-1 illustrating the limited distance to the back-edge of the soil-pit for the test article.

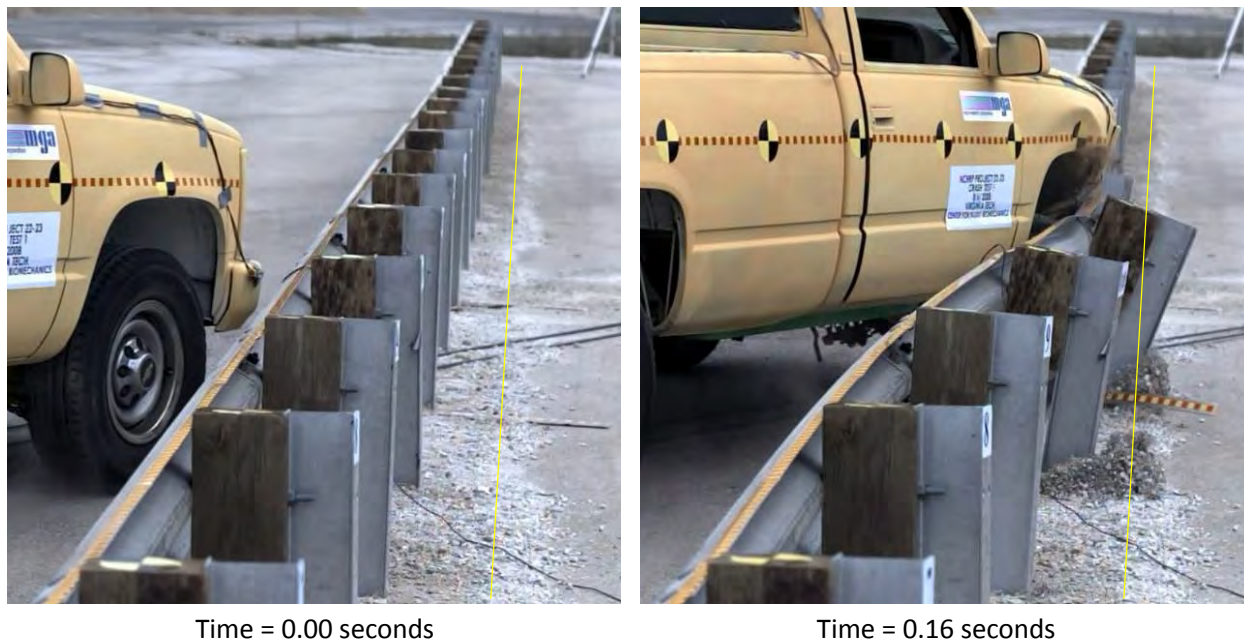
Figure 234. Snapshots from low-speed test C08C3-027-1 illustrating the position of the guardrail posts relative to the backside of the soil pit at the beginning of the test and at 0.16 seconds.

From a review of the high-speed video of the test, the lateral deflection of Post 11 was stopped abruptly at around 160 milliseconds of the impact event. Figure 234 shows snapshots from the test video for low-speed test C08C3-027-1 illustrating the position of the guardrail posts relative to the backside of the soil pit at the beginning of the test and at 0.16 seconds. Post 11 showed no signs of further deformation (e.g., torsional deflection, collapsing of the post cross-section, or further bending at the groundline). It was therefore assumed that the soil pit area was sufficient for the low-speed test.

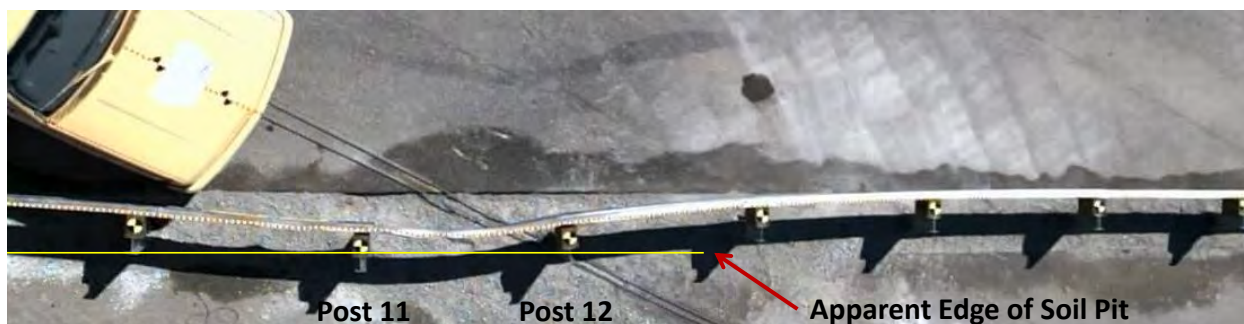
Figure 235. Test setup for high-speed test C08C3-027-2 illustrating the reduced distance from the back of Posts 11 and 12 to the back-edge of the soil-pit.

Figure 235 shows the test setup for high-speed test C08C3027-2. The initial deflections for Posts 11 and 12 were such that the back of the posts were already in contact (or nearly in contact) with the back edge of the soil pit prior to the start of the test. The reduced distance from the back of Posts 11 and 12 to the back-edge of the soil pit restricted the movement of the posts at the groundline.

overhead view of the test article just before impact, as shown in Figure 235. The resulting model is shown in Figures 236 and 237 from an overhead and a downstream viewpoint, respectively.

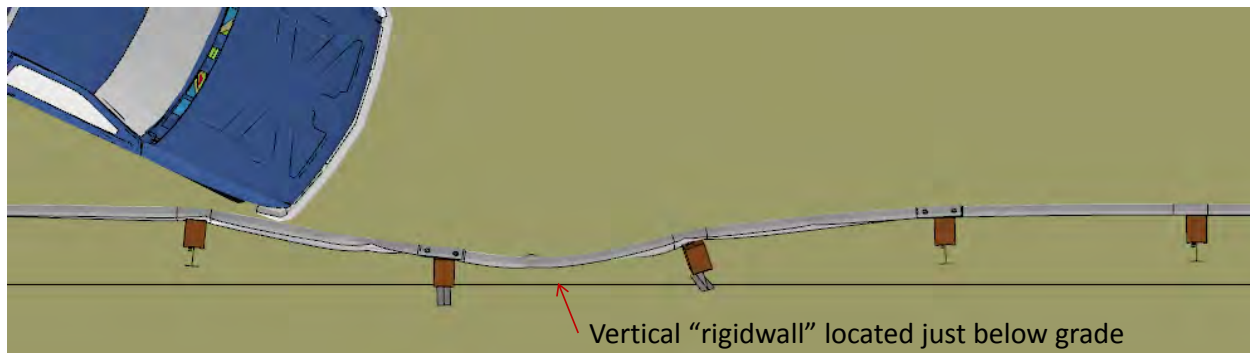
Figure 236. FE model for Case 2 with vertical "rigidwall" located just below grade to simulate back-edge of soil pit (overhead viewpoint).

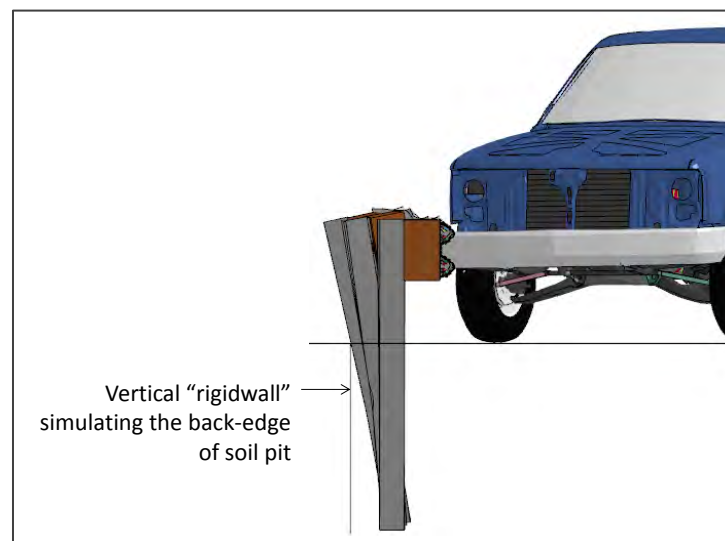
Figure 237. FE model for Case 2 with vertical "rigidwall" located just below grade to simulate back-edge of soil pit (downstream viewpoint).

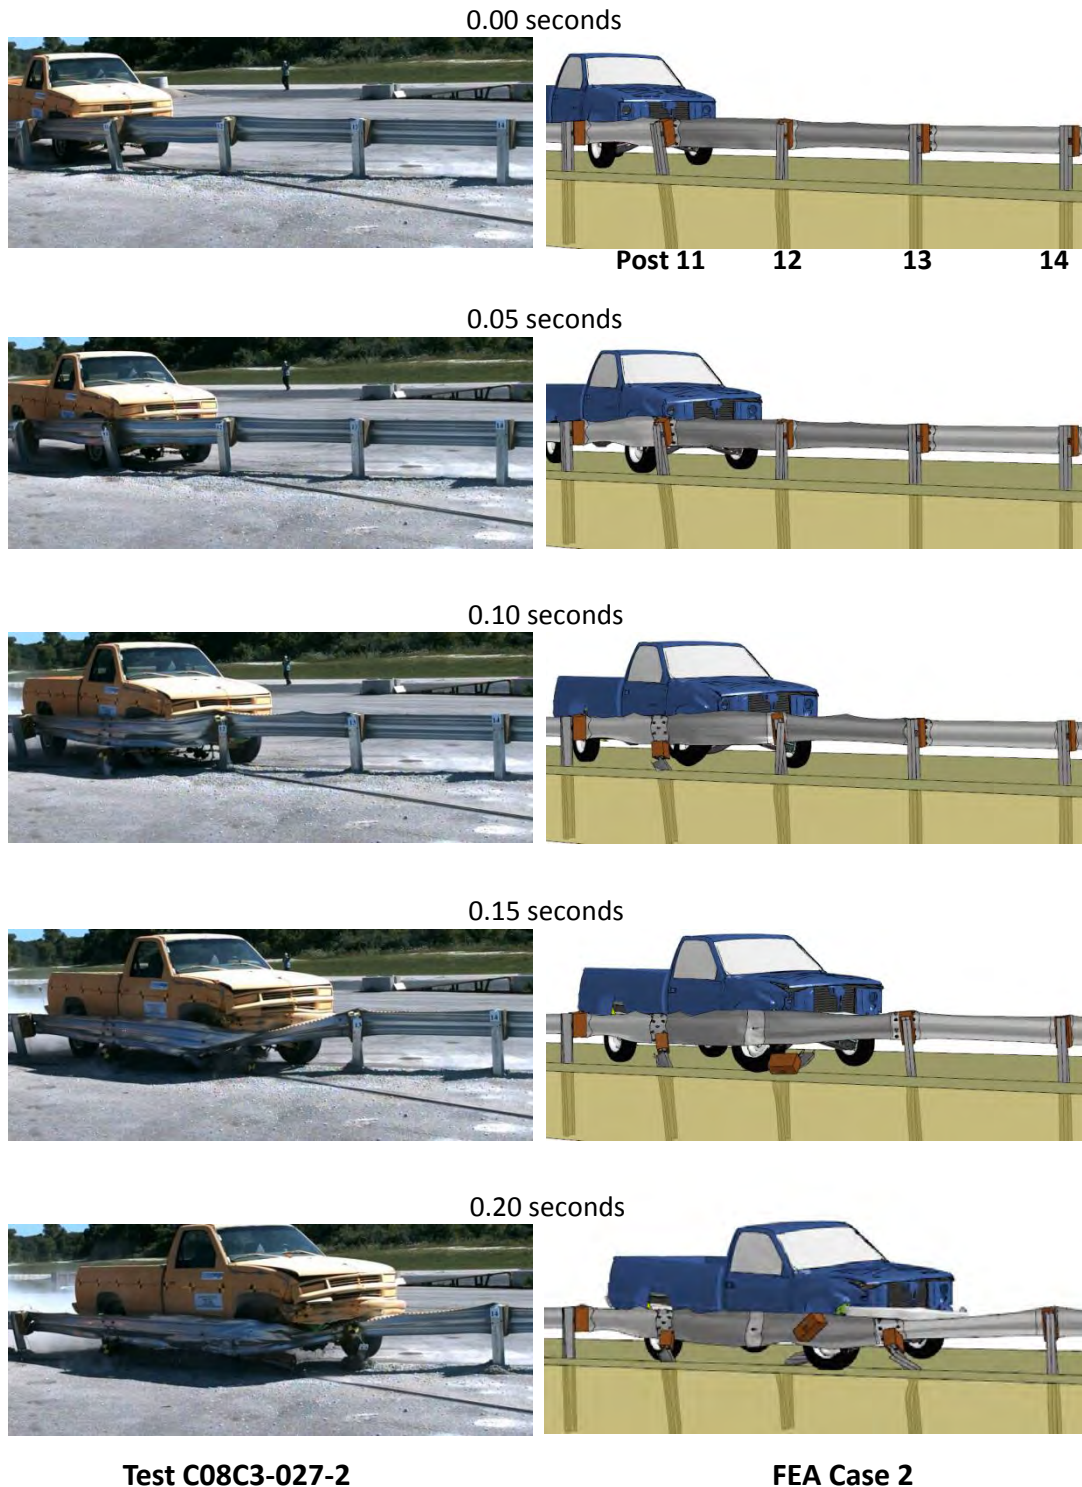
Figure 238. Sequential Views of Test C08C3-027-2 and FE analysis from downstream-backside view perspective.

Figure 238. [CONTINUED] Sequential Views of Test C08C3-027-2 and FE analysis from downstream-backside view perspective.

Figure 238 and Figure 239 show sequential snapshots of the impact event from a downstream-oblique view point and an upstream viewpoint, respectively. Table 2 provides a list of phenomenological events and their time of occurrence for both the full-scale test and the FE analysis. The model appears to reasonably simulate the basic kinematic behavior of the pickup until approximately 0.2 seconds of the impact event. After this time there was noticeable difference in the attitude of the vehicle, particularly in the yaw and pitch angles and the vertical trajectory. The front bumper and the front tire of the vehicle overrode the rail 0.05 seconds later in the analysis than it did in the full-scale test. As a result, the front of the vehicle remained in contact with the rail for a longer period of time in the analysis, resulting in greater yaw and pitch angles. This phenomenon is clearly evident in the sequential views beginning at 0.25 seconds.

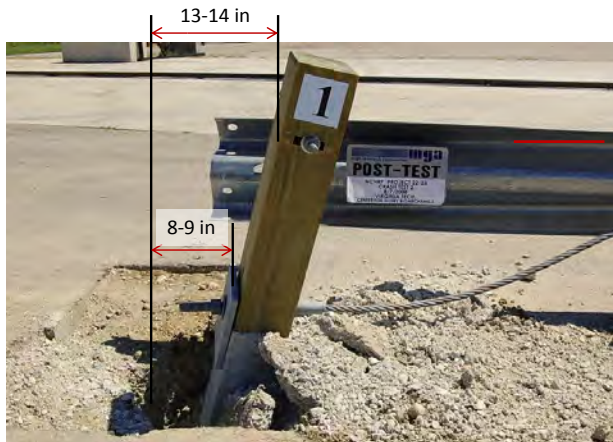
Figure 240. Permanent displacement of the upstream anchor in Test C08C3-027-2.

Although the maximum deflection of the end-terminal was not reported in the full-scale tests, the magnitude could be approximated from the post-test photos of the deflected anchor post. Figure 240 shows the post-test photo of the upstream anchor in Test C08C3-027-2. The permanent deflection of the anchor post at the groundline was estimated from the photo to be approximately 8-9 inches, and the deflection of the post at the post-bolt location was approximately 13-14 inches.

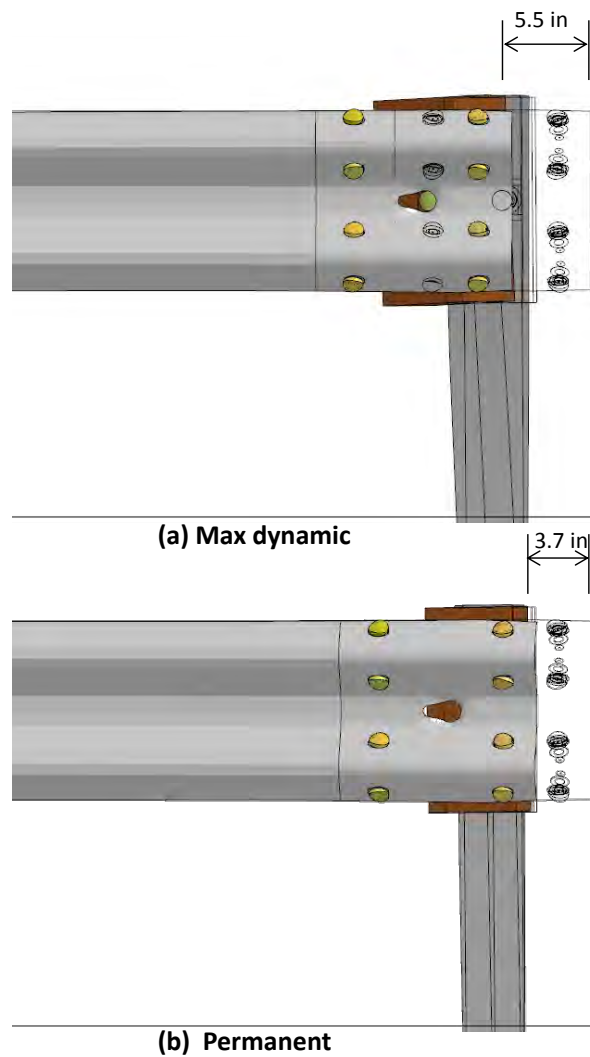
Figure 241. Displacement of upstream rail boundary in FEA analysis Case 2 (modeled with 47% baseline anchor stiffness).

The maximum dynamic and permanent deflections of the rail boundary in the analysis, as shown in Figure 241, were 5.5 inches and 3.7 inches, respectively, which were considerably lower than those of the full-scale test. This difference in anchor deflection is also apparent from the maximum rotation of the upstream posts, as illustrated in Figure 242. Since the end-terminal was modeled with less than half the stiffness of a standard two-post anchor system, it is not apparent why the displacement was so much greater in the test. Regardless, the seemingly low magnitude of rail tension in the full-scale test was likely a major contributing factor in how quickly and easily the rail was pulled down allowing the vehicle to override the guardrail.

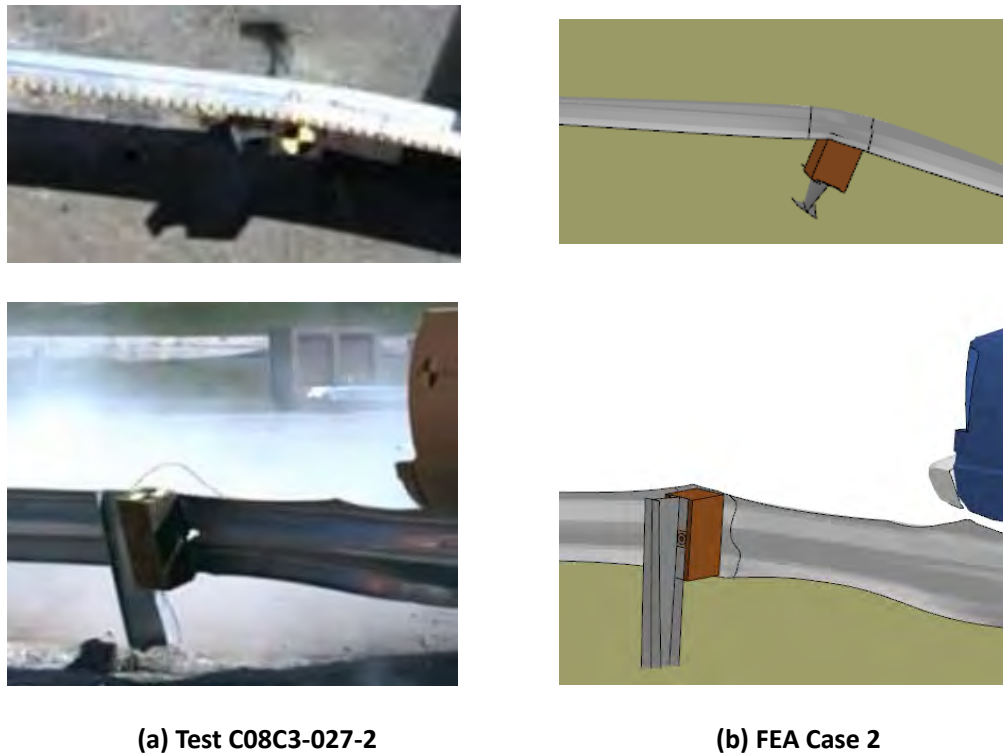
Figure 242. Maximum rotation displacement of Post 10 in (a) full-scale test and (b) FEA analysis Case 2.

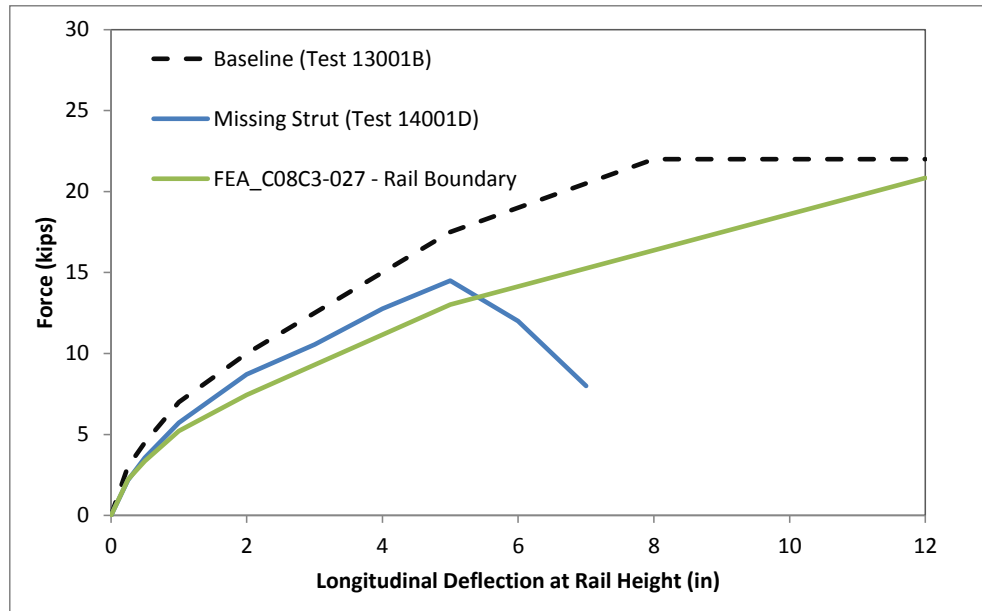
Figure 243. Anchor stiffness used in FEA model compared to anchor stiffness measured in physical tests.

In both analysis cases, however, the deflection of the anchor was significantly less than the anchor deflection in the full-scale test. The force-deflection characterization of the anchor used in the FEA model is shown in Figure 243. Also shown in the figure is the static force-deflection responses for a two-foundation-tube anchor (i.e., Test 13001B) and a single-foundation-tube anchor (i.e., Test 14001D on a standard anchor with groundline strut removed) measured via quasi-static tests in Chapter 12⁴. The plot shows that the anchor stiffness characterization of the FEA model was similar to that of Test 14001D up to approximately 5 inches deflection, at which point the resistance in the physical test suddenly dropped significantly. In the FE analyses, the deflection of the upstream anchor reached magnitudes of 11 inches and 5.5 inches for Case 1 and Case 2, respectively. It can therefore be assumed that the anchor system would likely have failed (i.e., experienced significant reduction in stiffness) in both of these analysis cases, which would have resulted in reduced tensile force in the w-beam and increased the potential for vehicle override.

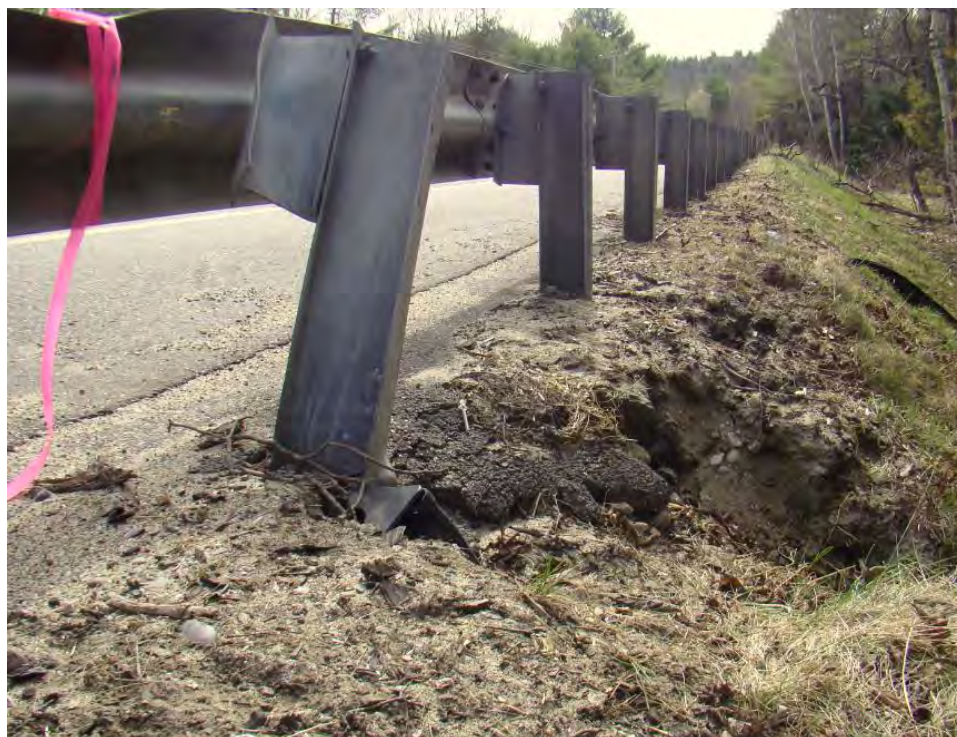
Figure 244. Example of soil erosion at a guardrail post.

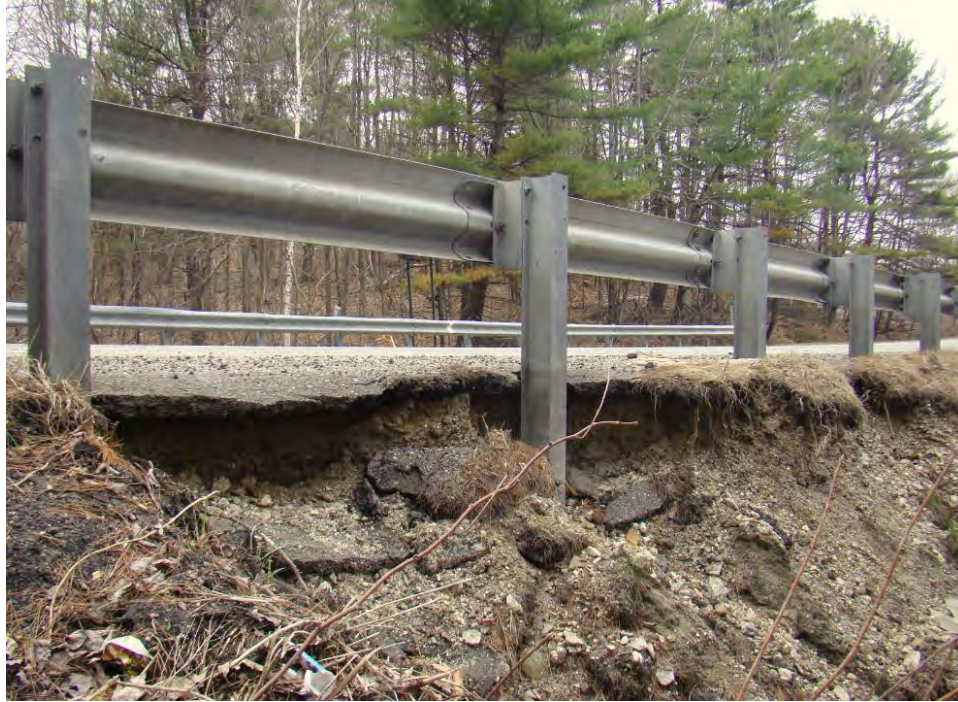
Figure 245. Example of severe soil erosion at multiple posts.

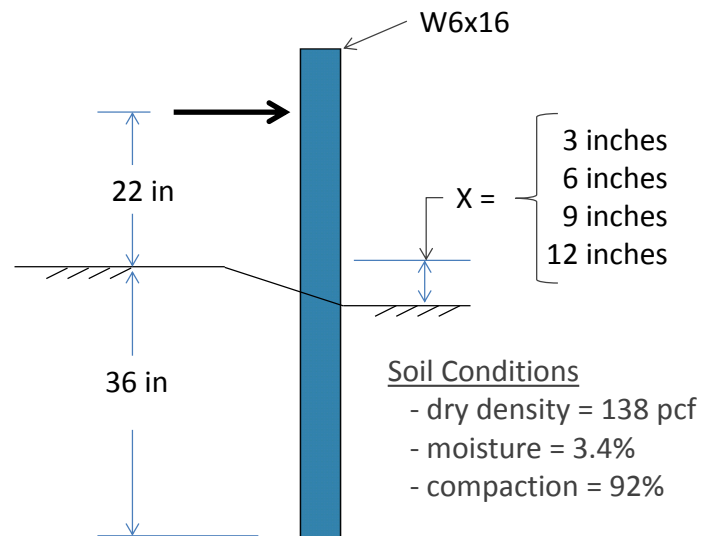
The erosion condition was manufactured by removing a layer of soil behind and on the side of the post, as illustrated schematically in Figure 246. Four erosion depths were investigated: 3 inches, 6 inches, 9 inches, and 12 inches. The soil behind the post was flat and level and conformed to the desired erosion depth. The soil in front of the post tapered gradually from grade level down to the specified erosion depth, starting at approximately 10 inches in front of the post and ending at the back-face of the post. There were a total of 7 tests conducted. The complete test matrix is shown in Table 68.

Figure 246. Test set-up for pendulum tests.

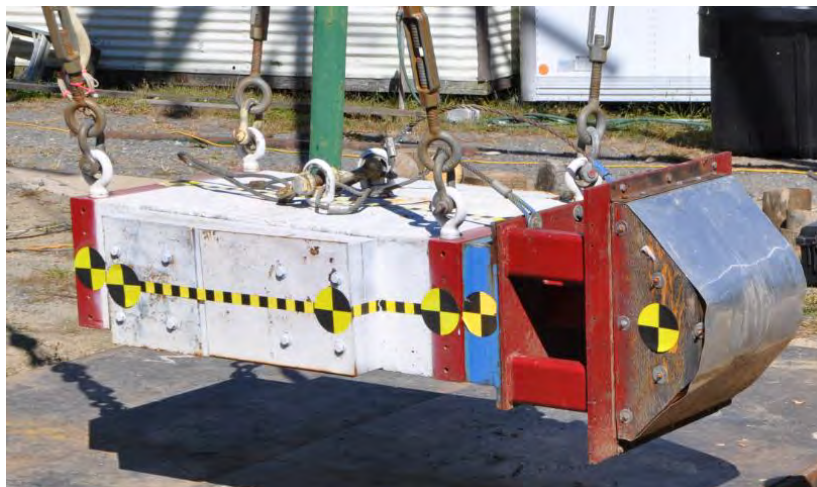
The striker for the tests was a 2,372-lb concrete pendulum with a semi-rigid nose, which was the same striker used to evaluate the effects of post deterioration in Chapter 8 (see Chapter 8 for more details).

Figure 247. 2,372-lb pendulum device with semi-rigid nose.

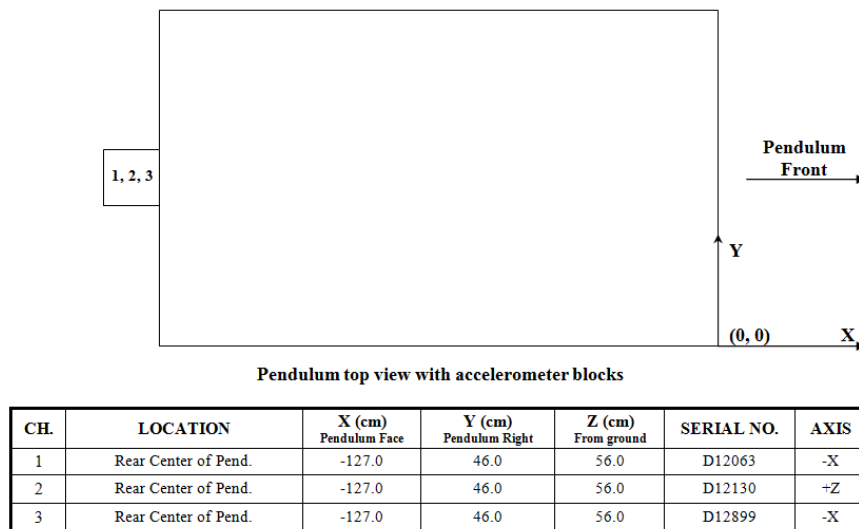
The pendulum was instrumented with three accelerometers mounted onto the backside of the pendulum mass. Accelerometers 1 and 3 recorded data in the x-direction (forward direction) and Accelerometer 2 recorded data in the z-direction (vertical direction). Figure 248 provides a schematic showing the locations of the accelerometers.

Figure 248. Schematic of the accelerometer instrumentation for the pendulum tests.

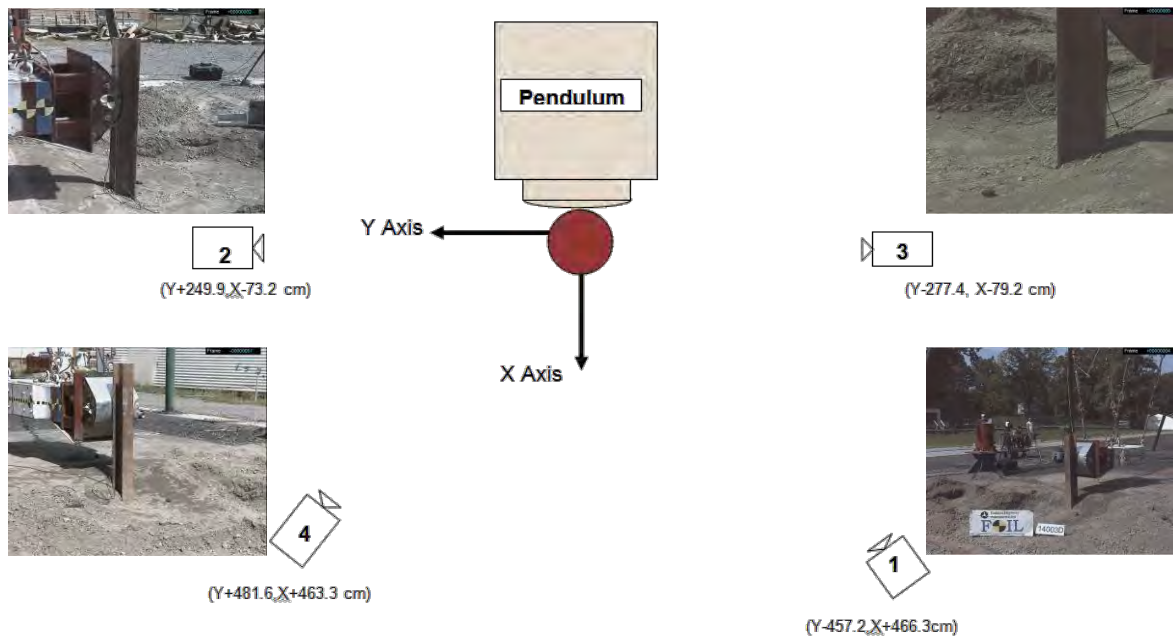
The tests were also recorded using four high-speed cameras with an operating speed of 500 frames per second and a digital video camera (~30 fps). Figure 249 provides the specifications and the general placement of the high-speed cameras for the tests. The accelerometers and the high-speed video were triggered using pressure tape switches when the pendulum contacted the post. The test setup and results were also documented with photographs taken before and after each test.

Figure 249. High-speed camera specifications and placement.

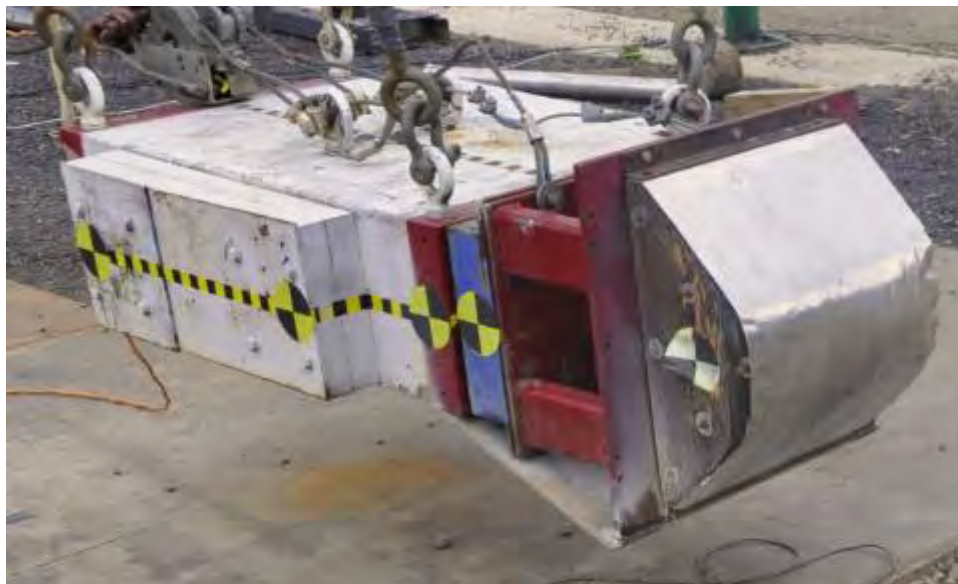
Figure 250. Repair to the pendulum head included adding a steel “slide Plate” underneath the head.

The peak force in all cases was due to the initial inertial/impulse force between the pendulum head and the steel post. The magnitude of this peak was essentially the same for all cases regardless of post-soil stiffness, as shown in Figure 255. The one exception was Test 14003A corresponding to the 3-inch erosion case, which was the first test performed in this test series. During the “return swing” of the pendulum after striking the post in Test 14003A, the impact head snagged on the top of the post and was detached from the pendulum. The repair to the pendulum head included a steel “slide plate” mounted underneath the pendulum covering the gap between the head and the body of the pendulum, as shown in Figure 250. The plate was welded to the impact head and to the pendulum body. This modification resulted in a more rigid connection between the head and the pendulum mass which, consequently, increased the initial impulse/inertial spike for all the subsequent tests.

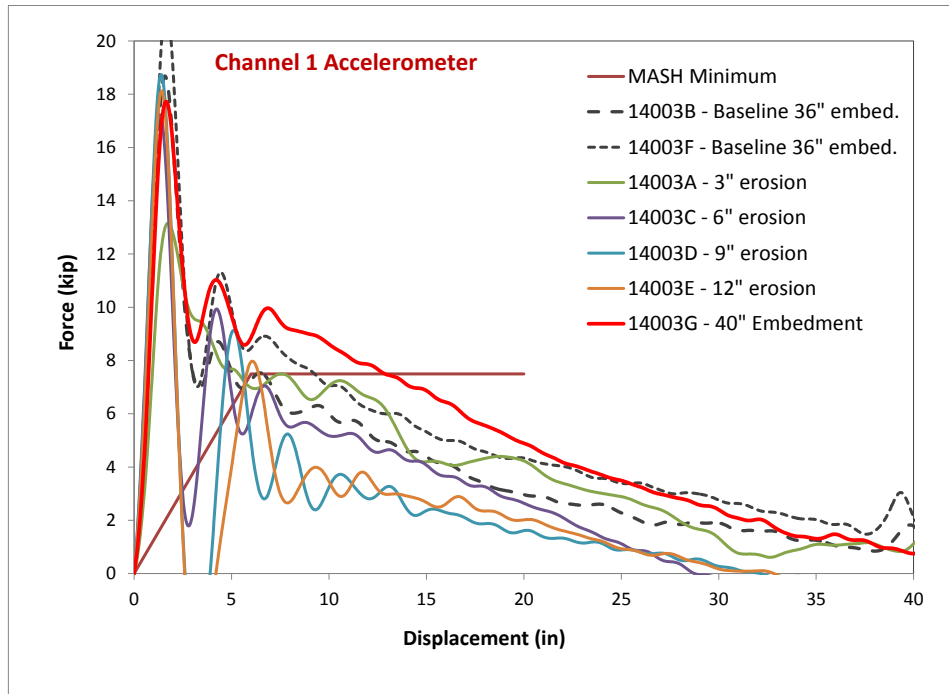
Figure 251. Force vs. deflection curves for Test Series 14003 from primary accelerometer.

The data from the primary accelerometer (i.e., Channel 1) resulted in somewhat inconsistent results, as evidenced in the force-deflection plot in Figure 251 and the energy vs deflection plot in Figure 253. The data from the secondary accelerometer were much more consistent, as shown in Figure 252 and Figure 254. The two baseline tests from the secondary accelerometer resulted in essentially identical response; further, the results from the erosion tests showed that the resistance reduced monotonically as the erosion depth increased. Thus, the results from the secondary accelerometer (Channel 3) were considered to be more accurate and were used for the calibration/validation study for the finite element model in the next section.

The impact conditions for Test Series 14003 were simulated using the finite element model shown in Figure 258. From the results of the pendulum tests, the initial spike at the beginning of the impact, as seen in Figures 251 and 252, was due in part to the impulse load between the pendulum and the post, but also to an increase in soil stiffness from “friction locking” of soil particles under high soil compaction. The soil-spring model developed in Chapter 7 was modified slightly to account for this “friction locking”. In particular, the force-deflection characterization for the soil springs was increased for the first 0.5 inches of soil deflection, and then then reverted back to their original stiffness. The following sections present a comparison of the FE model results compared to the physical tests for the baseline condition (i.e., 36-inch embedment depth) and various erosion depths.

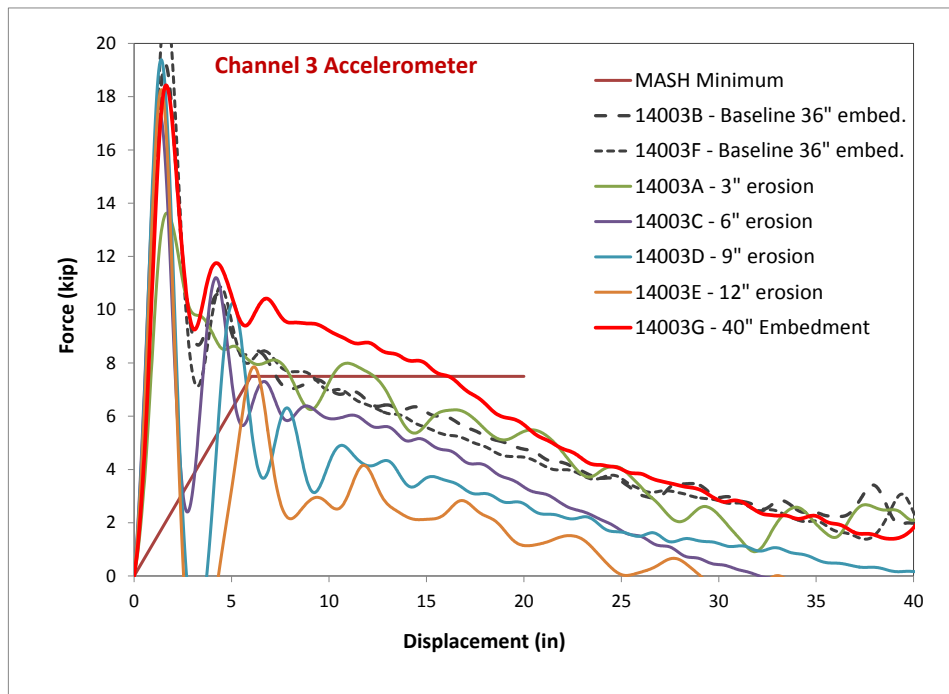
Figure 252. Force vs. deflection curves for Test Series 14003 from secondary accelerometer.

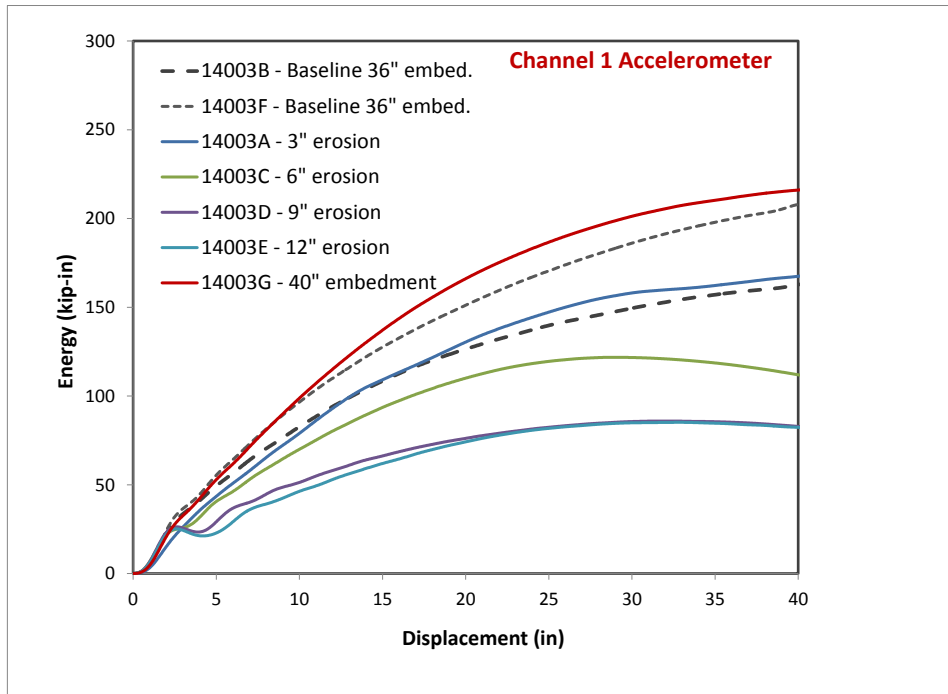
Figure 253. Energy vs. deflection curves for Test Series 14003 from primary accelerometer.

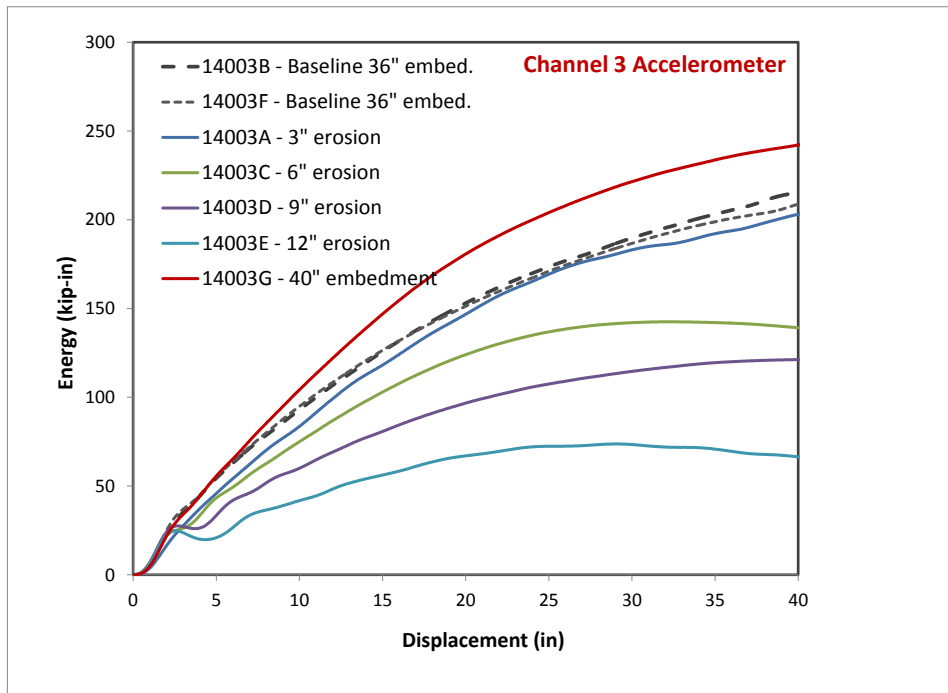
Figure 254. Energy vs. deflection curves for Test Series 14003 from secondary accelerometer.
