Criteria for Restoration of Longitudinal Barriers, Phase II (2021)

Criteria for Restoration of Longitudinal Barriers, Phase II

Contractor's Final Report for NCHRP Project 22-28
Submitted June 2015

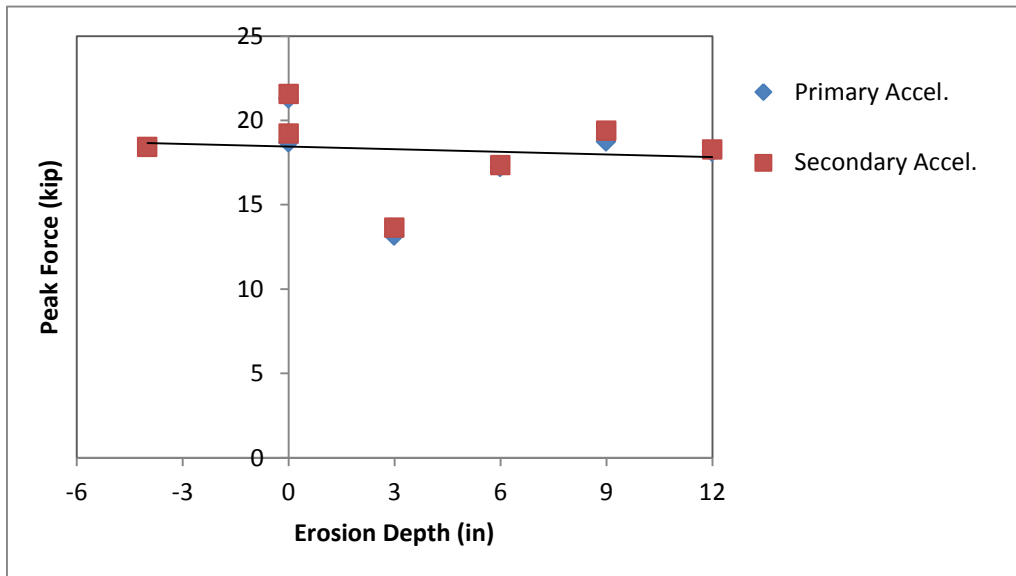
Figure 255. Peak “impulse” force in Test Series 14003.

The peak force in all cases was due to the initial inertial/impulse force between the pendulum head and the steel post. The magnitude of this peak was essentially the same for all cases regardless of post-soil stiffness, as shown in Figure 255. The one exception was Test 14003A corresponding to the 3-inch erosion case, which was the first test performed in this test series. During the “return swing” of the pendulum after striking the post in Test 14003A, the impact head snagged on the top of the post and was detached from the pendulum. The repair to the pendulum head included a steel “slide plate” mounted underneath the pendulum covering the gap between the head and the body of the pendulum, as shown in Figure 250. The plate was welded to the impact head and to the pendulum body. This modification resulted in a more rigid connection between the head and the pendulum mass which, consequently, increased the initial impulse/inertial spike for all the subsequent tests.

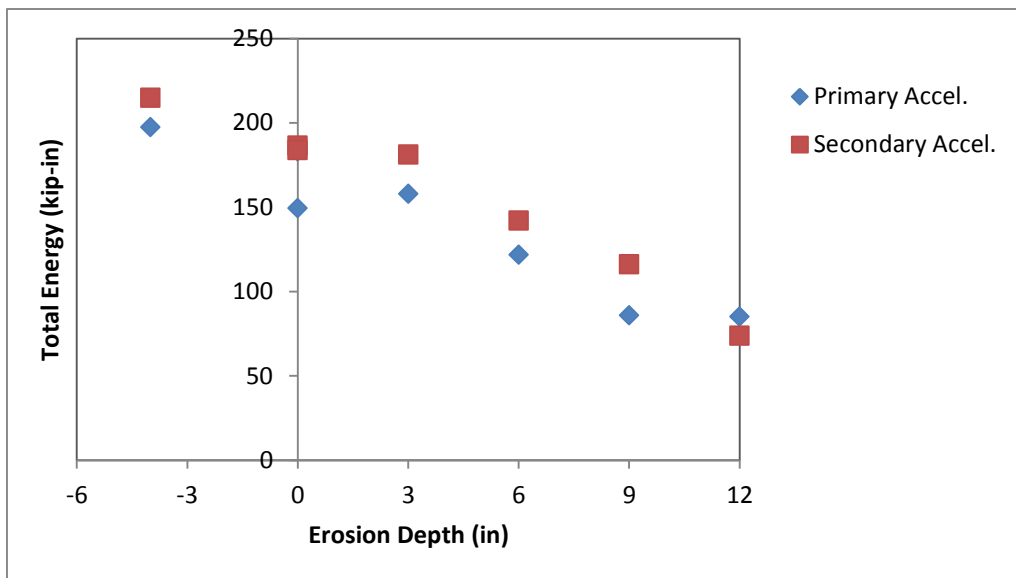
Figure 256. Total energy vs. erosion for Test Series 14003 – energy values correspond to point when pendulum overrides the post.

Figure 256 shows a plot of the total energy absorbed by the post-soil system as a function of erosion depth. The data in the plot corresponds to the total energy absorbed at the time when the pendulum overrode the post. As indicated in the plot, the data from the primary accelerometer generally resulted in slightly lower magnitudes than those from the secondary accelerometer. Since it has not been confirmed which of the accelerometers is correct, the data from both accelerometers were averaged and plotted in Figure 257. The data for the 40-inch embedment case was also included in the plot (e.g., the erosion depth was included as -4 inches). The results indicate that the energy capacity of the post-soil system reduces linearly with respect to erosion depth. Using an embedment depth of 36 inches as the baseline, the reduction in energy capacity as a function of erosion depth can be approximated using the following relationship:

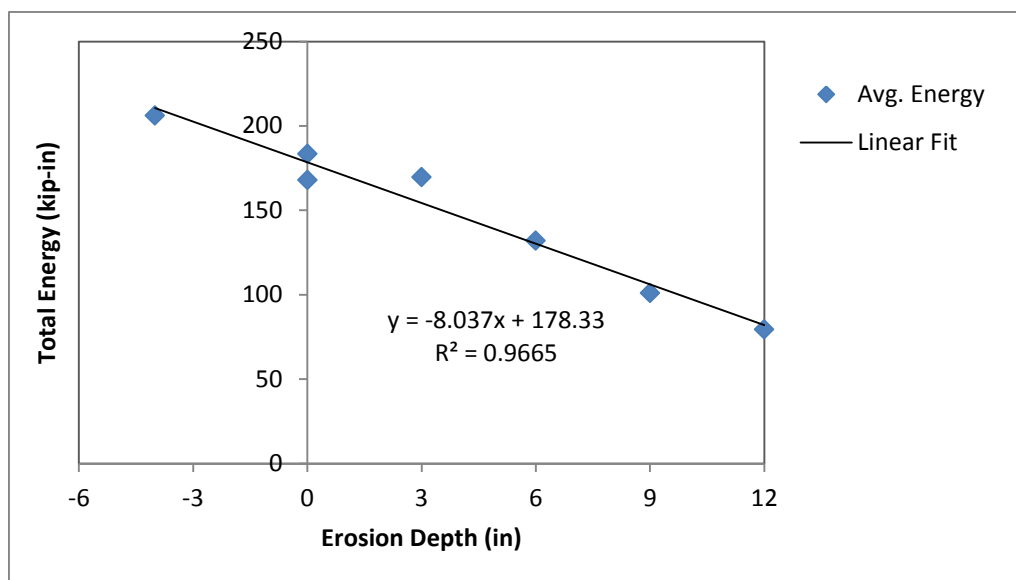
Figure 257. Total energy vs. erosion for Test Series 14003 – average of primary and secondary accelerometers – including linear curve fit to the data.

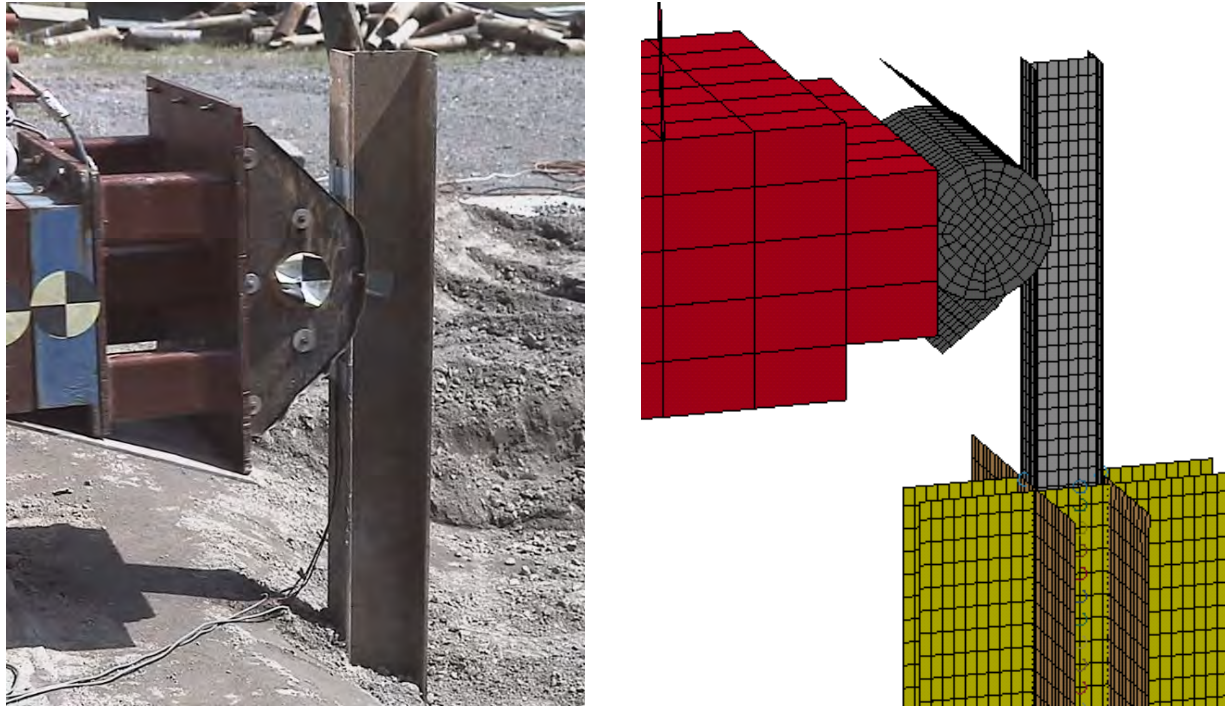
Figure 258. Finite element model used for validating/calibrating soil-spring stiffness corresponding to various levels of soil erosion.

The impact conditions for Test Series 14003 were simulated using the finite element model shown in Figure 258. From the results of the pendulum tests, the initial spike at the beginning of the impact, as seen in Figures 251 and 252, was due in part to the impulse load between the pendulum and the post, but also to an increase in soil stiffness from “friction locking” of soil particles under high soil compaction. The soil-spring model developed in Chapter 7 was modified slightly to account for this “friction locking”. In particular, the force-deflection characterization for the soil springs was increased for the first 0.5 inches of soil deflection, and then then reverted back to their original stiffness. The following sections present a comparison of the FE model results compared to the physical tests for the baseline condition (i.e., 36-inch embedment depth) and various erosion depths.

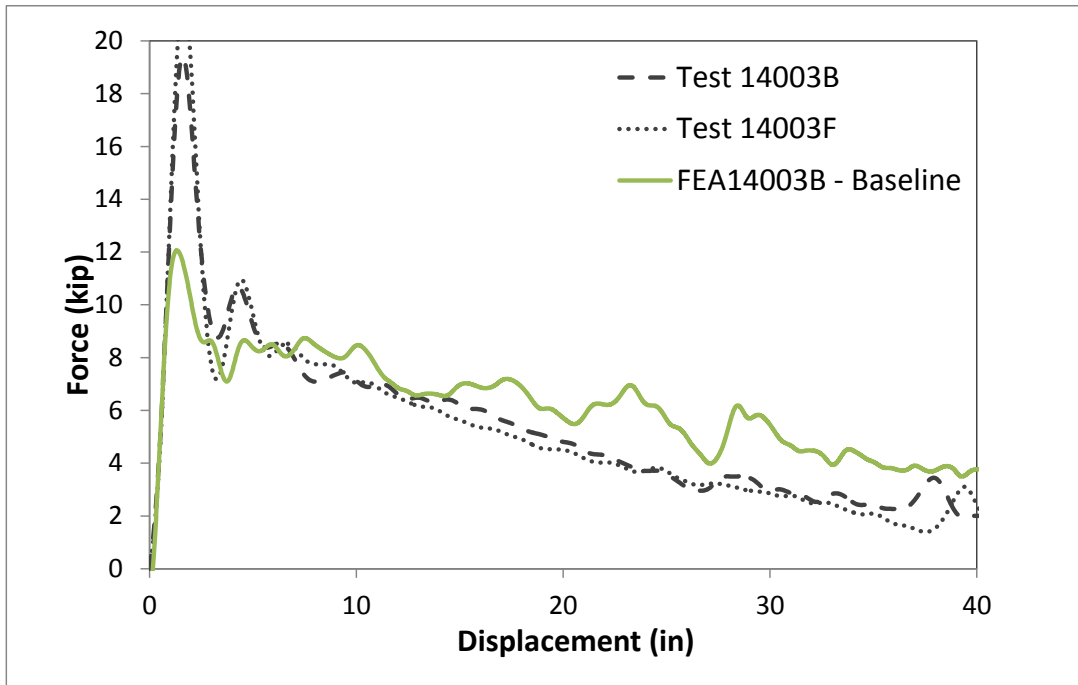
Figure 259. Force vs. deflection for DL0 soil model compared to Tests 14003B and 14003F.

The results of the model for the baseline condition are compared to full-scale test results in Figures 259 through 261. The force vs. deflection curves and the energy vs. deflection curves are shown in Figure 259 and Figure 260, respectively. As indicated from these plots, the FE model does not accurately capture the magnitude of the initial force response; otherwise, the overall response of the model matches reasonably well to the physical test. The model shows slightly higher response than the tests at post deflections beyond 20 inches. From the high-speed videos of the physical tests, it is evident that the soil is loosened significantly as the post rotates through the soil at increasingly higher deflections; at that point the post is essentially moving through a loose soil mass. The characterization of the soil in FE model does not include this softening behavior; however, the friction between the post and soil in the model effectively results in a similar response as the post slides up and out of the soil plates.

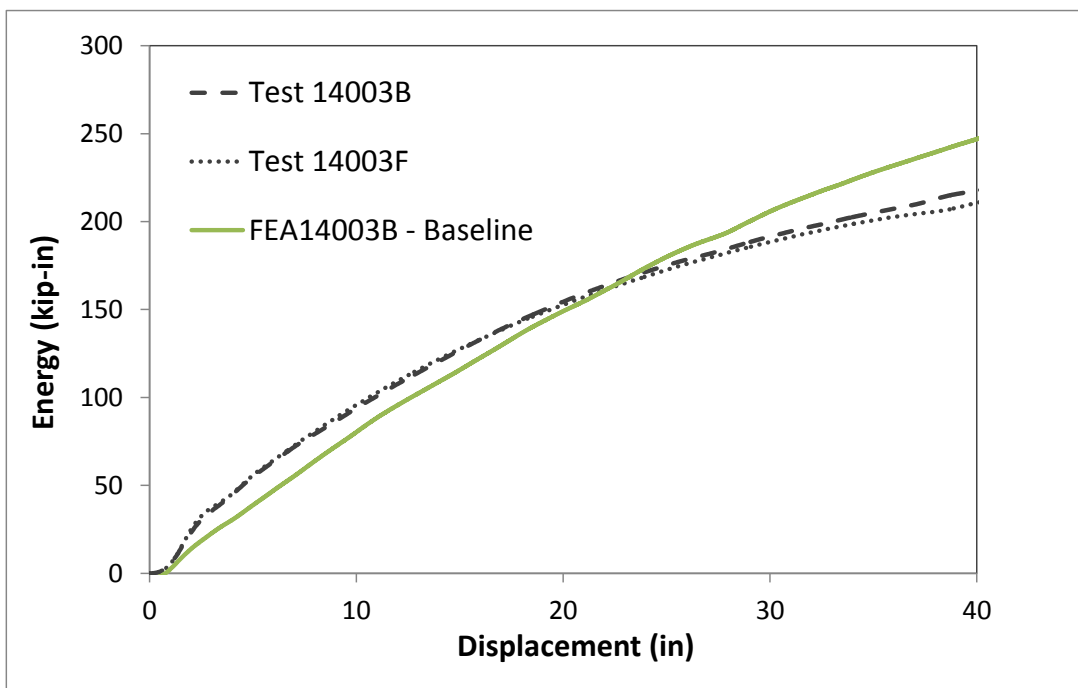
Figure 260. Energy vs. deflection for DL0 soil model compared to Tests 14003B and 14003F.

The total energy absorbed at 12 inches displacement in the analysis was 95.4 kip-in compared to 109 kip-in in Test 14003F; the total energy absorbed at 20 inches displacement in the analysis was 149 kip-in compared to 152 kip-in in Test 14003F; and the total energy absorbed at 40 inches displacement in the analysis was 247 kip-in compared to 211 kip-in in Test 14003F. Figure 261 shows sequential views comparing analysis results to dynamic impact Test 14003F.

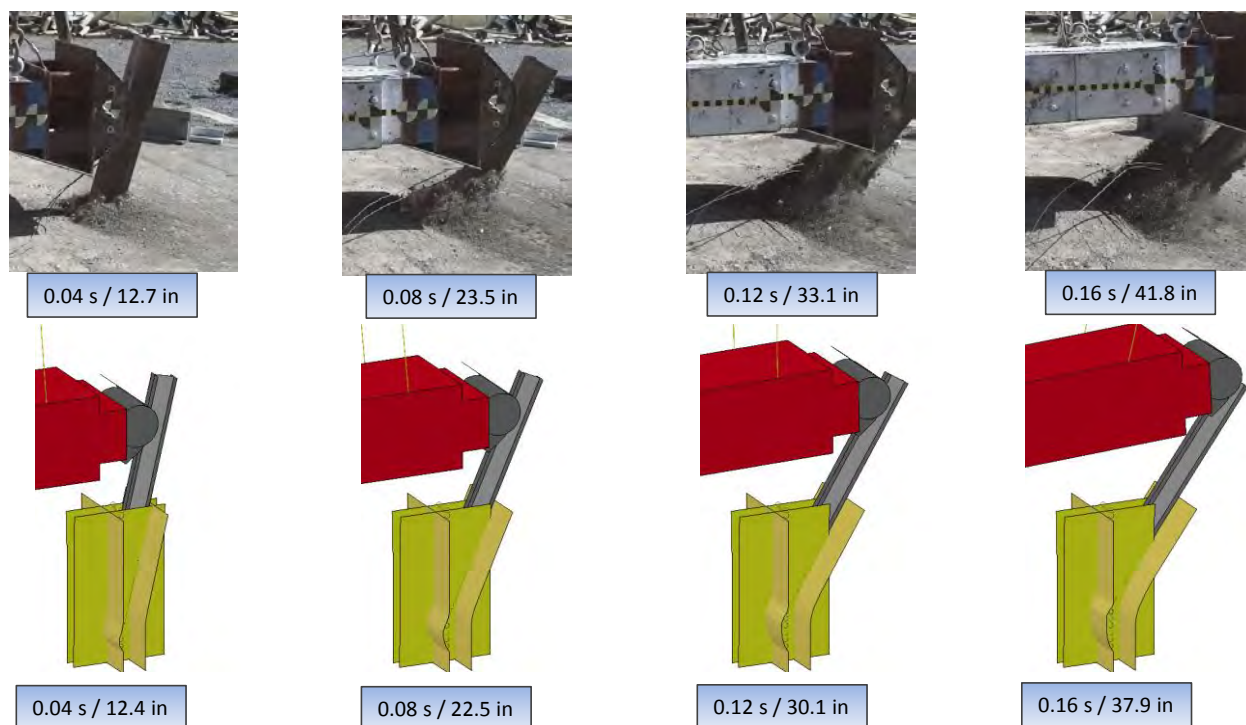
Figure 261. Sequential views of Test 14003F and FE analysis on baseline post-soil case, DL0.

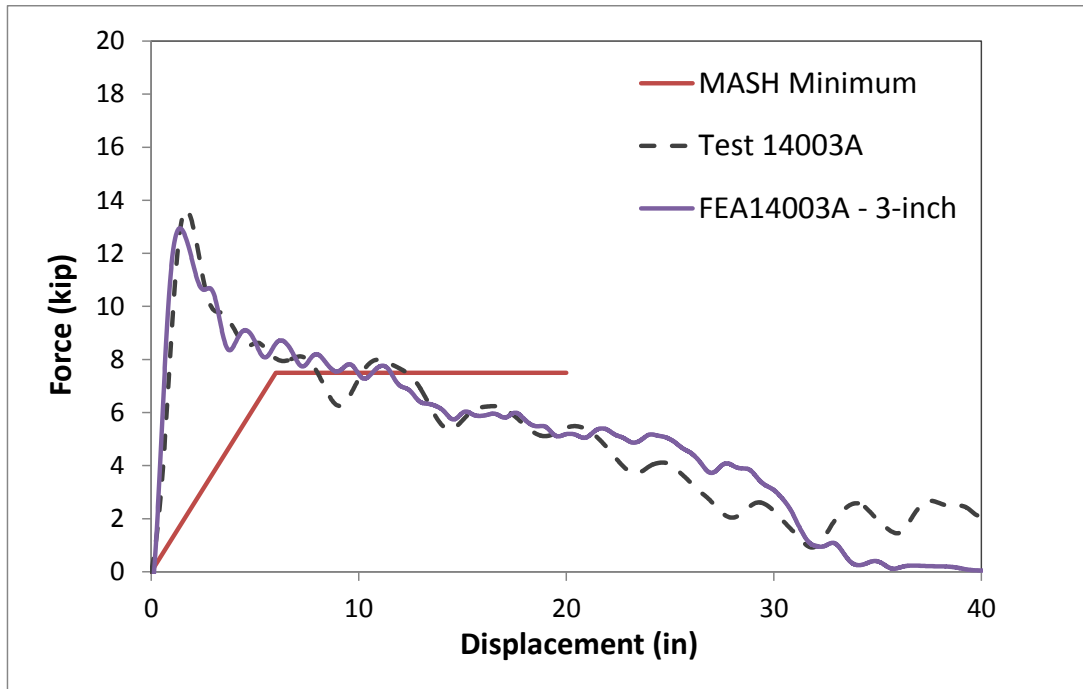
Figure 262. Force vs. deflection for soil model with 3” erosion compared to Test 14003A.

Figure 262 and Figure 263 show the force vs. deflection and energy vs. deflection results, respectively, for the FE model compared to pendulum Test 14003A. The overall response of the model matches reasonably well to the physical test, including the impulsive force spike at the beginning of the impact event. Recall that this test was performed using the original pendulum head (before the head was repaired), which resulted in a lower impulse/inertial spike compared to subsequent tests with the repaired head.

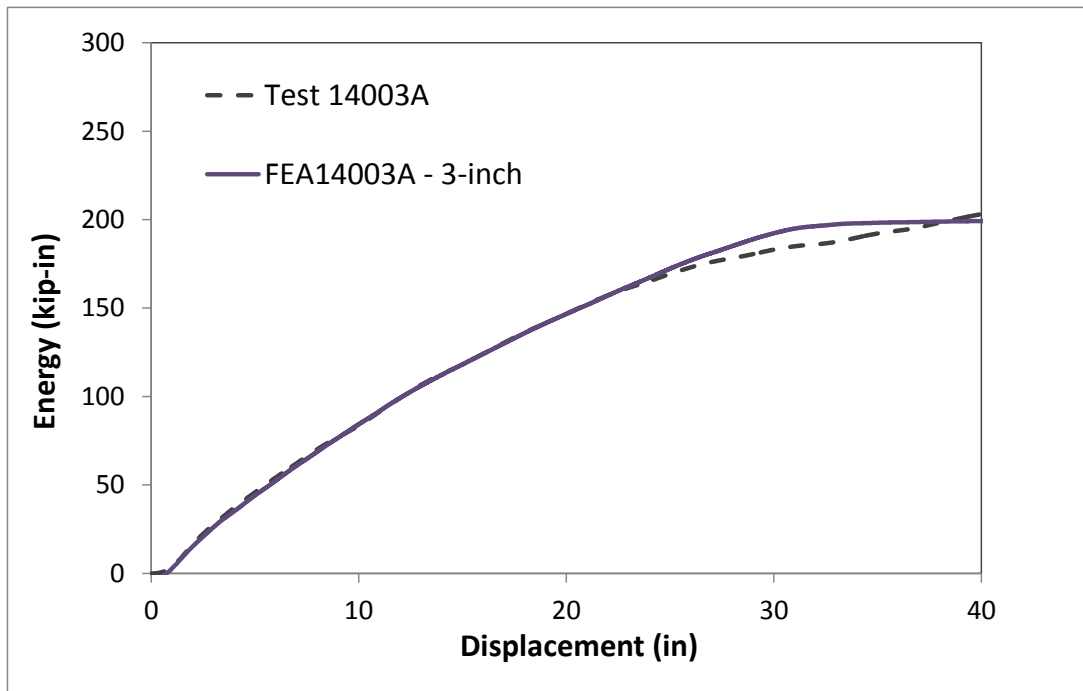
Figure 263. Energy vs. deflection for soil model with 3” erosion compared to Test 14003A.

The total energy absorbed at 12 inches displacement in the analysis was 99 kip-in, which was the same as that measured in Test 14003A; the total energy absorbed at 20 inches displacement in the analysis was 146 kip-in compared to 147 kip-in in Test 14003A; and the total energy absorbed at 40 inches displacement in the analysis was 199 kip-in compared to 203 kip-in in Test 14003A. Figure 264 shows sequential views comparing analysis results to dynamic impact test 14003A.

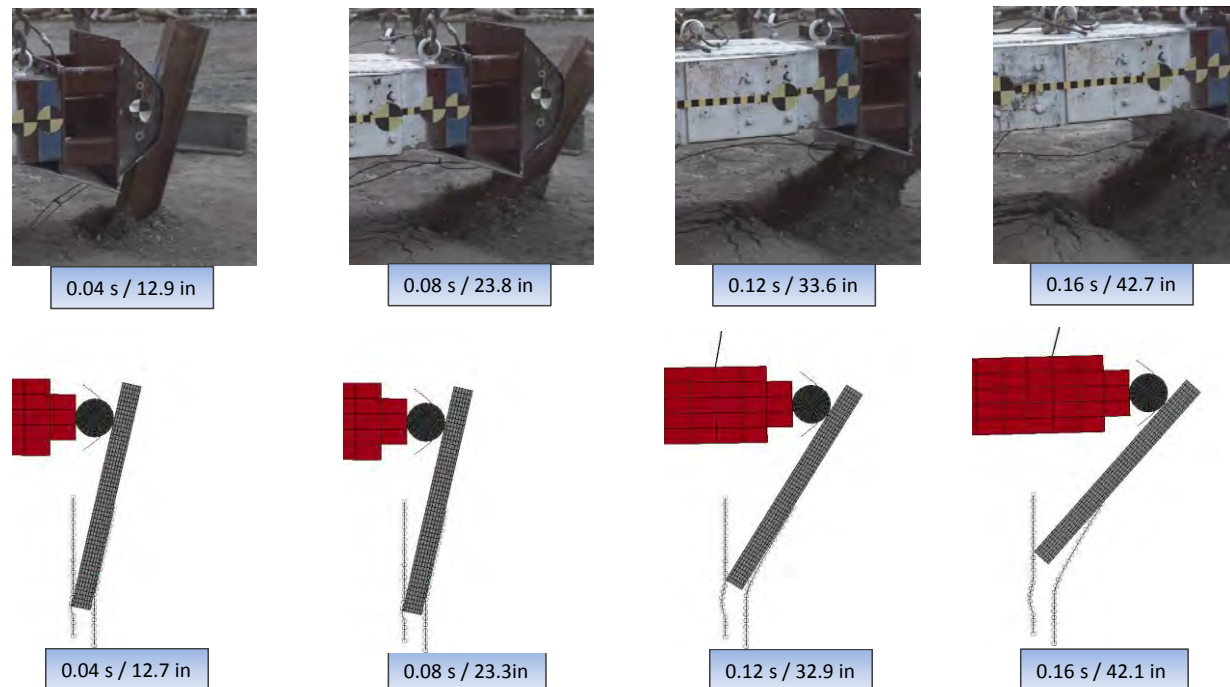
Figure 264. Sequential views of Test 14003A and FE analysis for 3-inch erosion case.

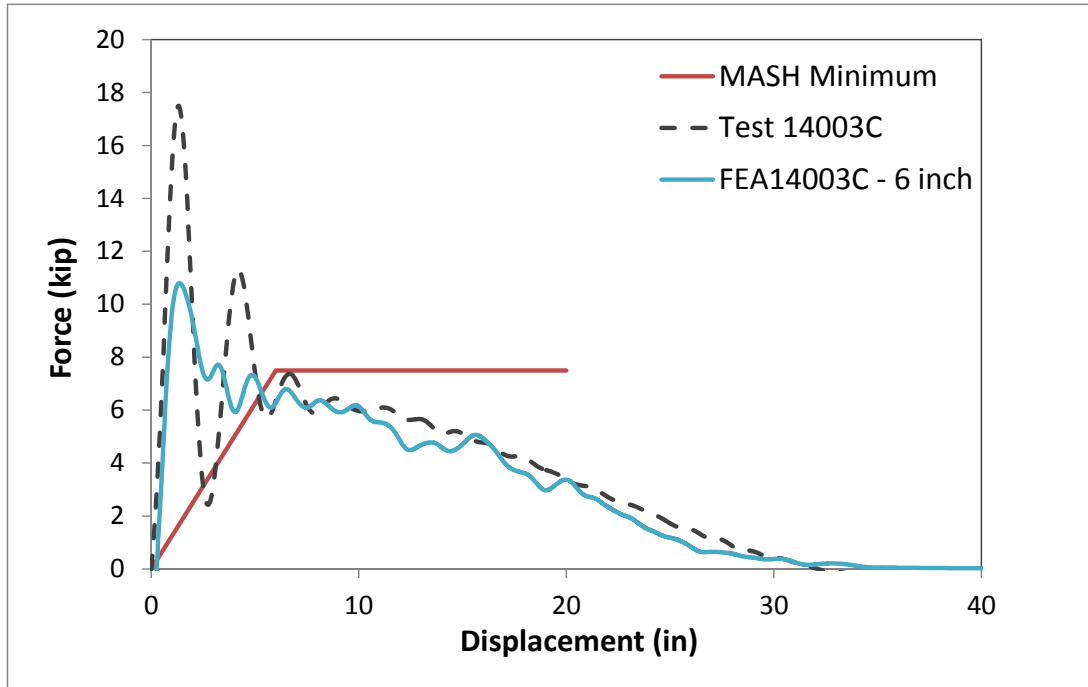
Figure 265. Force vs. deflection for soil model with 6” erosion compared to Test 14003C.

Figure 265 and Figure 266 show the force vs. deflection and energy vs. deflection results, respectively, for the FE model compared to pendulum Test 14003C. The overall response of the model matches reasonably well to the physical test, except for the impulse/inertial spike at the beginning of the impact. Note that this test was performed using the repaired pendulum head which resulted in higher impulse/inertial force magnitude compared to the original head.

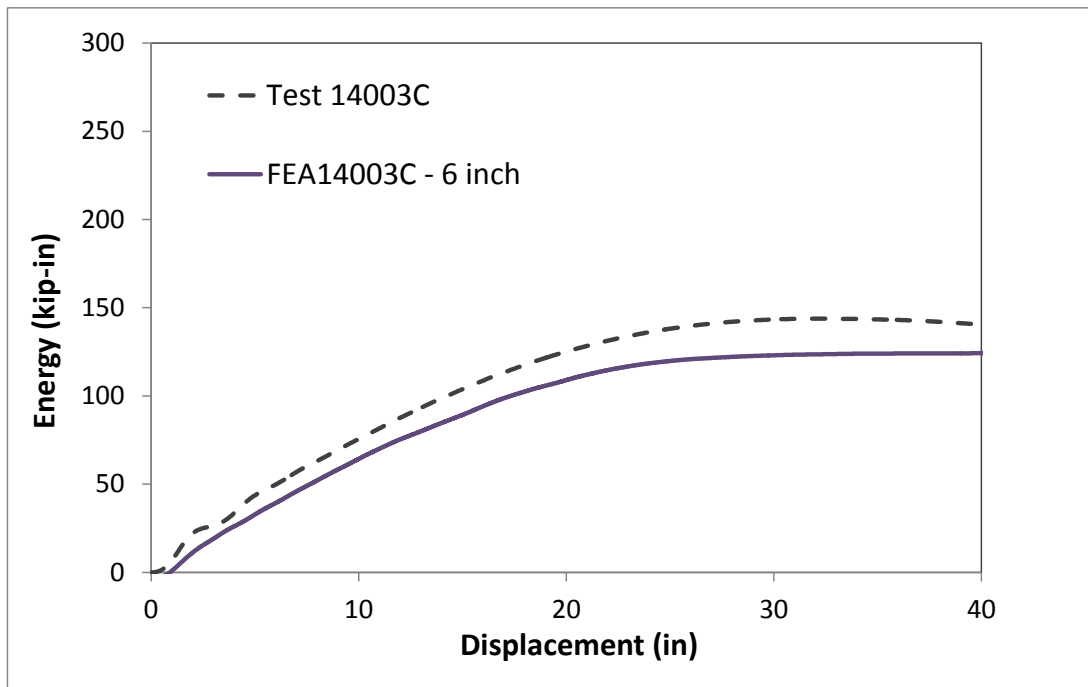
Figure 266. Energy vs. deflection for soil model with 6” erosion compared to Test 14003C.

The total energy absorbed at 12 inches displacement in the analysis was 75.2 kip-in compared to 87.6 kip-in in Test 14003C; the total energy absorbed at 20 inches displacement in the analysis was 109 kip-in compared to 125 kip-in in Test 14003C; and the total energy absorbed at 40 inches displacement in the analysis was 124 kip-in compared to 140 kip-in in Test

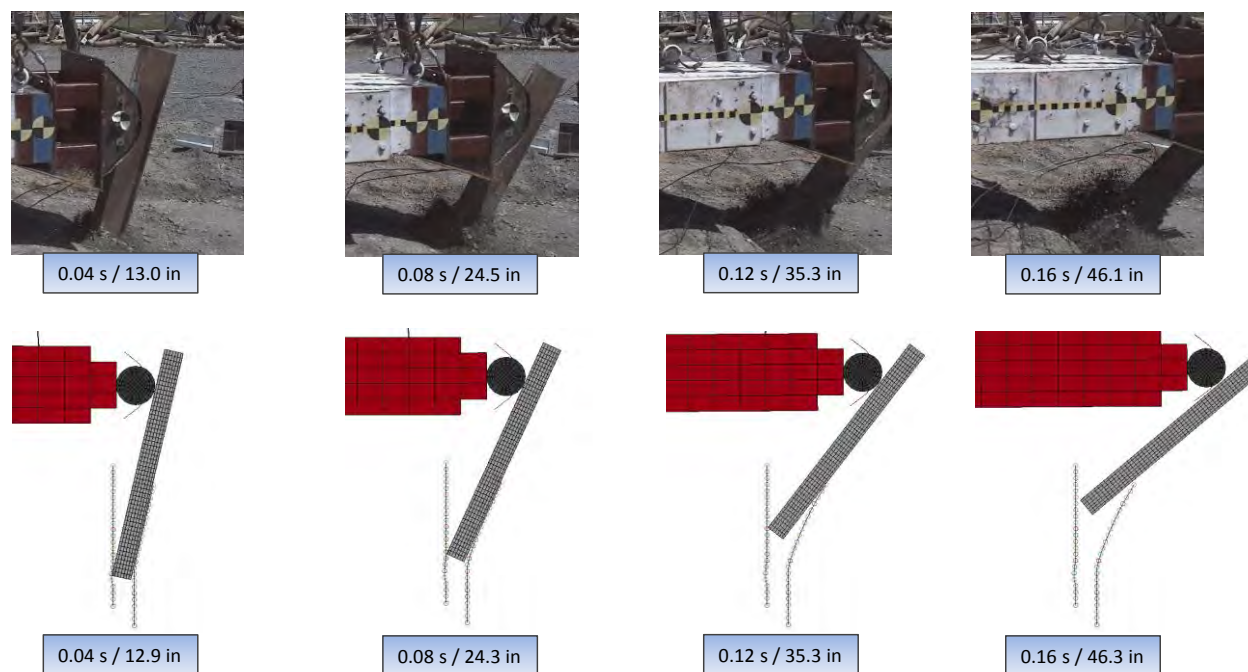
Figure 267. Sequential views of Test 14003C and FE analysis for 6-inch erosion case.

14003C. Figure 267 shows sequential views comparing analysis results to dynamic impact Test14003C.

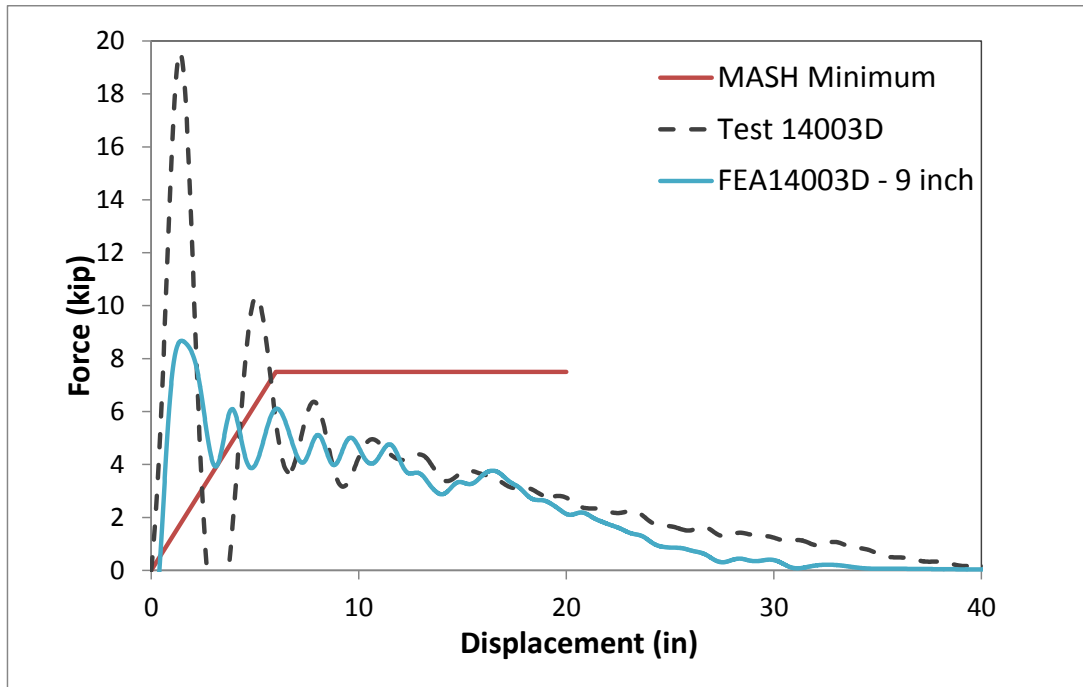
Figure 268. Force vs. deflection for soil model with 9” erosion compared to Test 14003D.

Figure 268 and Figure 269 show the force vs. deflection and energy vs. deflection results, respectively, for the FE model compared to pendulum Test 14003D. The overall response of the model matches reasonably well to the physical test, except for the impulse/inertial spike at the beginning of the impact. Again, this test was performed using the repaired pendulum head which tended to result in higher impulse/inertial force magnitude compared to the original head.

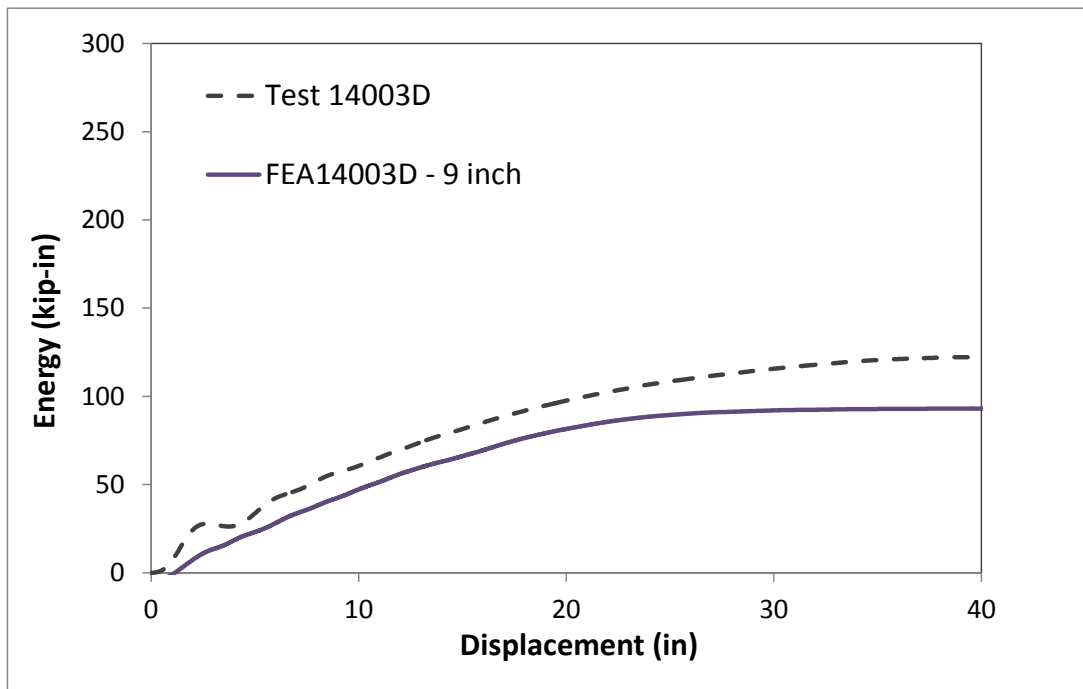
Figure 269. Energy vs. deflection for soil model with 9” erosion compared to Test 14003D.

The total energy absorbed at 12 inches displacement in the analysis was 55.9 kip-in compared to 69.8 kip-in in Test 14003D; the total energy absorbed at 20 inches displacement in the analysis was 81.5 kip-in compared to 97.7 kip-in in Test 14003D; and the total energy absorbed at 40 inches displacement in the analysis was 93.1 kip-in compared to 122 kip-in in Test 14003D. Figure 270 shows sequential views comparing analysis results to dynamic impact Test 14003D.

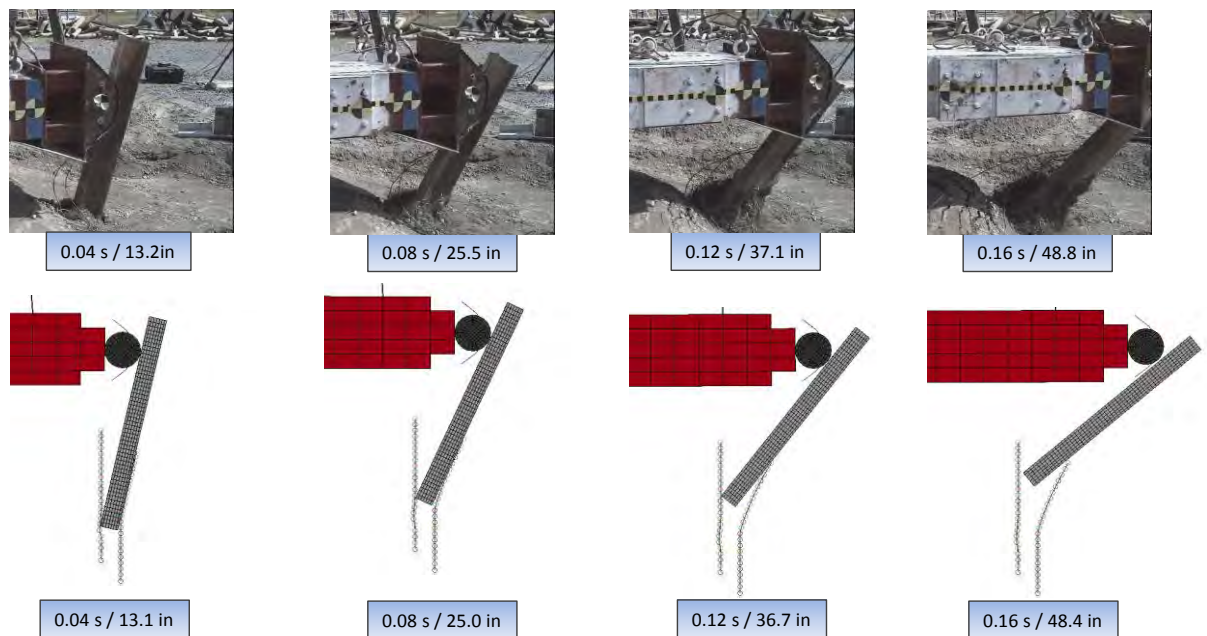
Figure 270. Sequential views of Test 14003D and FE analysis for 9-inch erosion case.

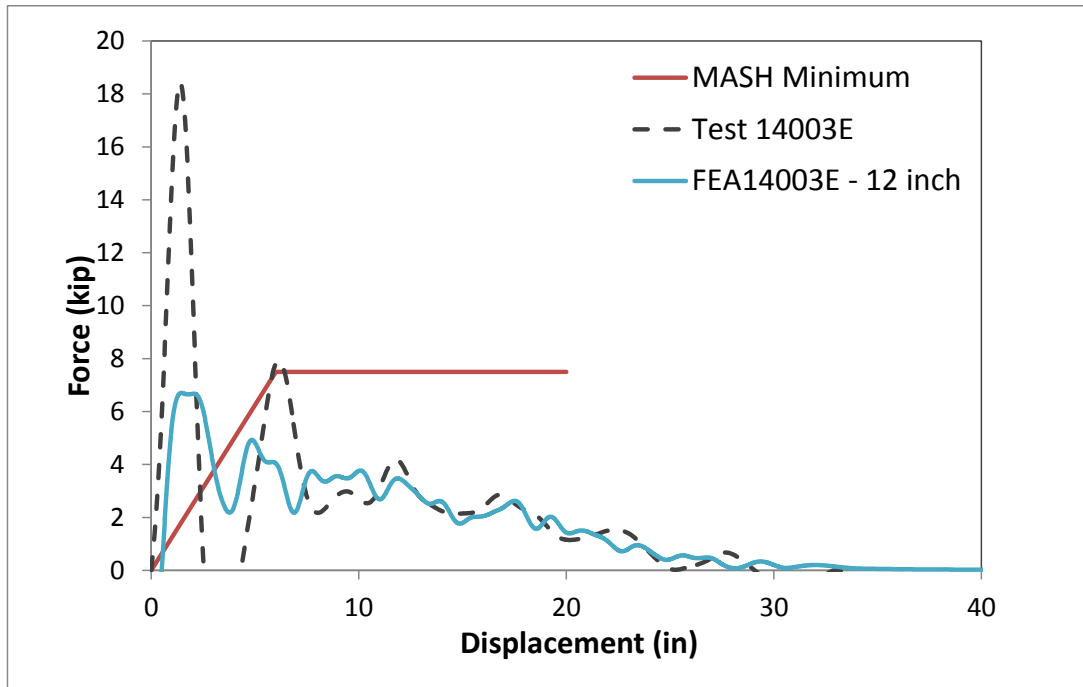
Figure 271. Force vs. deflection for soil model with 12” erosion compared to Test 14003E.

Figure 271 and Figure 272 show the force vs. deflection and energy vs. deflection results, respectively, for the FE model compared to pendulum Test 14003E. This test was performed using the repaired pendulum head, and the overall response of the model matched reasonably well to the physical test, except for the impulse/inertial spike at the beginning of the impact.

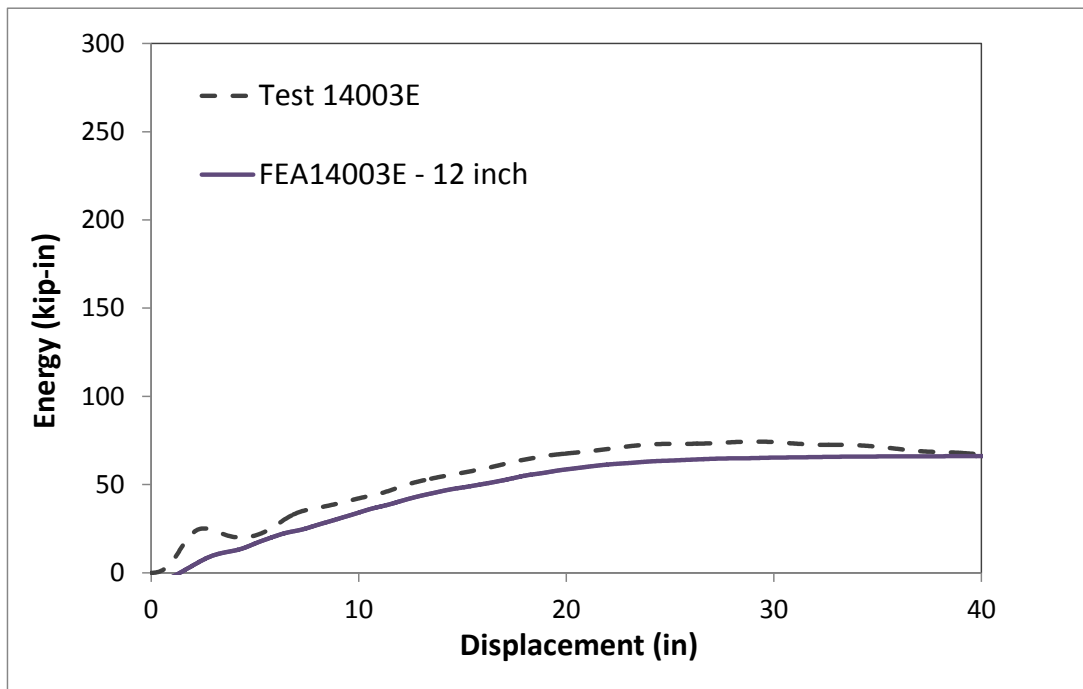
Figure 272. Energy vs. deflection for soil model with 12” erosion compared to Test 14003E.

The total energy absorbed at 12 inches displacement in the analysis was 40.4 kip-in compared to 48.8 kip-in in Test 14003E; the total energy absorbed at 20 inches displacement in the analysis was 58.6 kip-in compared to 67.6 kip-in in Test 14003E; and the total energy absorbed at 40 inches displacement in the analysis was 66.1 kip-in compared to 67.1 kip-in in Test 14003E. Figure 273 shows sequential views comparing analysis results to dynamic impact Test 14003E.

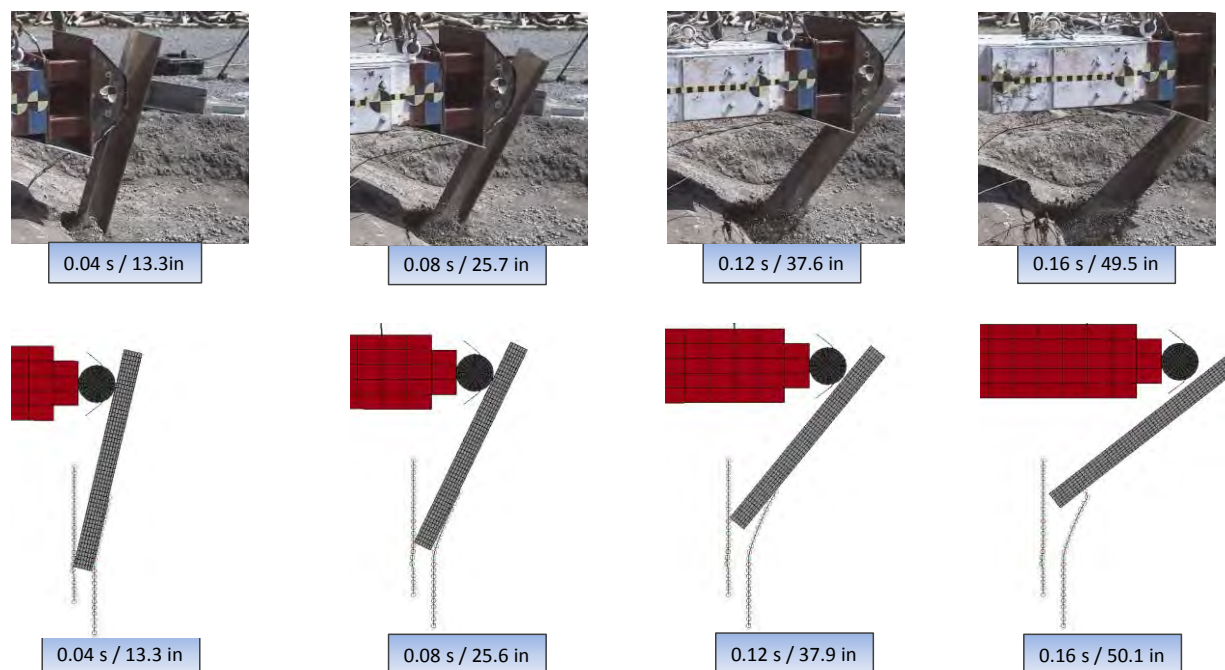
Figure 273. Sequential views of Test 14003E and FE analysis for 12-inch erosion case.

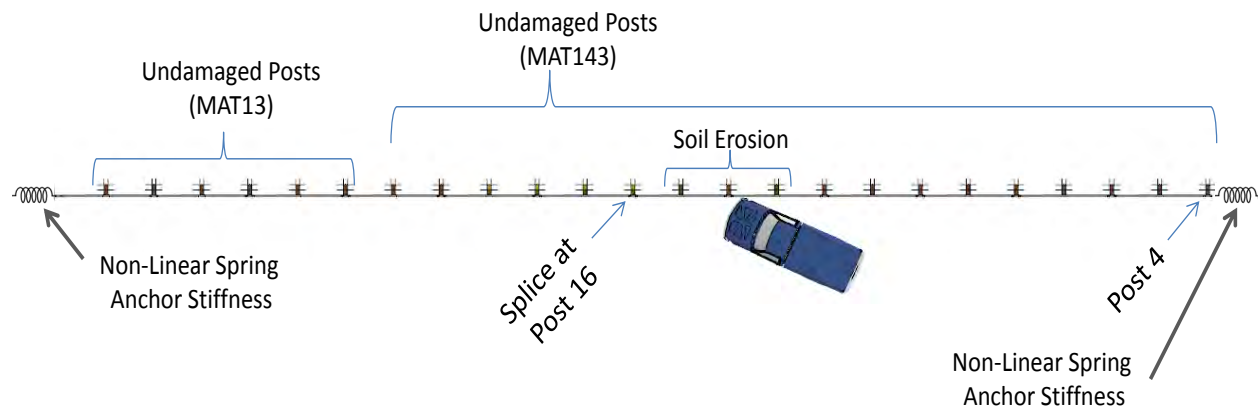
The analysis model used for the evaluations is shown in Figure 274. Posts 4 through 21 were modeled using MAT143 in LS-DYNA; while the posts located upstream of the impact zone were modeled using MAT13. The material properties corresponded to undamaged wood posts (i.e., no deterioration) for all posts in the model. Refer to Chapter 8 for more details on wood post model development and validation.

Figure 274. Analysis setup for evaluating effects of anchor strength on the performance of the G4(2W).

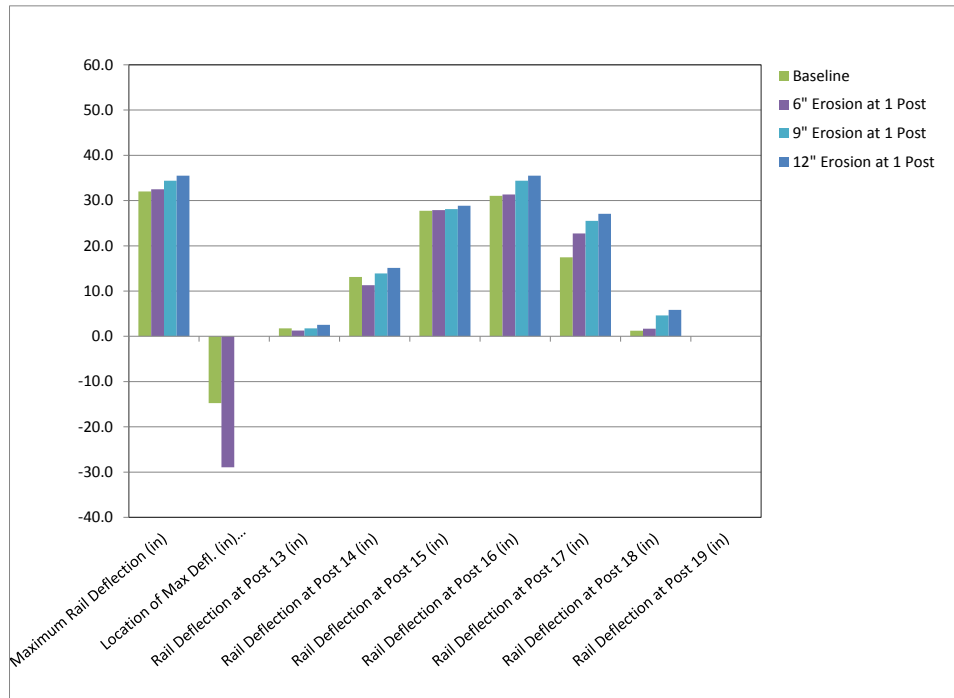
Figure 275. Summary of barrier damage evaluation from analyses of undamaged G4(2W) guardrail with various levels of soil erosion at a single post.

The following is an evaluation of the G4(2W) guardrail with various levels of soil erosion at a single post location. Sequential views of the FE analysis results for each case are provided in Appendix N. Table 71 provides a summary of barrier damage from the analyses related to rail deflections, anchor movement and splice damage. This information is also presented graphically in Figures 275 and 276. The maximum lateral rail deflection was 32 inches for the baseline case and increased to 35.5 inches at 12 inches of erosion (i.e., 9.2 percent higher than the baseline case).

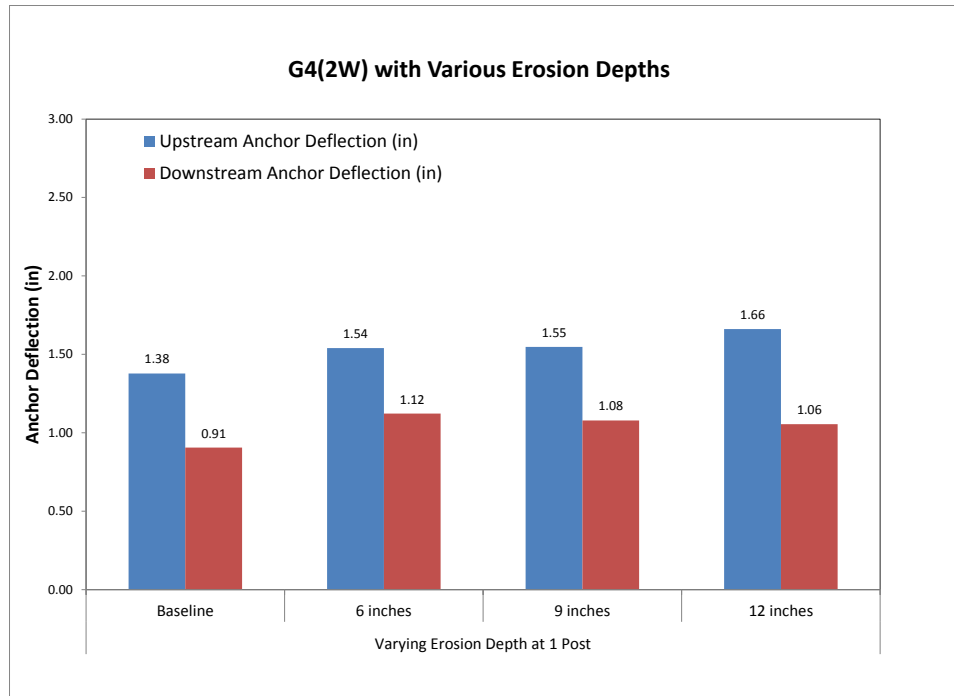
Figure 276. Summary of anchor displacement at rail height from analyses of undamaged G4(2W) guardrail with various levels of soil erosion at a single post.

Regarding the “location of maximum deflection” in Table 71, a negative number indicates that the maximum deflection occurred upstream of the w-beam splice located at Post 16, while a positive number indicates that maximum deflection occurred downstream of the splice. For the 6-inch erosion case, the maximum lateral deflection occurred at 29 inches upstream of the splice connection at Post 16. For the 9-inch and 12-inch cases the maximum deflection occurred exactly at Post 16. Figure 276 shows the longitudinal displacement of the upstream and downstream ends of the w-beam at the anchor locations. In all erosion cases, the loading on the upstream anchor was of similar magnitude as the baseline case. The longitudinal rail deflections at the downstream anchor increased slightly with each level of erosion. In general, higher lateral deflections in the impact region were associated with higher anchor deflections.

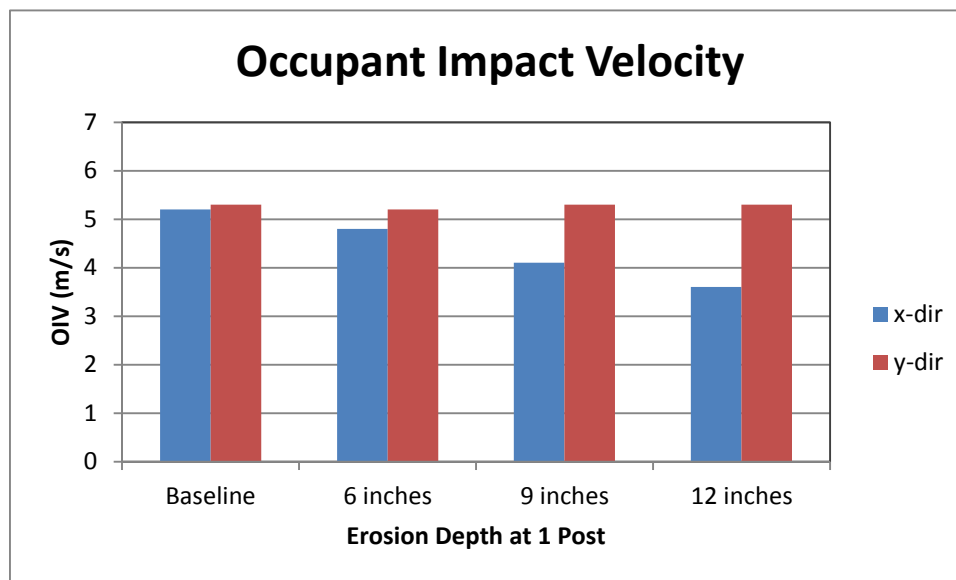
Figure 277. Summary of occupant impact velocities for undamaged G4(2W) guardrail with various levels of soil erosion at a single post.

A summary of occupant risk measures computed from the acceleration and angular rate time-histories at the vehicle's center of gravity is provided in Table 72. This data is also presented graphically in Figures 277 through 279. The results indicated that increased levels of erosion at a single post did not significantly affect occupant risk; and, in general, the values were slightly lower for the erosion cases. A summary of the maximum effective plastic strains around the splice-bolt holes in the w-beam for each analysis case is shown in Figure 280. The results indicated that the potential for splice rupture increased as erosion levels increased. For example, the plastic strains at the splice-bolt holes reached magnitudes of 1.05, 1.04, and 1.12 for cases of 6, 9 and 12 inches of erosion, respectively. The values computed from the 9-inch and 12-inch analysis case likely under-predict the actual strains, since the critical impact point was not achieved.

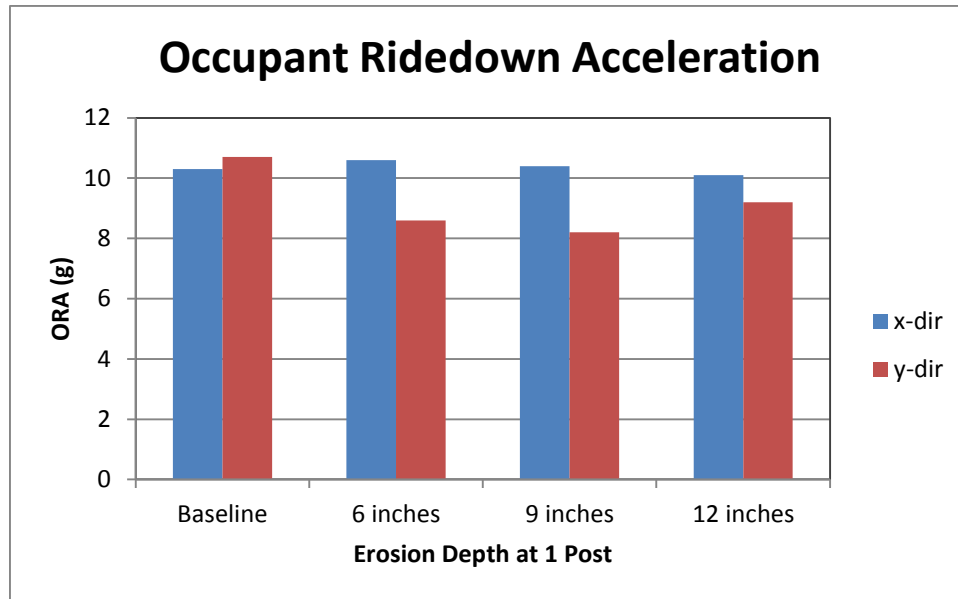
Figure 278. Summary of maximum occupant ridedown accelerations for undamaged G4(2W) guardrail with various levels of soil erosion at a single post.

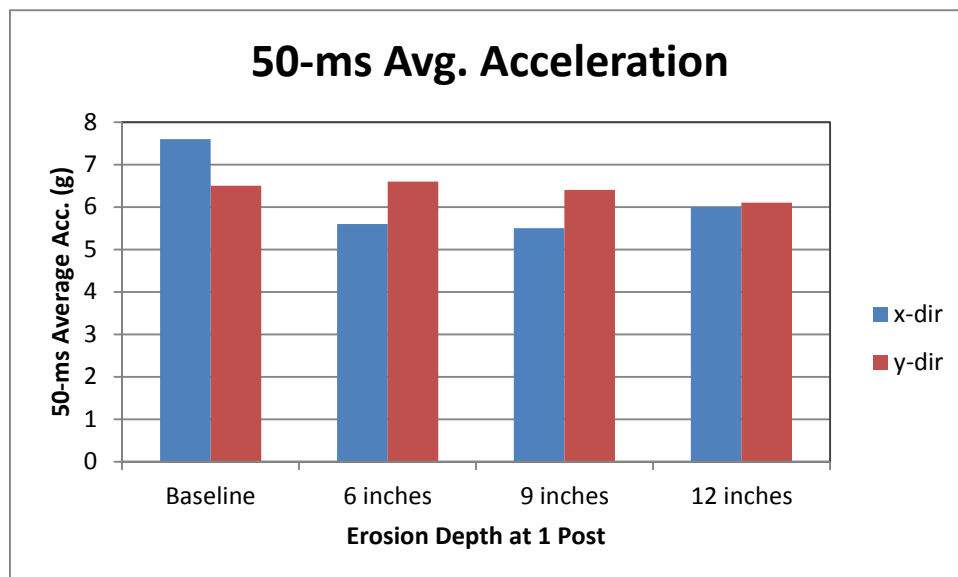
Figure 279. Summary of maximum 50-ms running average accelerations for undamaged G4(2W) guardrail with various levels of soil erosion at a single post.

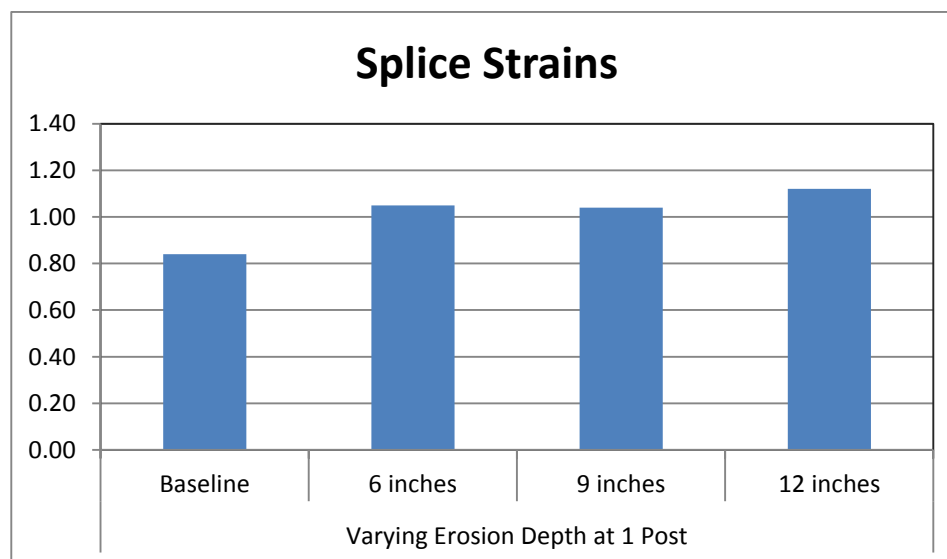
Figure 280. Summary of maximum effective plastic strains occurring at the splice-bolt locations at Post 16.
