Criteria for Restoration of Longitudinal Barriers, Phase II (2021)

Criteria for Restoration of Longitudinal Barriers, Phase II

Contractor's Final Report for NCHRP Project 22-28
Submitted June 2015

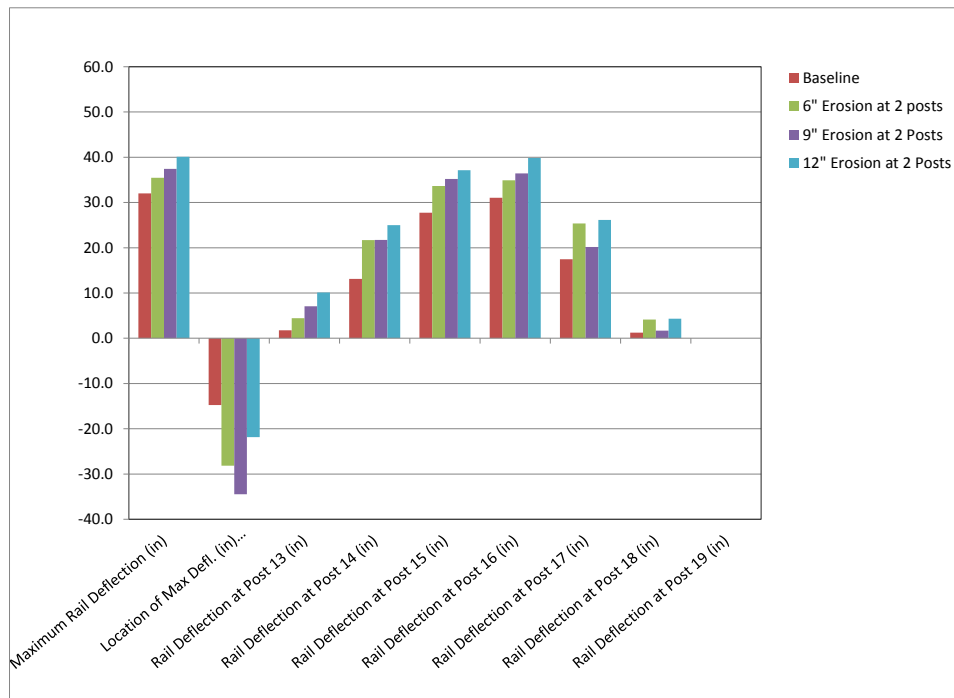
Figure 281. Summary of barrier damage evaluation from analyses of undamaged G4(2W) guardrail with various levels of soil erosion at two consecutive posts.

The following is an evaluation of the G4(2W) guardrail with various levels of soil erosion at two consecutive post locations. Sequential views of the FE analysis results for each case are provided in Appendix O. Table 73 provides a summary of barrier damage from the analyses related to rail deflections, anchor movement and splice damage. This information is also presented graphically in Figures 281 and 282. The maximum lateral rail deflection was 32 inches for the baseline case and increased to 40.1 inches at 12 inches of erosion (i.e., 25.3 percent higher than baseline case).

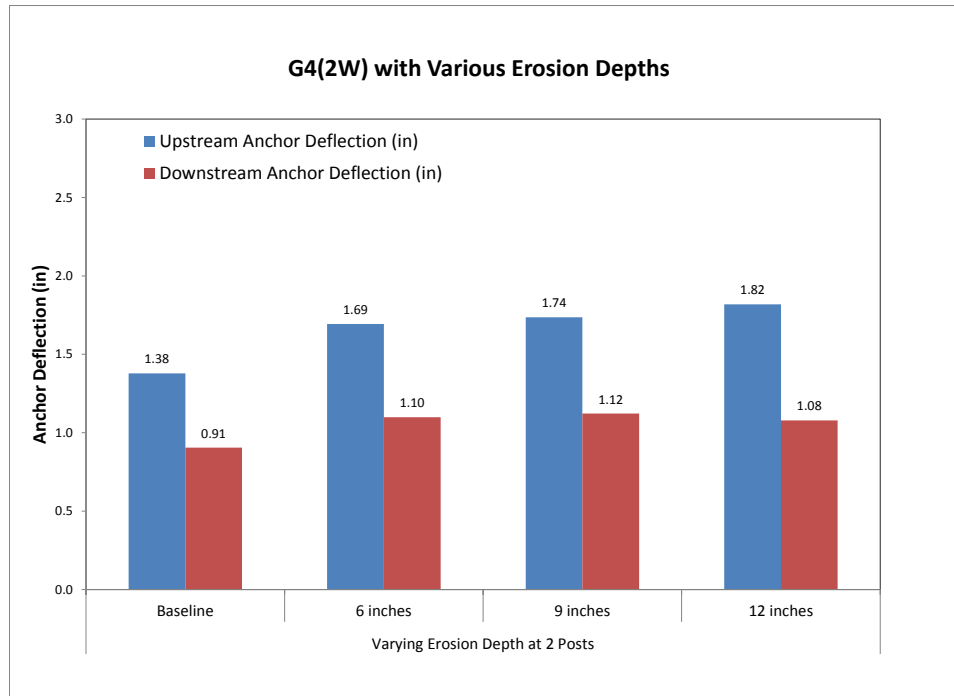
Figure 282. Summary of anchor displacement at rail height from analyses of undamaged G4(2W) guardrail with various levels of soil erosion at two consecutive posts.

As shown in Table 73, the maximum lateral deflection generally occurred within 34 inches upstream of the splice connection at Post 16. Thus, the impact conditions were considered to correspond to critical impact conditions for the various cases. Figure 282 shows the longitudinal displacement of the upstream and downstream ends of the w-beam at the anchor locations. In all erosion cases, the loading on the upstream anchor was of similar magnitude as the baseline case; while the longitudinal rail deflections at the downstream anchor increased slightly with each level of erosion. In general, higher lateral deflections in the impact region were associated with higher anchor deflections.

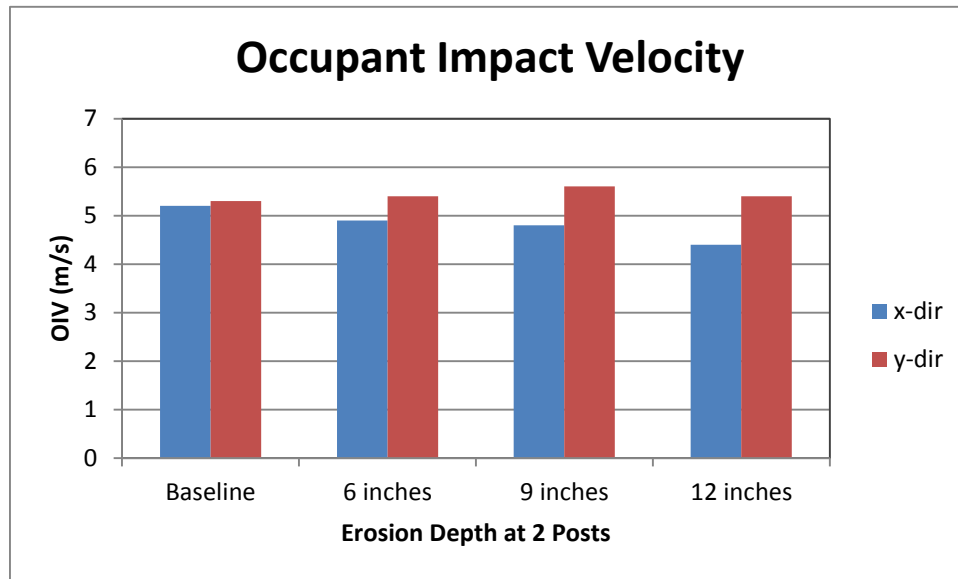
Figure 283. Summary of occupant impact velocities for undamaged G4(2W) guardrail with various levels of soil erosion at two consecutive posts.

A summary of occupant risk measures computed from the acceleration and angular rate time-histories at the vehicle's center of gravity is provided in Table 74. This data is also presented graphically in Figures 283 through 285. The results indicate that increased levels of erosion at two consecutive posts do not significantly affect occupant risk; and, in general, the values were again slightly lower for the erosion cases.

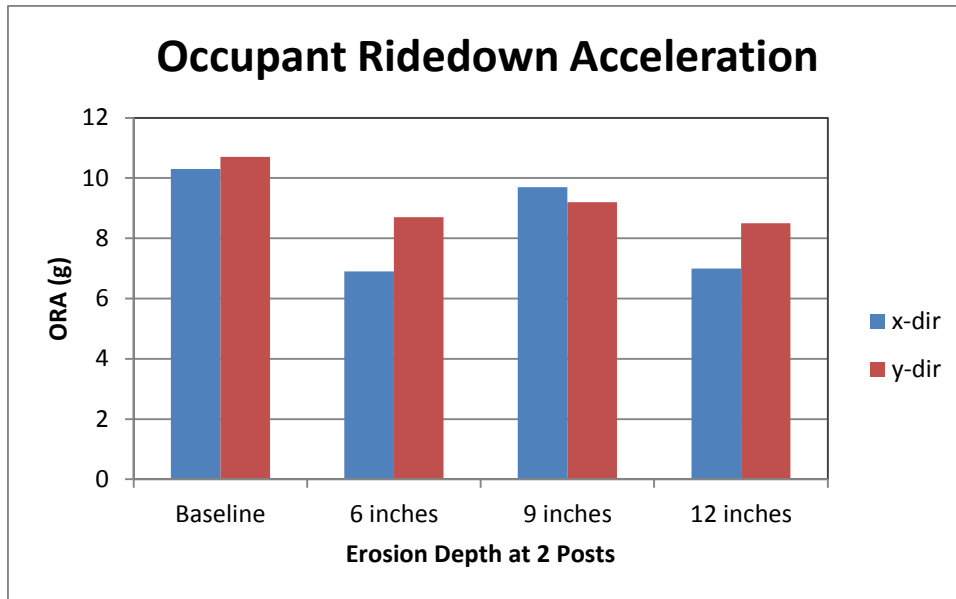
Figure 284. Summary of maximum occupant ridedown accelerations for undamaged G4(2W) guardrail with various levels of soil erosion at two consecutive posts.

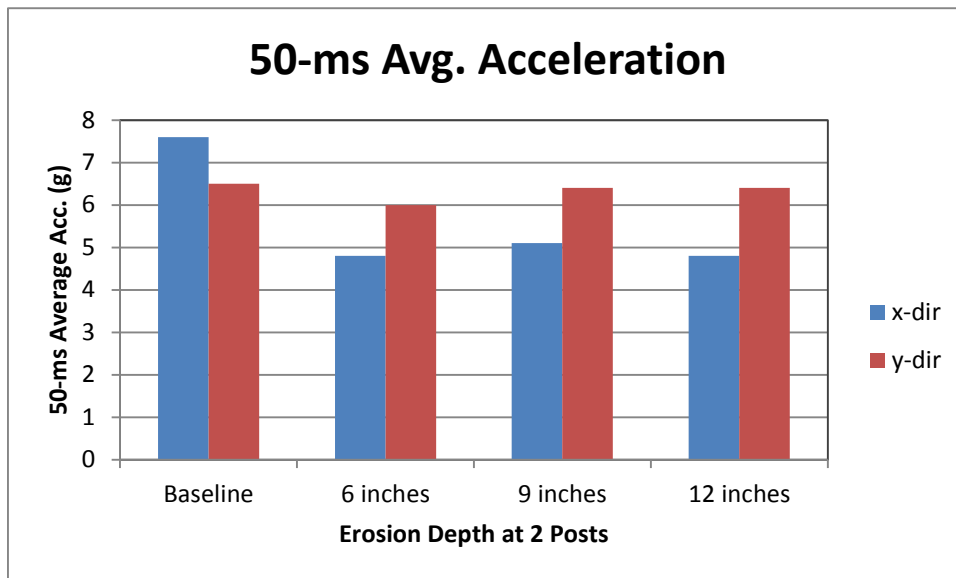
Figure 285. Summary of maximum 50-ms running average accelerations for undamaged G4(2W) guardrail with various levels of soil erosion at two consecutive posts.

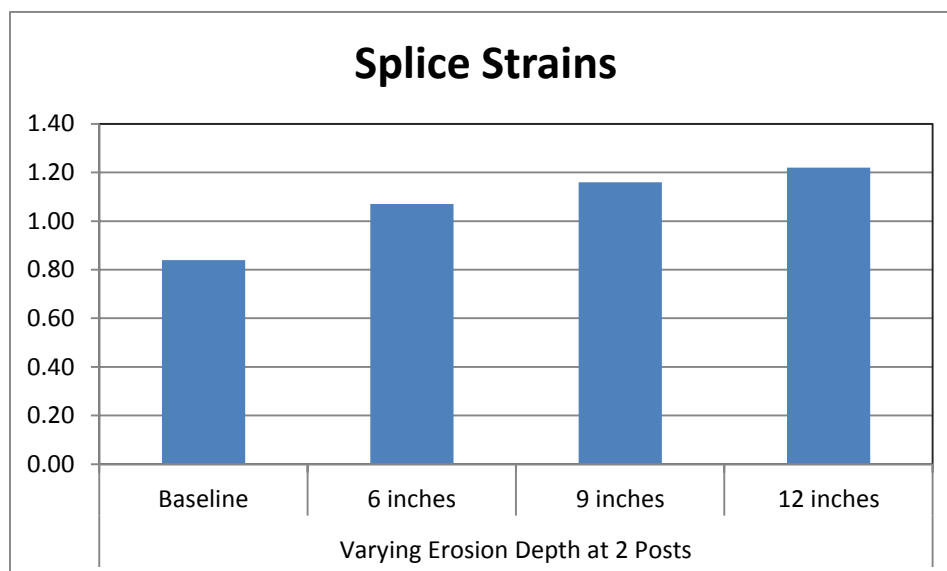
Figure 286. Summary of maximum effective plastic strains occurring at the splice-bolt locations at Post 16.

A summary of the maximum effective plastic strains around the splice-bolt holes in the w-beam for each analysis case is shown in Figure 286. The results indicated that the potential for splice rupture increased as erosion levels increased. For example, the plastic strains at the splice-bolt holes reached magnitudes of 1.07, 1.16, and 1.22 for cases of 6, 9 and 12 inches of erosion, respectively. As was discussed in Chapter 11, strains of this magnitude for steel are generally associated with a high potential for material failure. In these cases, however, the strains are restricted to a very localized area at the end of the splice-bolt holes and are compressive (i.e., caused from the bearing load between the splice-bolt and the edge of the w-beam hole). Thus, the potential for tear initiation is much lower than the same magnitude of strain in a tensile region of the w-beam (e.g., on the lateral edge of the upper or lower edge of the splice-bolt holes).

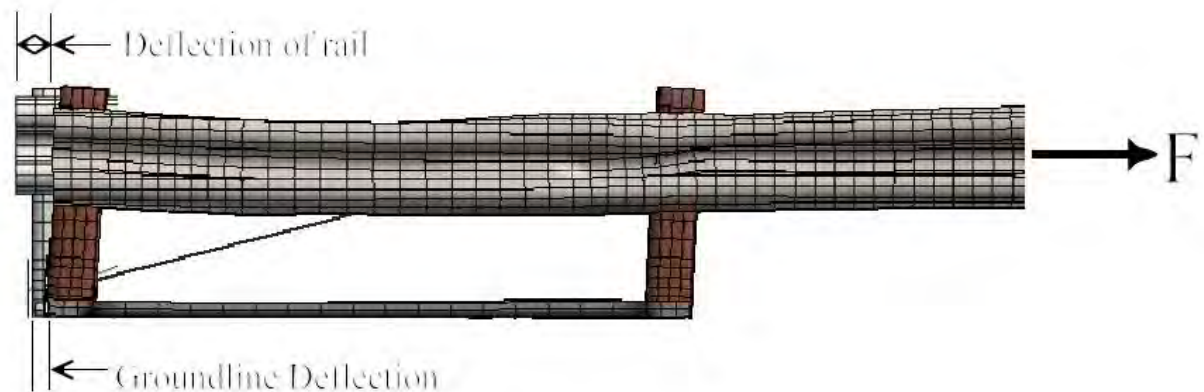
Figure 287. Example – finite element model for computing force-deflection response of the standard two-post guardrail anchor system.[Plaxico03]

The force-deflection response of a standard two-post anchor system with various types and levels of damage was determined through physical testing by applying a displacement-time history to the w-beam rail at the downstream end of the system and measuring the force-deflection response, as illustrated in Figure 287.

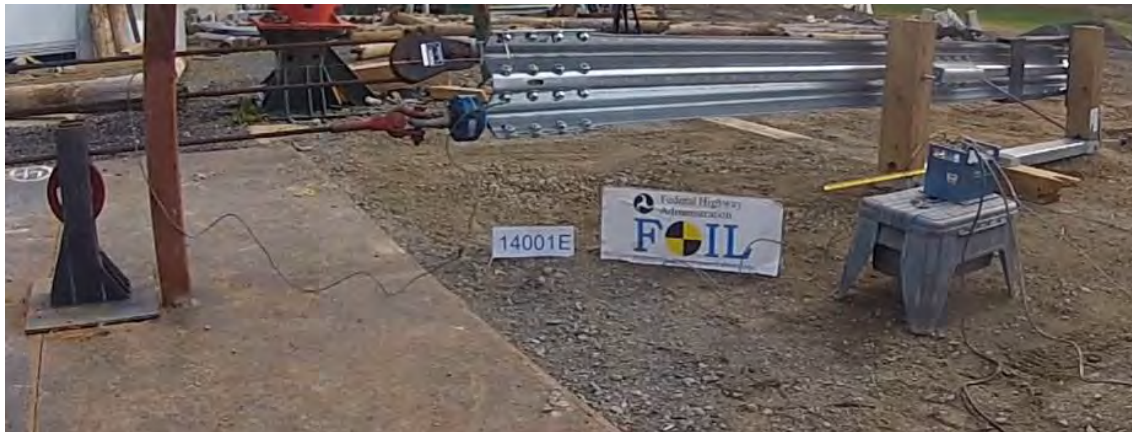
Figure 288. Typical test set-up for measuring force-deflection response of the guardrail end-terminal anchor.

The tests were performed by the staff of the Federal Outdoor Impact Laboratory (FOIL) at the Federal Highway Administration's Turner Fairbank Highway Research Center in McLean, Virginia. Figure 288 shows the typical test setup used for the study. The components of the test articles were donated by three guardrail distributors: Trinity Industries, Gregory Industries, Inc. and Road Systems, Inc. Since the purpose of these tests was to measure the force-displacement response of the anchor, only those components directly related to the anchor system were included in the test article. After each test, the components were inspected for damage. Those that showed no signs of damaged were reused in subsequent tests.

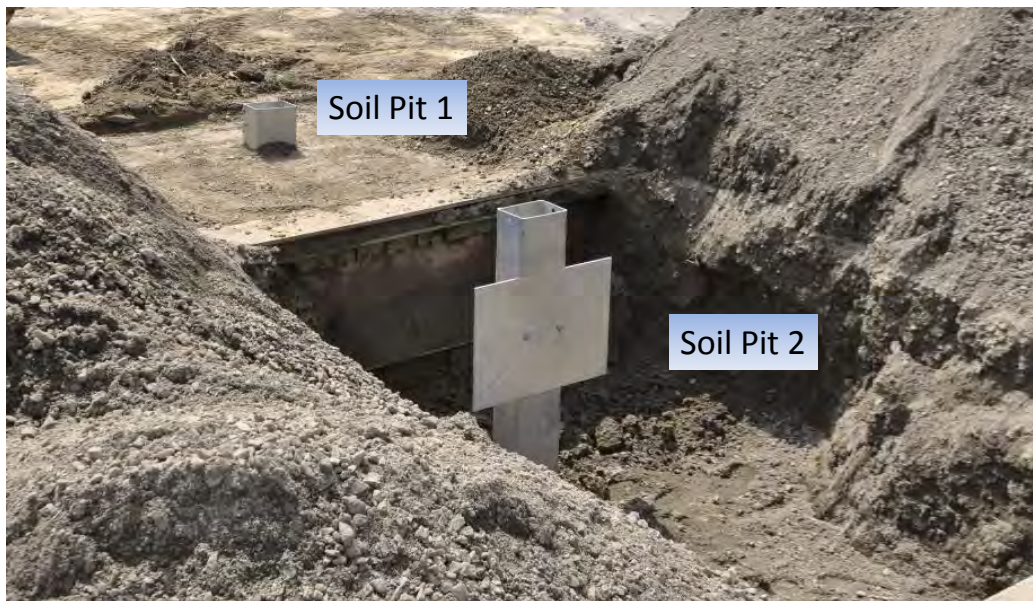
Figure 289. Photograph of anchor tubes with soil plates during installation (from preliminary Test 14011B).

Figure 289 shows a photo of the two foundation tubes with soil plates taken during the installation process. Because of the limited size of the primary soil pit, it was necessary to also utilize the adjacent soil pit to accommodate installation of the test article. This allowed sufficient distance between the posts and the edges of the soil pit for mitigating the influence of the soil pit walls on the response of the system. The distance from the front of the foundation tube at Post 1 to the front wall of Soil Pit 1 was approximately 88 inches; and the distance from the front of the foundation tube at Post 2 to the front wall of Soil Pit 2 was approximately 43 inches. The soil for all tests was classified as 21A, which conformed to Grading B of AASHTO M147-95, and was compacted in 6-inch lifts using a pneumatic tamper. The density, moisture content and degree of compaction of the soil was measured in front of and behind the post after each compaction process using a Troxler-Model 3440 Surface Moisture-Density Gauge. There were a total of twelve readings which were averaged to determine the effective soil conditions.

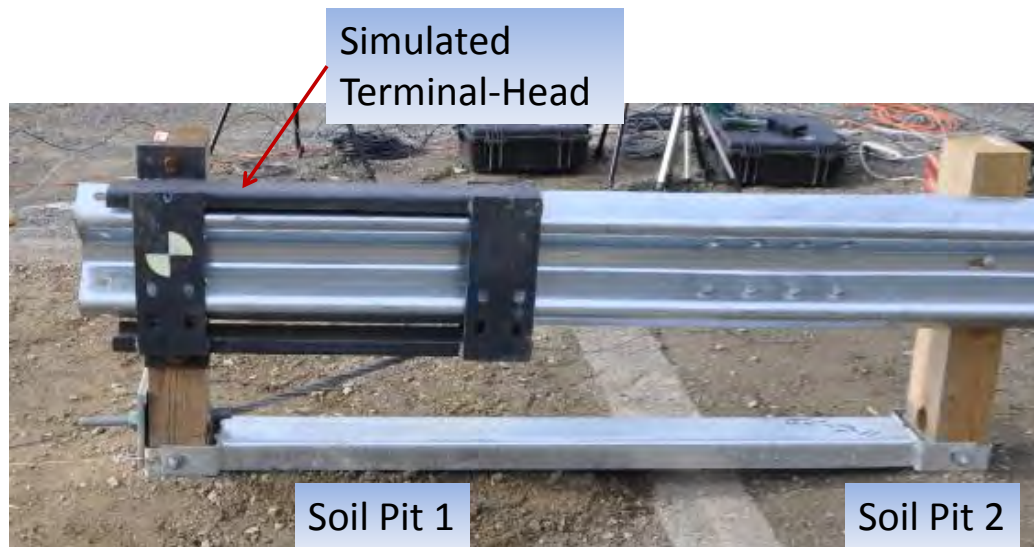
Figure 290. Photo of the simulated terminal-head bracket mounted onto the end-post.

The posts were spaced at 6.25 feet (typical). The w-beam rail was bolted to Post 2 using a 5/8-inch diameter bolt (ASTM F568) that was 10 inches long. A bracket, similar to the design used for most end-terminals, was mounted onto the end-post (Post 1), as shown in Figure 290, to allow the w-beam to slide freely in the longitudinal direction relative to the rail element. The w-beam was not bolted at the end-post. Construction drawings for the baseline generic end-terminal are provided in Appendix P.

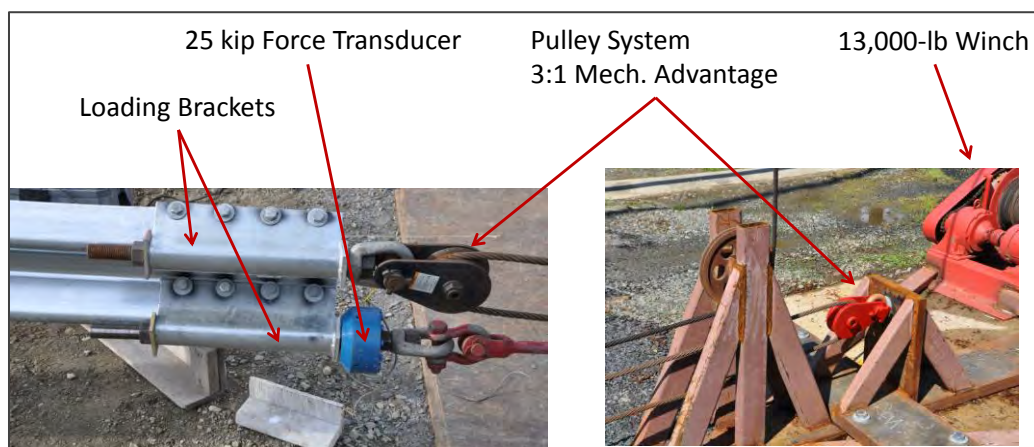
Figure 291. Cable and pulley system used to apply tensile loading on end-terminal anchor.

The load was applied to the end of the test article using a winch and a cable-pulley system with a 3:1 mechanical advantage, as shown in Figure 291. The winch system used for the quasi-static test was an existing component of the pendulum test device – used primarily to hoist the pendulum into position for dynamic tests. For the tests, the winch cable was run through a pulley aligned with the top corrugation of the w-beam on the test article, around another stationary pulley that was attached to a fixed bracket near the winch system, and then back to the test article and attached to the lower corrugation of the w-beam rail. For the attachment to the end of the test article, a 1-inch diameter steel rod was attached to the pulley, and another was attached to the end of the force transducer. These two rods were then fastened to the end of the w-beam rail using a standard cable-anchor-bracket (i.e., RWE02), as shown in Figure 291. A bracket-and-idler-pulley system was also mounted just downstream of the test article, as shown in Figure 292, to maintain vertical position of loading cables during the tests (e.g., simulate the continuation of the w-beam mounted to the downstream posts).

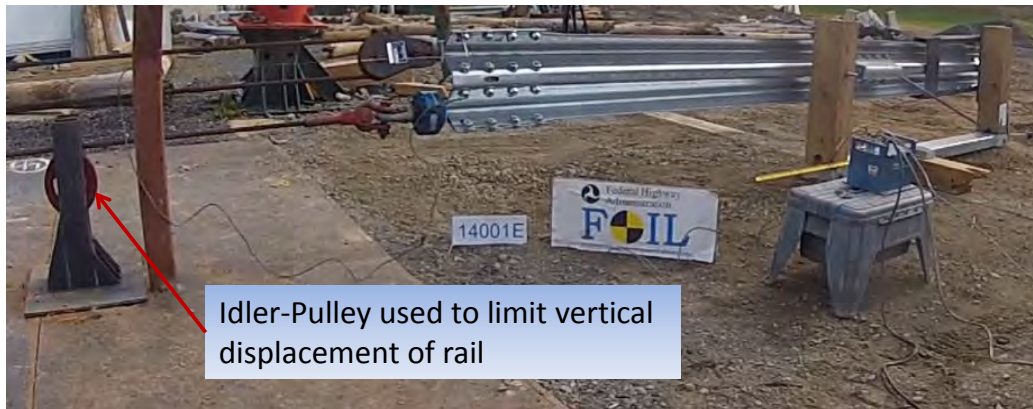
Figure 292. Idler-pulley mount used to maintain vertical position of loading cable.

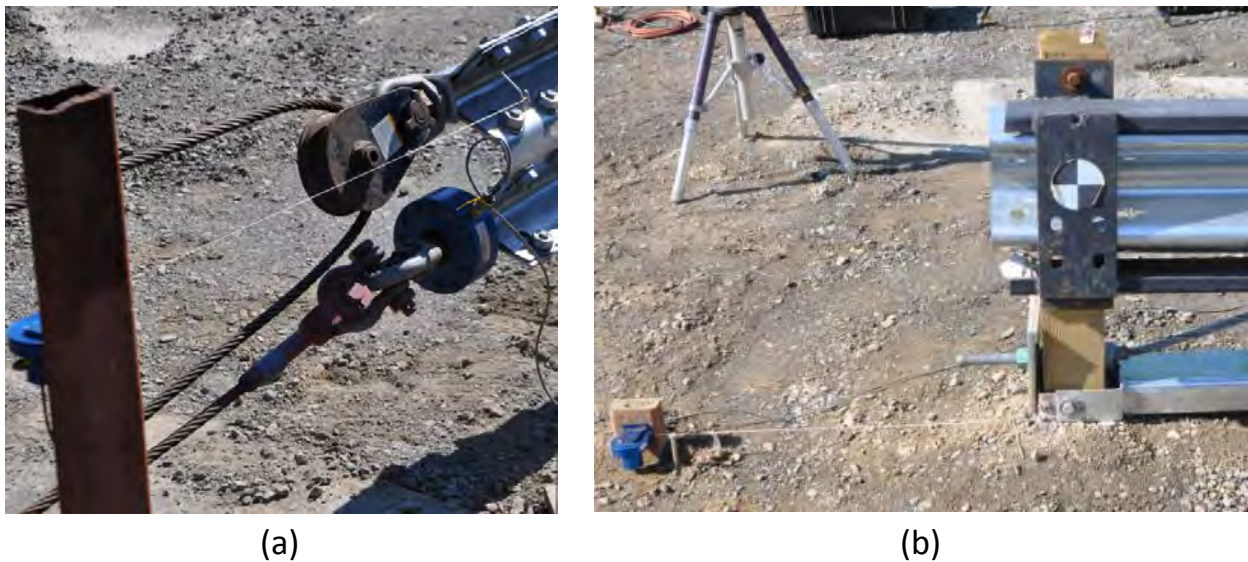
Figure 294. Displacement transducers mounted to (a) w-beam rail at load point and (b) top of foundation tube at Post 1.

SpaceAge Control, Inc. Series 162 Miniature Position Transducers (i.e., string-pots) were used to measure displacements at two key locations on the test article during the test, as shown in Figure 294. One string-pot was used to measure displacement at the downstream end of the w-beam rail at the load point, and another was used to measure the groundline displacement of the foundation tube at Post 1 (i.e., end post).

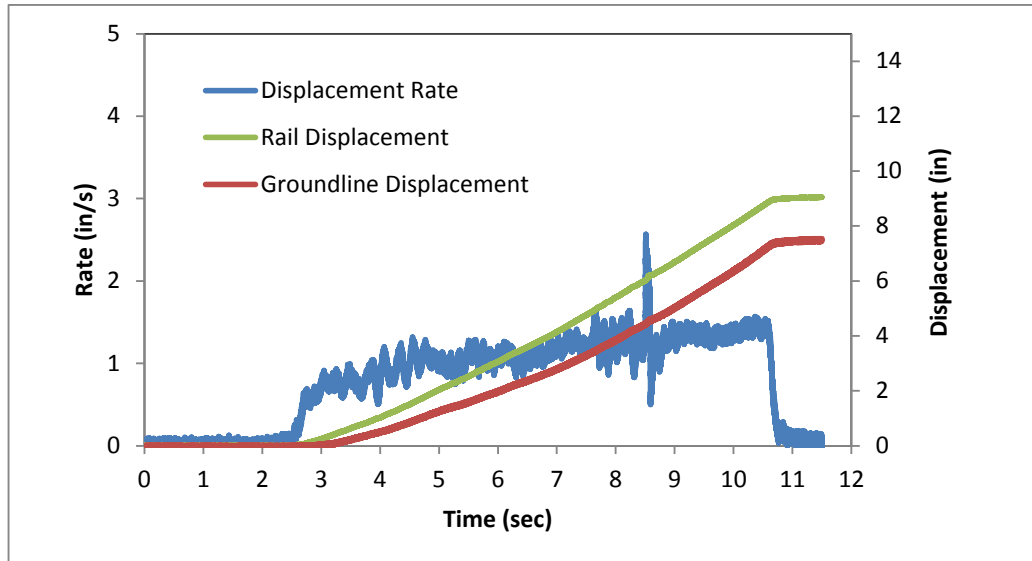
Figure 296. Displacement- and displacement rate-time histories measured at the load point on the end of the rail and at the groundline of Post 1 for baseline case.

A quasi-static displacement-time history was applied to the end of the w-beam rail of the end-terminal at a rate of approximately 0.5 – 1.4 in/sec. The test continued until there was a sudden decrease in resistance (e.g., failure of an end-terminal component) or when the displacement of the rail reached 10 inches, whichever came first. Figure 296 shows the displacement- and displacement rate-time histories measured at the load point on the end of the rail and at the groundline of Post 1 for the undamaged end-terminal case. The blue curve in Figure 297 shows the resulting force-deflection response of the end-terminal measured at the end-of the w-beam rail. The test data was resampled to obtain the “apparent” force-deflection response of the system denoted by the green curve in Figure 297. To account for the effects of loading rate on the anchor response in the finite element model, a dynamic magnification factor of 1.45 was used to scale the quasi-static force-deflection curve denoted by the red curve in Figure 297. Only two displacement transducers were available, so the displacement-time history at Post 2 was not measured in the tests. Sequential views of the undamaged end-terminal case from two view-points are shown in Figure 298.

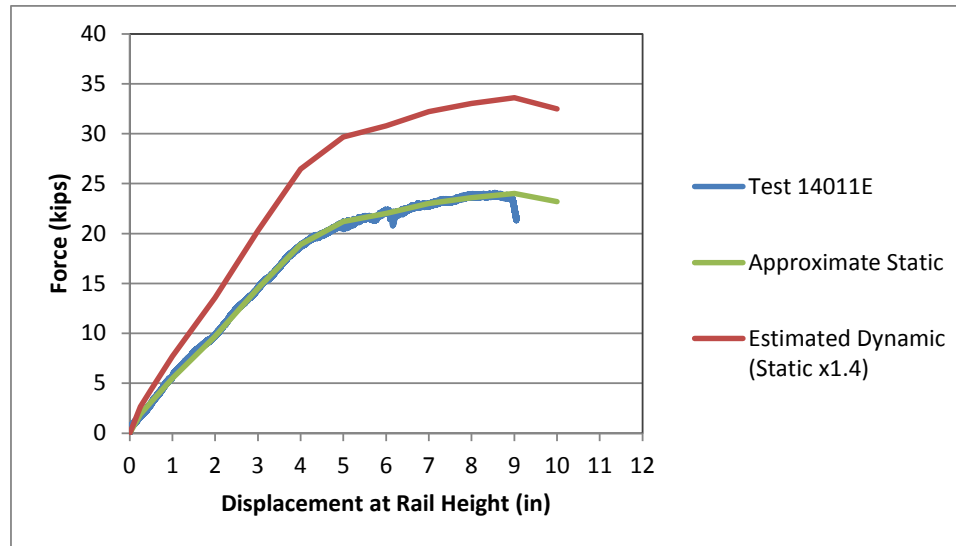
Figure 297. Force-displacement response of the anchor system measured at the load point on the end of the rail for undamaged end-terminal case.

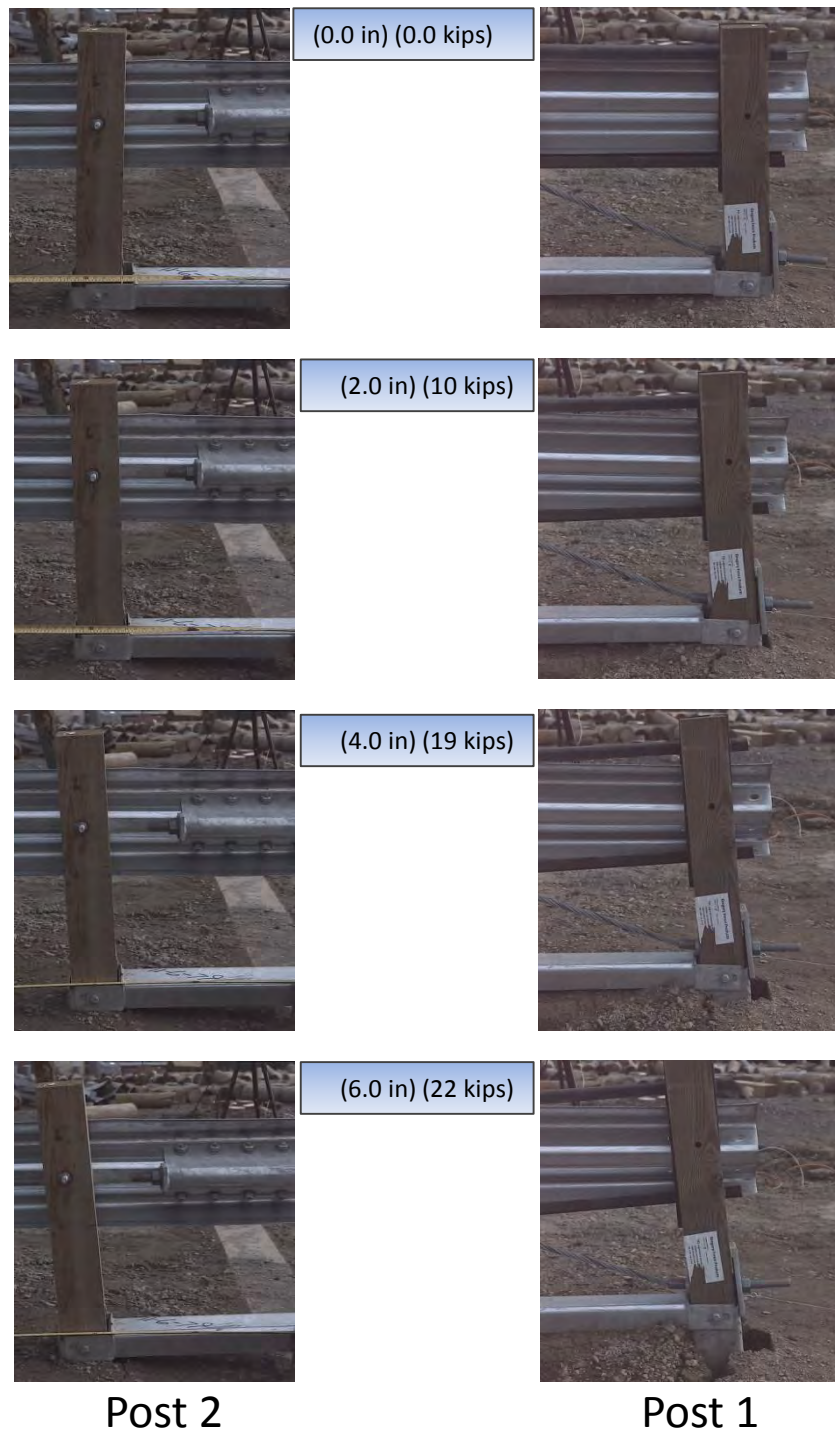
Figure 298. Sequential views of quasi-static test conducted for undamaged end-terminal case (Test 14011E).

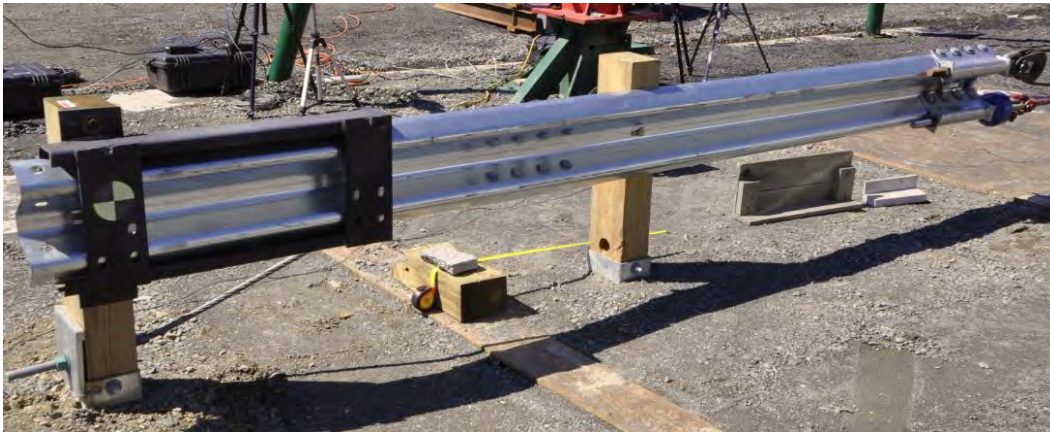
Figure 299. Pre-test photo of Test 14001D (front view).

Pre-test and post-test photos of Test 14011D are shown in Figures 299 and 300, respectively. The data from the test were resampled to obtain the “approximate static” force-deflection response, which is compared to that of the undamaged system in Figure 301. Refer to the test-summary sheets in Appendix Q for the “unprocessed” force-deflection results. Figure 302 shows the displacement-time history measured at the load-point on the rail and at the groundline of Post 1.

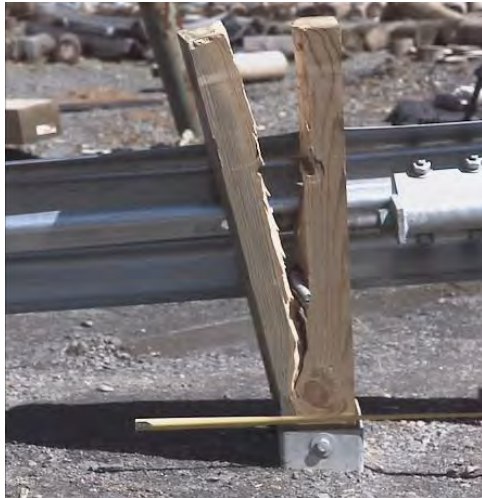
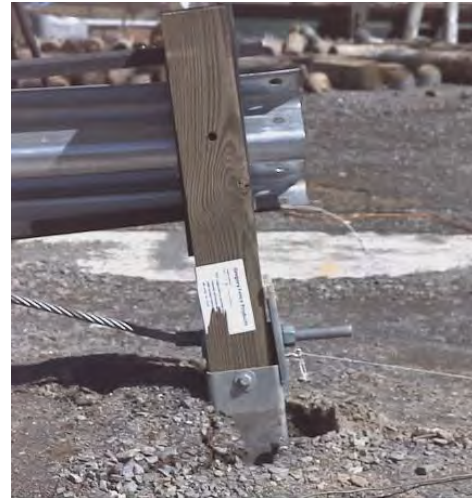
Post 2

Post 1

Figure 300. Post-test photo of Test 14001D (back view).

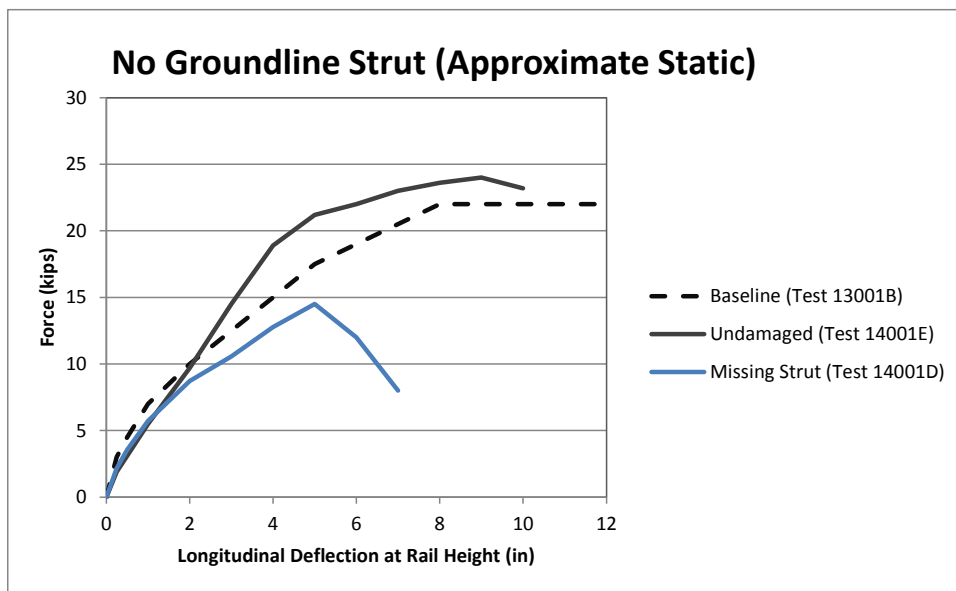
Figure 301. Force vs. deflection response for the standard end-terminal with missing groundline strut.

The “apparent” initial stiffness⁶ of the anchor was 4.5 kips/in for the first 2 inches of displacement measured at the load point, compared to 4.9 kips/in for the undamaged system. Between 2-4 inches displacement the stiffness dropped to 1.9 kips/in, compared to 4.5 kips/in for the undamaged system. Post 2 split at approximately 5 inches displacement at which point the loading on the system was 14.8 kips resulting in a sudden loss of the anchor resistance. The test was terminated immediately after the loss of Post 2 with a maximum displacement of 6.4 inches measured at the load point; thus, the response of the system beyond this displacement was not determined. The apparent strength of the anchor was 14.8 kips and occurred at 5 inches deflection.

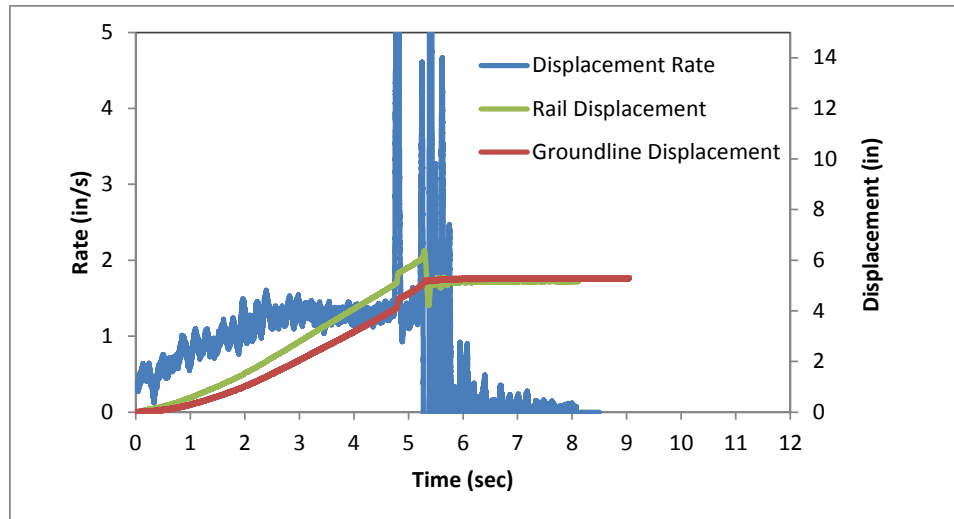
Figure 302. Displacement and displacement rate vs. time for Test 14001D.

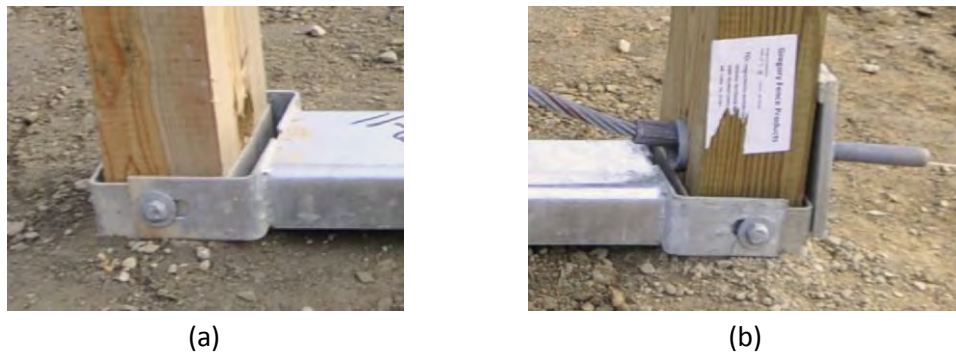
Figure 303. Typical position of groundline strut in a standard two-post-strut anchor system relative to (a) Post 2 and (b) Post 1.

The results for the test involving the missing groundline strut showed that the initial stiffness of the end-terminal was similar to that of the undamaged system for approximately the first 1.5 inches of longitudinal rail movement. This was because the length of the groundline strut was 67 inches, compared to the distance of 68 inches measured between the two foundation tubes for the undamaged test case (refer to Test 14001E in Table 79). This resulted in a total gap of 1.0 inch between the strut and foundation tubes, as shown in Figure 303. Thus, the foundation tube at Post 1 during the test on the undamaged system experienced 1 inch of movement before the groundline strut engaged the foundation tube at Post 2.

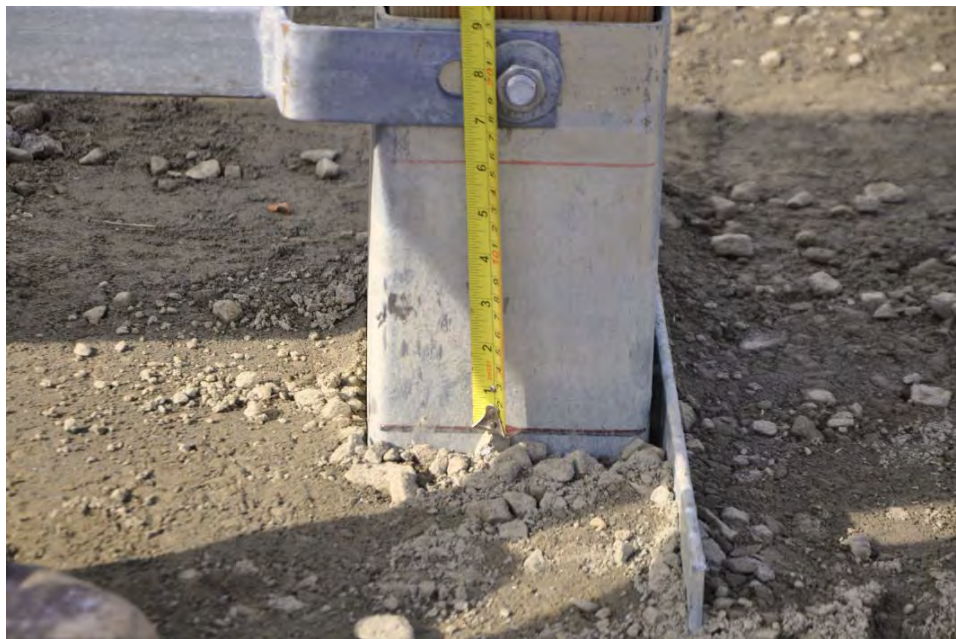
Figure 304. Procedure for measuring reduced embedment depth.

A total of four tests were performed to quantify the effects of reduced embedment depth on the force-deflection response of the standard anchor system. These tests included installations with 2, 4, 6 and 8 inches of reduced embedment depth. At the standard embedment depth for the system, the top of the foundation tube protrudes 3 inches above the ground. Thus, amount of reduced embedment was determined by measuring the distance from the top of the soil to a point three inches from the top of the foundation tube at Post 1. Figure 304 shows an example of the procedure for the case of 6 inches reduced embedment.

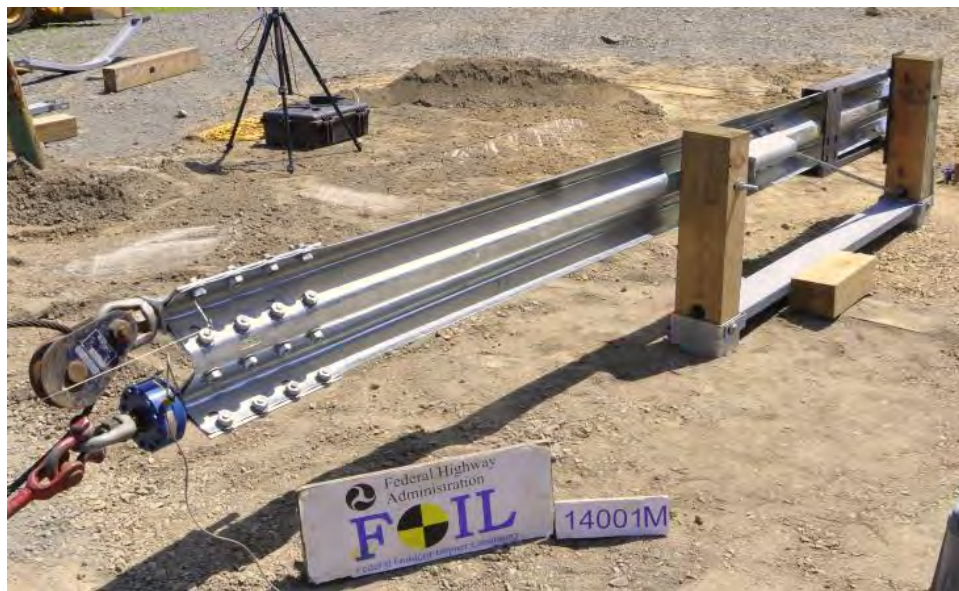
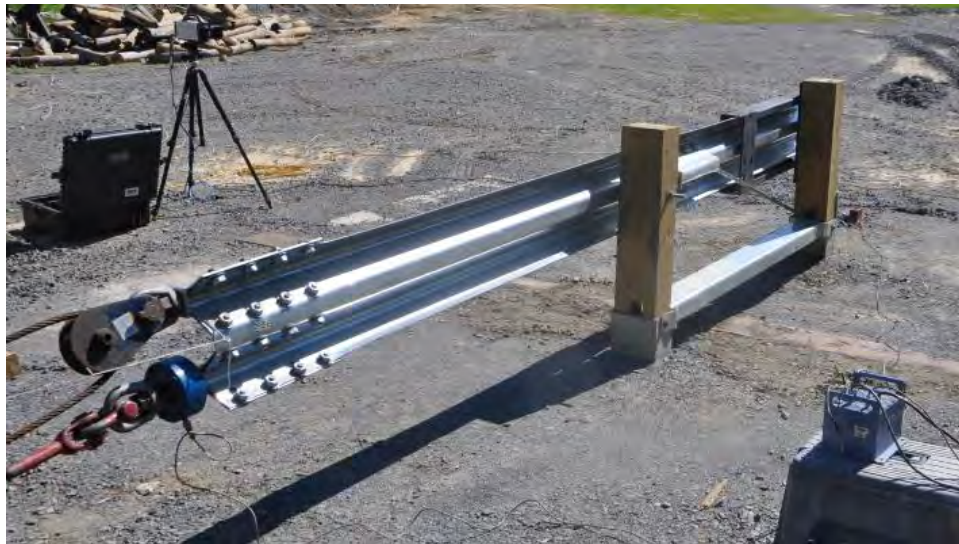
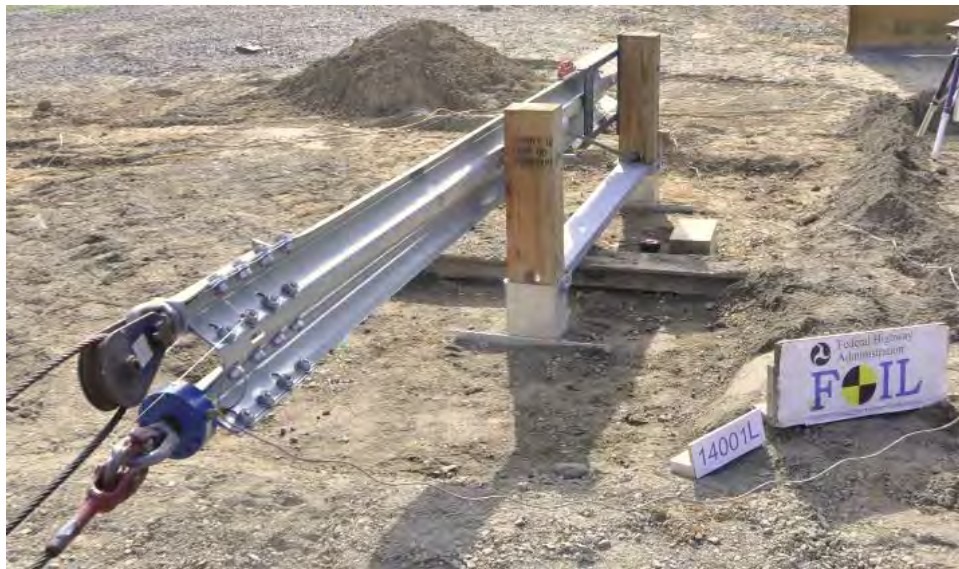
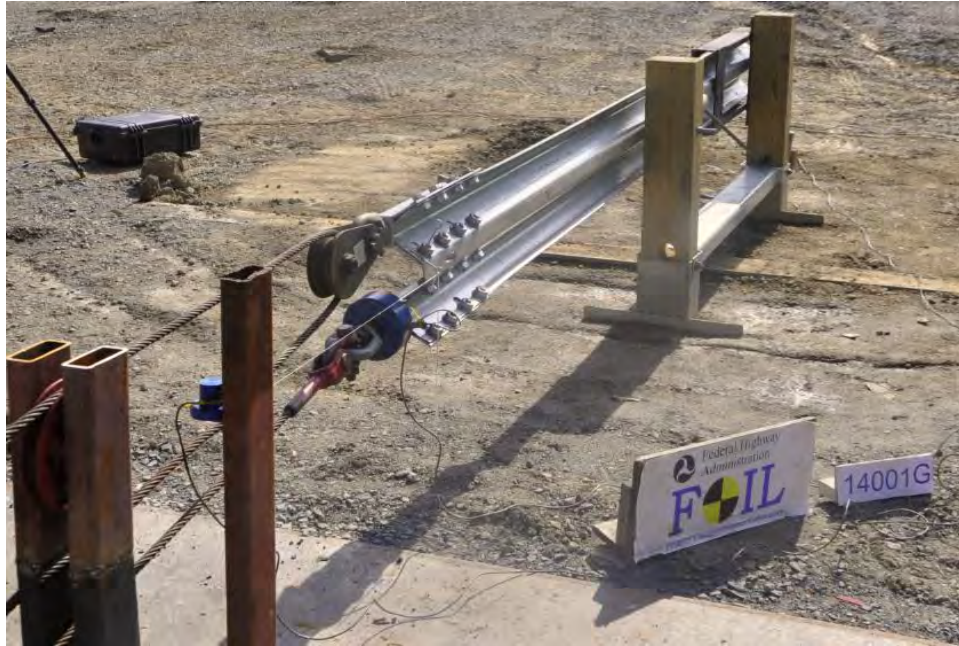
Figure 305. Pre-test photo of Test 14001M for 2-inch reduced embedment case.

Figure 306. Pre-test photo of Test 14001F for 4-inch reduced embedment case.

Figure 307. Pre-test photo of Test 14001L for 6-inch reduced embedment case.

Figure 308. Pre-test photo of Test 14001G for 8-inch reduced embedment case.

Pre-test photos for the four reduced-embedment cases are shown in Figures 305 through 308, and post-test photos are shown in Figures 309 through 312. The “approximate static” force-displacement results from the tests are shown in Figure 313, including the undamaged cases. The results from this series of tests were somewhat inconclusive. The initial stiffness (i.e., between 0-2 inches displacement) for all reduced embedment cases was essentially identical to the undamaged case (i.e., 4.9 kips/in). The stiffness at deflections of 2 to 4 inches, however, was significantly lower for reduced embedment cases of 2, 4 and 6 inches, and reduced slightly for each successive reduction of embedment (i.e., 1.9, 1.5 and 0.9 kips/in, respectively, compared to 4.5 kips/in for the undamaged case). For the 8-inch reduced embedment depth, on the other hand, the stiffness at this second level of displacement was essentially the same as the undamaged case (e.g., 4.2 vs. 4.5 kips/in).

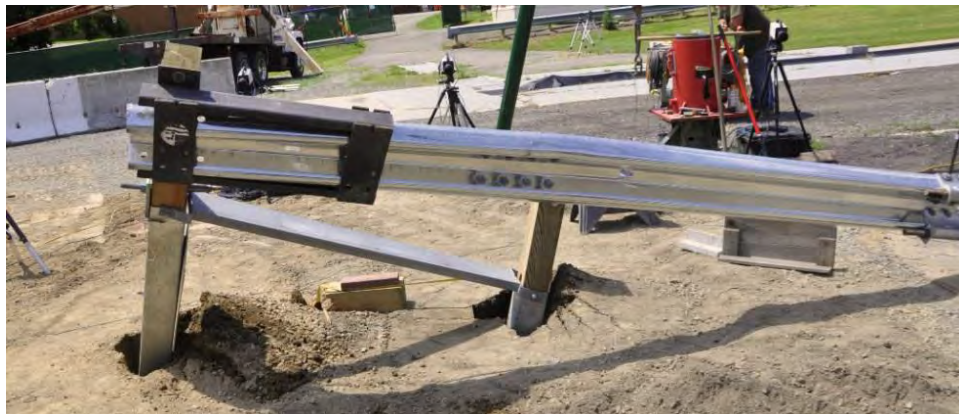
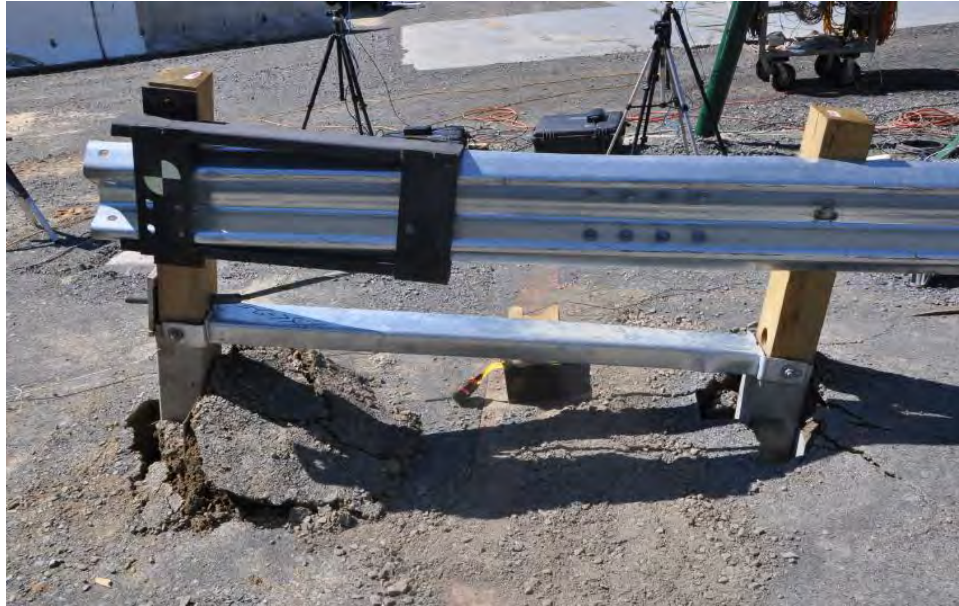
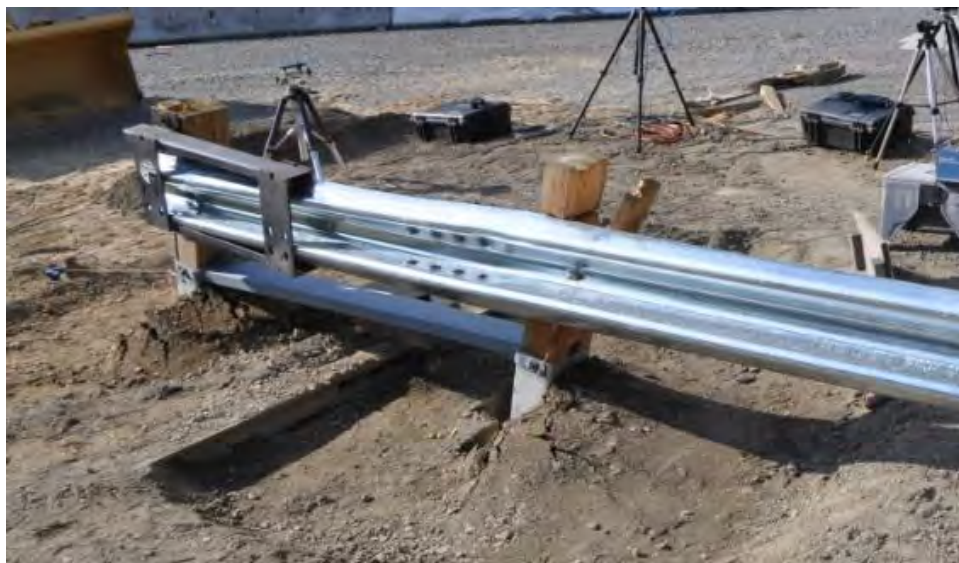
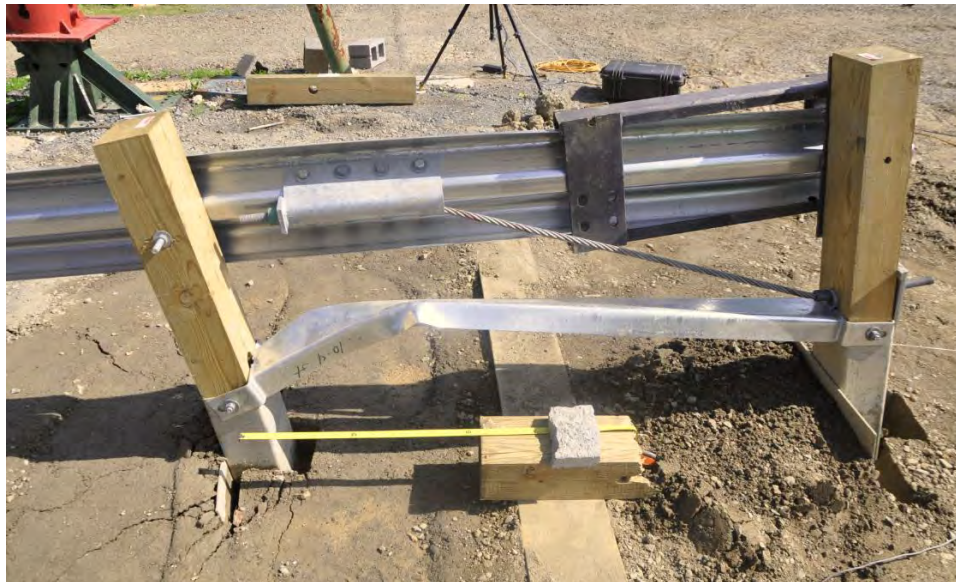
Figure 309. Post-test photo of Test 14001M for 2-inch reduced embedment case.

Figure 310. Post-test photo of Test 14001F for 4-inch reduced embedment case.

Figure 311. Post-test photo of Test 14001L for 6-inch reduced embedment case.

Figure 312. Post-test photo of Test 14001G for 8-inch reduced embedment case.

For cases in which the foundation tube at Post 1 began pulling out of the ground, there was noticeable reduction in stiffness of the system during the extraction process (e.g., refer to Tests 14001M, 14001F, and 14001G). This failure mode was primarily associated with reduced embedment of the foundation tubes. When the foundation tube was fully extracted there was an abrupt loss of the anchor. There was also an abrupt loss of anchor resistance for cases in which the groundline strut buckled. Although there was one case of this failure mode occurring for the reduced embedment cases, it was principally associated with slack in the anchor cable, and generally occurred when *groundline* deflections at Post 1 reached approximately 7-8 inches.

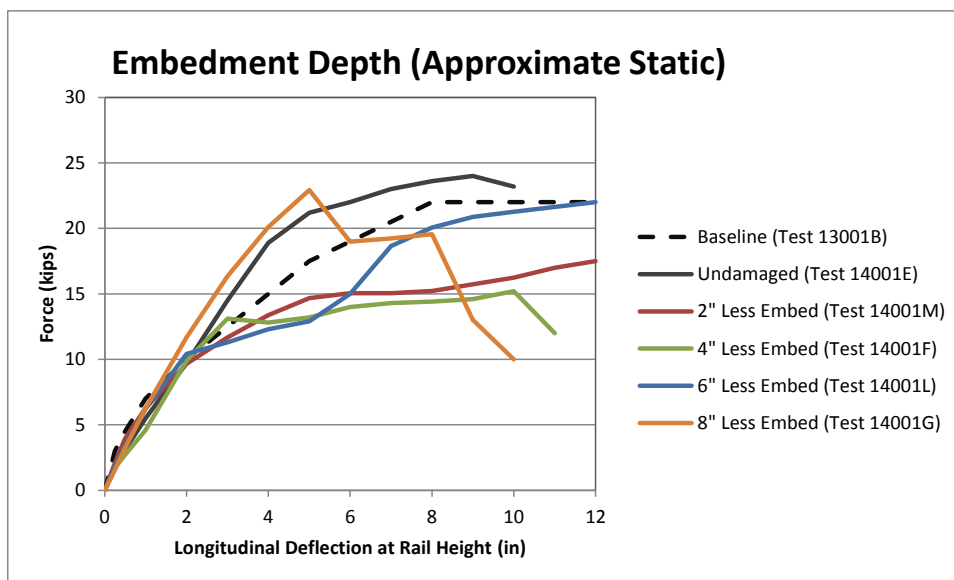
Figure 313. Force vs. deflection response for the standard end-terminal with 0 to 8 inches reduced embedment depth of foundation tubes.

For the case involving 6 inches of reduced embedment of the foundation tubes, the “apparent” initial stiffness of the anchor was 5.2 kips/in for the first 2 inches of displacement measured at the load point. Between 2-4 inches displacement the stiffness dropped to 0.9 kips/in. Between 4-6 inches displacement the stiffness increased to 1.3 kips/in. The maximum load measured during the test was 22.6 kips at 12 inches displacement. Post 2 split at approximately 5.1 inches of rail deflection. The rail then dropped at Post 2. The foundation tube at Post 1 showed no signs of pulling out of the ground for this case. Refer to the test-summary sheets in Appendix Q for more details.

For the case involving 8 inches of reduced embedment of the foundation tubes, the “apparent” initial stiffness of the anchor was 5.8 kips/in for the first 2 inches of displacement measured at the load point. Between 2-4 inches displacement the stiffness was 4.2 kips/in. Between 4-6 inches displacement the stiffness was 2.8 kips/in. The maximum load measured during the test was 23.2 kips at 5.0 inches displacement. The foundation tube at Post 1 began to extract from the ground at approximately 5 inches rail deflection. At approximately 8 inches deflection the groundline strut buckled near Post 2, resulting in a sudden loss of anchor resistance. Refer to the test-summary sheets in Appendix Q for more details.
