Criteria for Restoration of Longitudinal Barriers, Phase II (2021)

Criteria for Restoration of Longitudinal Barriers, Phase II

Contractor's Final Report for NCHRP Project 22-28
Submitted June 2015

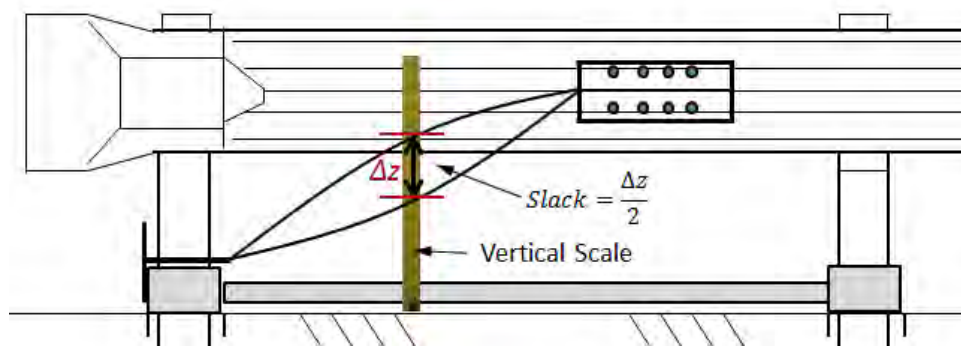
Figure 314. Illustration showing procedure for measuring slack in cable-anchor.

A total of four tests were performed to quantify the effects of slack in the anchor-cable on the force-deflection response of a standard anchor system. These tests included installations with 1, 2, 3 and 4 inches of slack in the anchor cable. The procedure for measuring the amount of slack in the cable involved applying a downward vertical force of 7 lbs. at the center of the cable length and then measuring the vertical distance from the top of the cable to the ground. The cable was then pulled upward with a vertical force of 7 lbs. and again the distance from the top of the cable to the ground was measured. The amount of slack in the cable was then calculated as the difference in these two values divided by 2. In other words, slack was defined as one-half the maximum vertical range of cable's deflection when pushed down then pulled up using a force of 7-lbs, as shown schematically in Figure 314. This definition of slack is consistent with that specified by most manufacturers of proprietary end-terminals. The 7-lb force is representative of the amount of force required when applying reasonable pressure with one's index finger to push down or pull up on the cable. When performing this procedure, care was taken to ensure that all the slack was taken out of the cable by visually confirming that the bearing plate on the front of Post 1 was seated firmly against the post under the applied pressure.

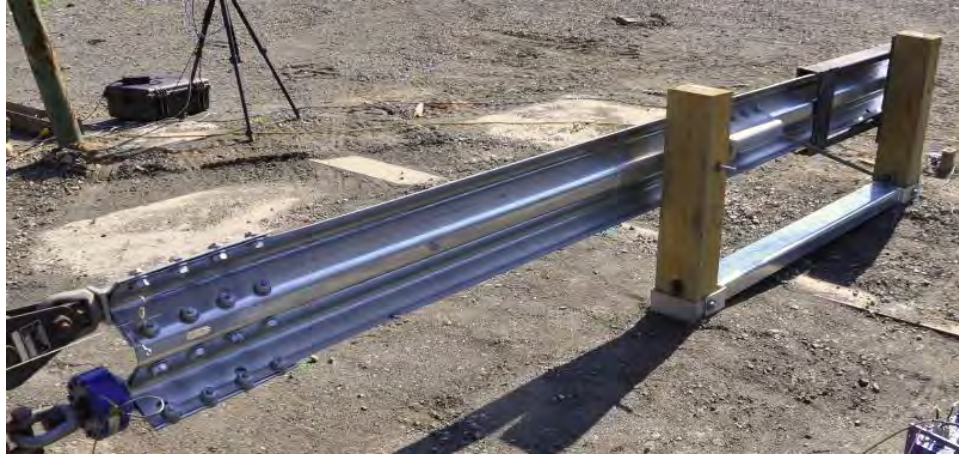
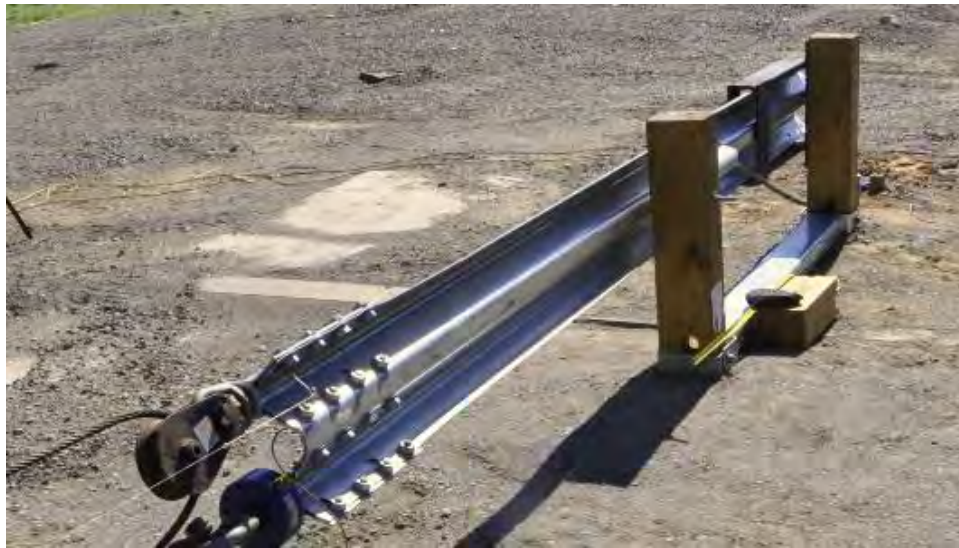
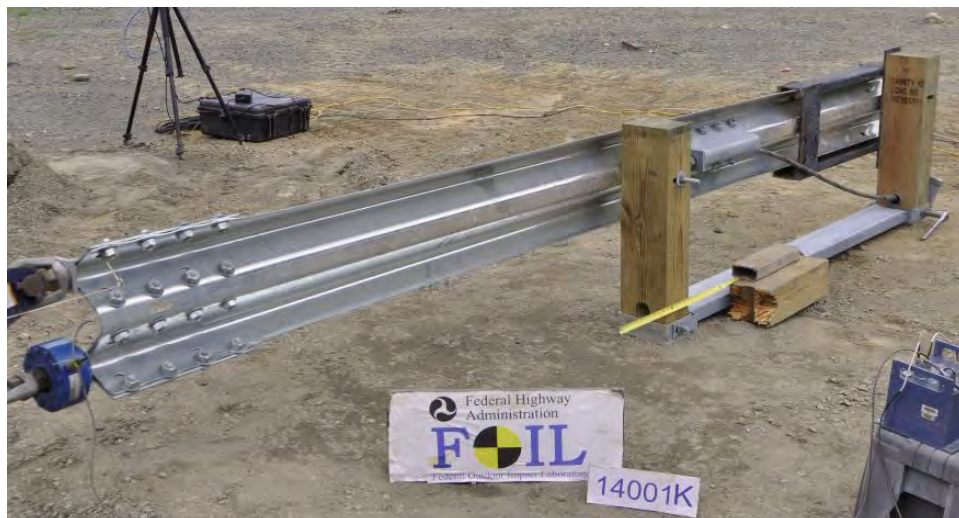
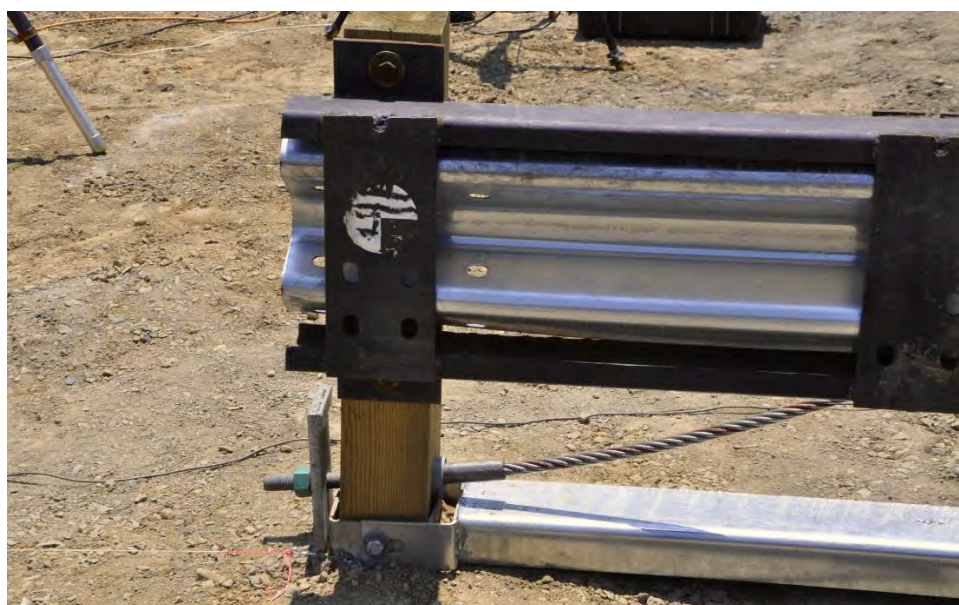
Figure 315. Pre-test photo of Test 14001H for 1" slack-cable case.

Figure 316. Pre-test photo of Test 14001I for 2" slack-cable case.

Figure 317. Pre-test photo of Test 14001K for 3” slack-cable case.

Figure 318. Pre-test photo of Test 4001J for 4” slack-cable case.

Pre-test photos for the four slack-cable cases are shown in Figures 315 through 318, and post-test photos of are shown in Figures 319 through 322. The “approximate static” force-displacement results from the tests are shown in Figure 323, including the undamaged cases. The results show that the initial force-deflection response of the end-terminal was essentially unaffected until the slack in the cable exceeded 2 inches. At 3 inches of slack, there was a significant drop in the force-deflection response, particularly during the first 1-inch of displacement. This was partly due to the fact that Post 2 for that test included a 2.5-inch long slotted post-bolt hole (rather than the 0.625” diameter post-bolt hole for all other tests). The slotted hole effectively delayed the point at which the post-bolt engaged the edge of the hole and began to load the post. The end result was that Post 2 was able to survive significant rail displacement without failure, but also with the effect of slightly reducing the initial stiffness of the anchor system.

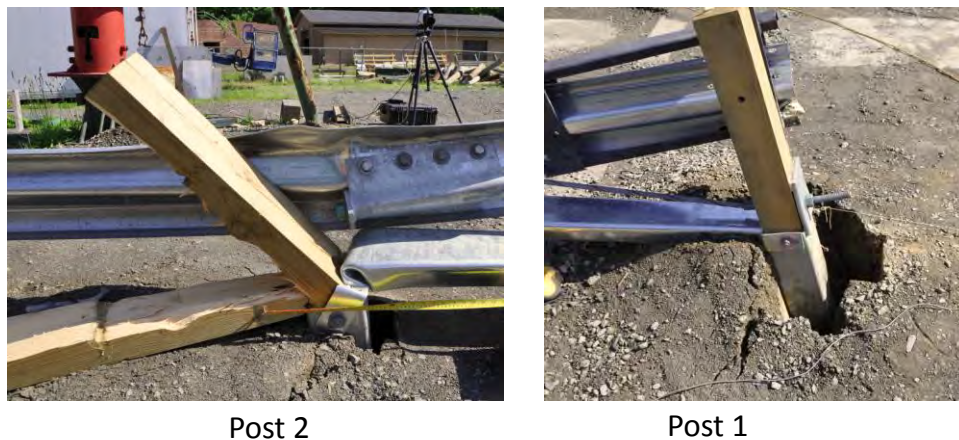
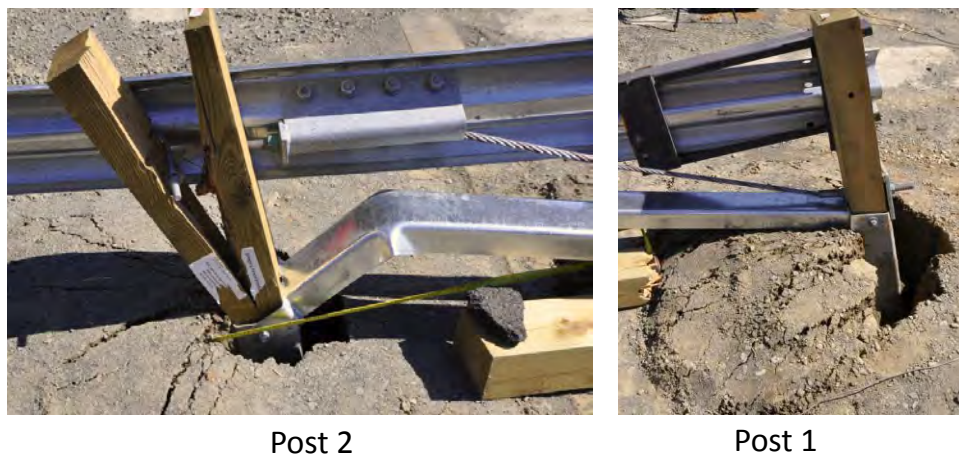
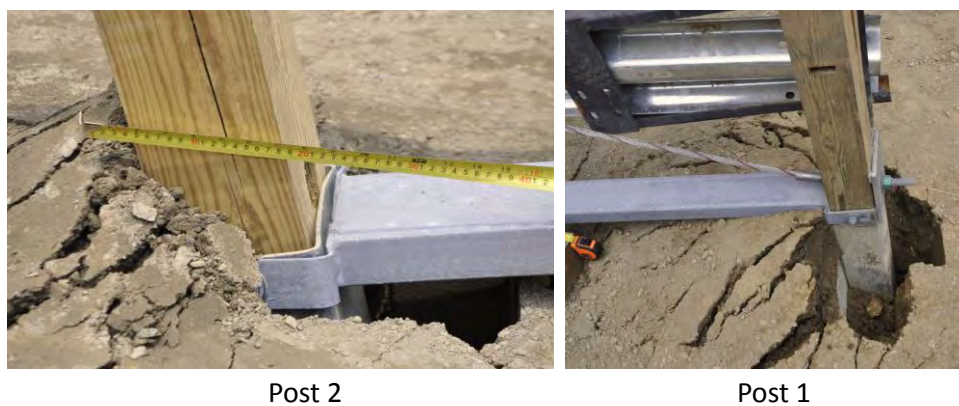
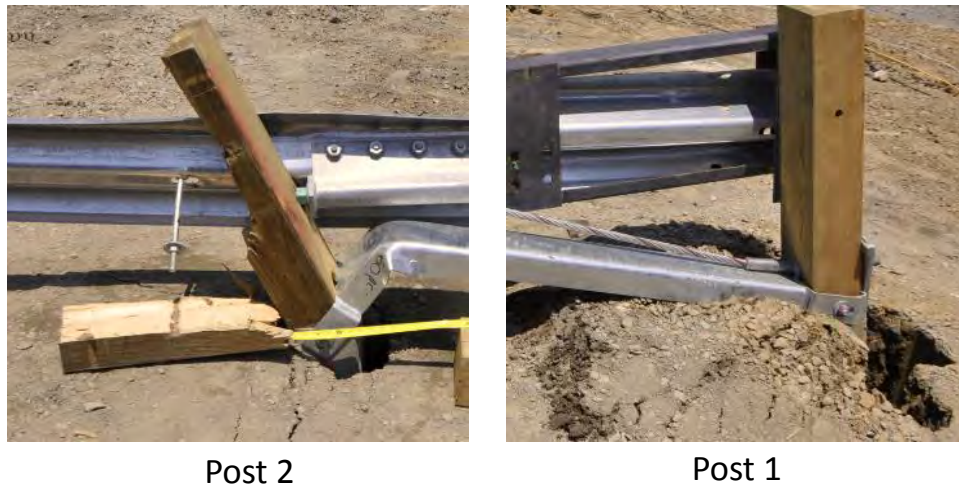
Figure 319. Post-test photos of Test 14001H for 1” slack-cable case.

Figure 320. Post-test photos of Test 14001I for 2” slack-cable case.

Figure 321. Post-test photos of Test 14001K for 3” slack-cable case.

Figure 322. Post-test photos of Test 14001J for 4" slack-cable case.

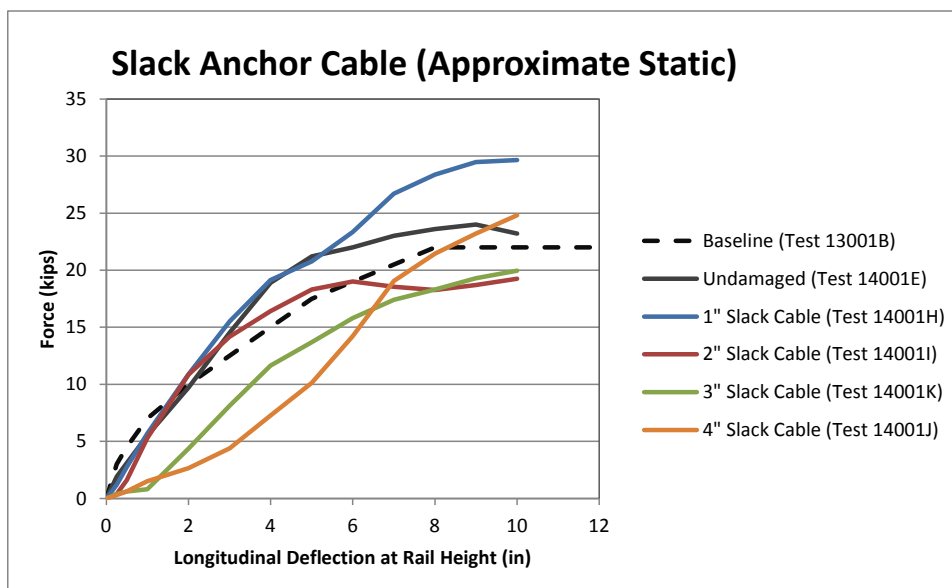
Figure 323. Force vs. deflection response for the standard end-terminal with 0 to 4 inches of slack in the anchor-cable.

For the case involving 3 inches of slack in the cable, the “apparent” initial stiffness of the anchor was 2.2 kips/in for the first 2 inches of displacement measured at the load point, compared to 4.9 kips/in for the undamaged system. Between 2-4 inches displacement the stiffness increased to 3.6 kips/in, compared to 4.5 kips/in for the undamaged system. Between 4-6 inches displacement the stiffness dropped back to 2.1 kips/in, compared to 1.7 kips/in for the undamaged case. The maximum load measured during the test was 22.5 kips at 12 inches displacement. No significant failures occurred during the test. Refer to the test-summary sheets in Appendix Q for more details.

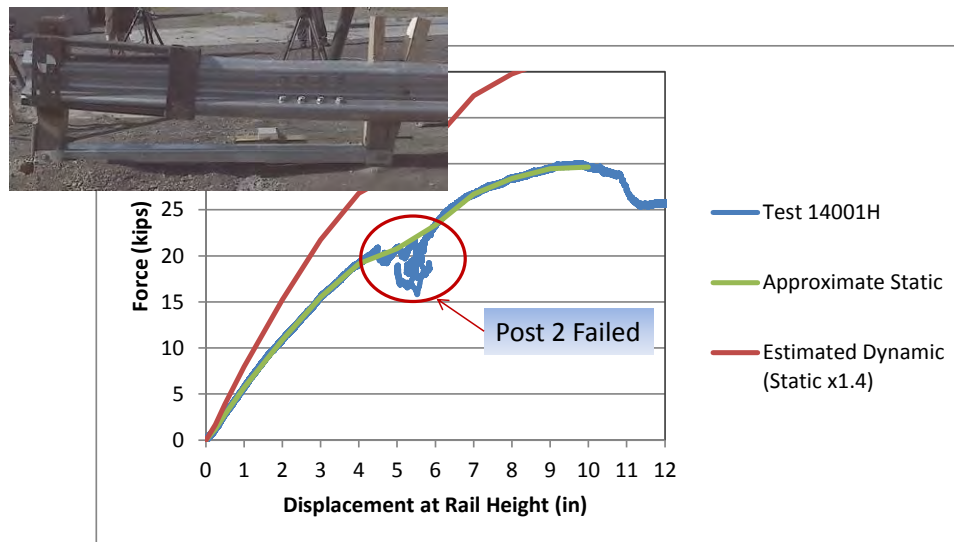
Figure 324. Test 14001H showing continuing effectiveness of anchor after Post 2 fails.

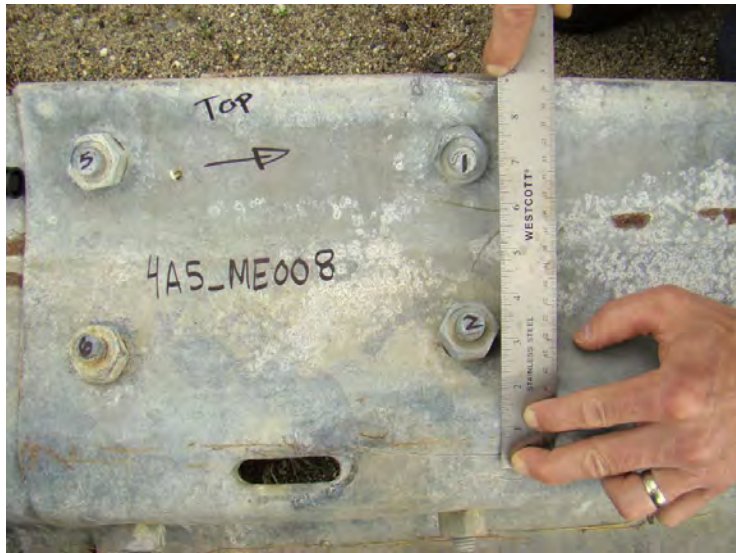
Figure 325. Rail flattening – Rail flattening and rail crush at each quadrant of the splice is measured from the center of the w-beam to the top/bottom edge at the splice bolts.

- a. Downstream, top section – The distance from the center of the w-beam to the top edge was measured from the back-side of the w-beam splice at the downstream splice bolts, as shown in Figure 325.

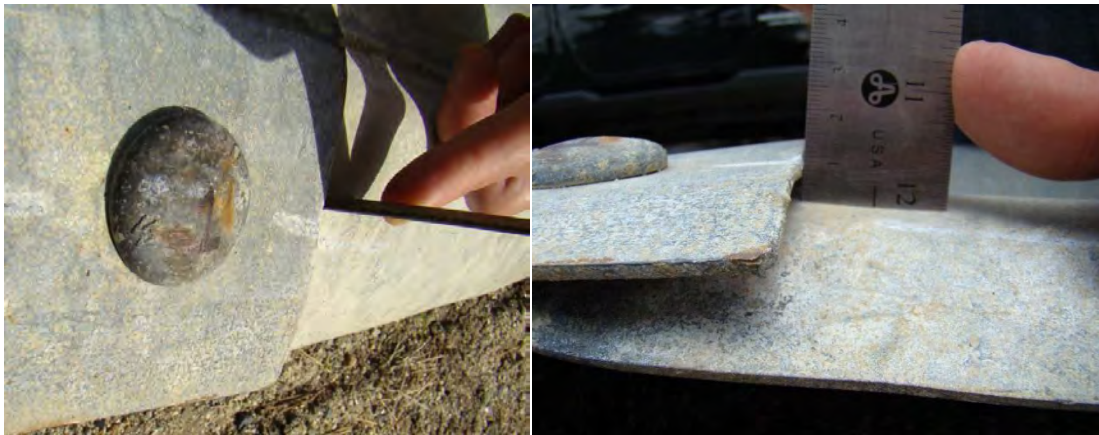
Figure 326. Rail separation - Lateral gap between rail elements at splice connection (measurements taken at locations adjacent to the eight splice bolts).

2. *Rail Separation* – Two types of rail separation were measured:
 - a. The lateral gap opening at the upstream edge of the splice (traffic face of rail) and at the downstream edge of the splice (back face of rail). The measurements were taken at eight points, adjacent to the splice-bolt locations, as illustrated in Figure 326.

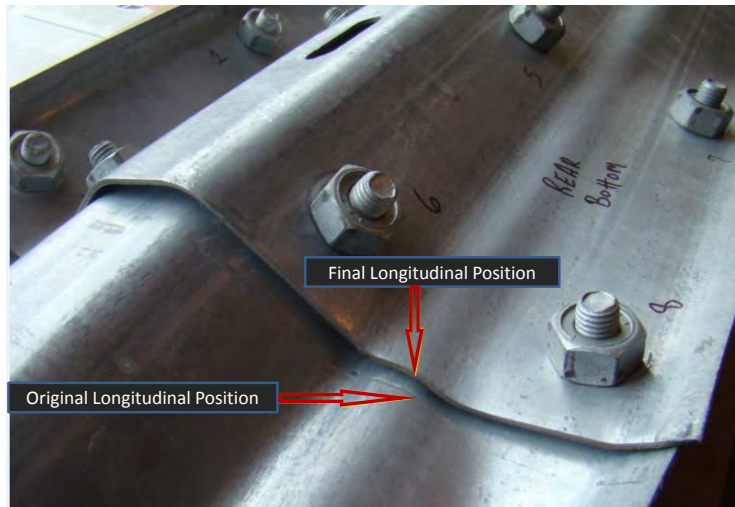
Figure 327. Rail separation – Longitudinal slip in splice connection.

- b. The longitudinal slip in the splice – taken as the distance measured from the original position of the rail (discernible in most cases) to the current position, as illustrated in Figure 327.

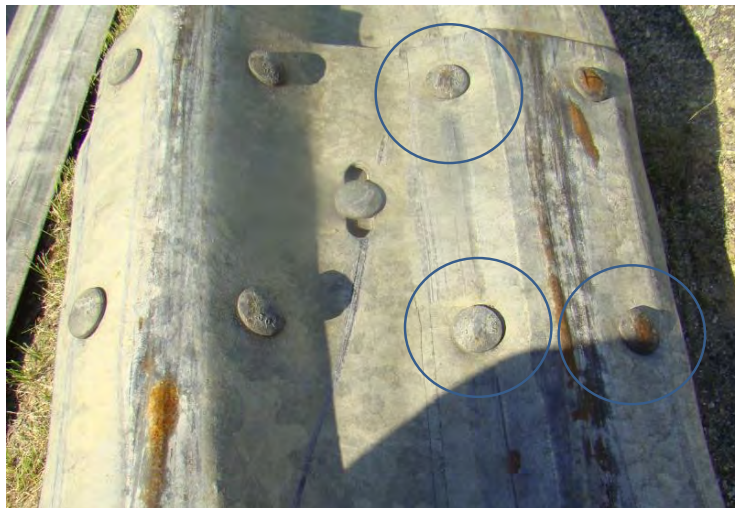
Figure 328. Gouging – Gouging of splice-bolts into w-beam panel is evidenced by rotation of the bolt about the vertical axis.

3. *Condition of Splice Bolts* – The condition for each splice bolt was recorded as missing, loose, gouging, or torn-through. The term gouging refers to the condition of a splice-bolt rotated about the vertical axis of the rail, where the edge of the bolt-head is pressed into the w-beam panel. This damage mode generally results from high tensile load in the rail during a crash event. An example of “light gouging” is shown in Figure 328 evidenced by visible rotation of the splice-bolt.

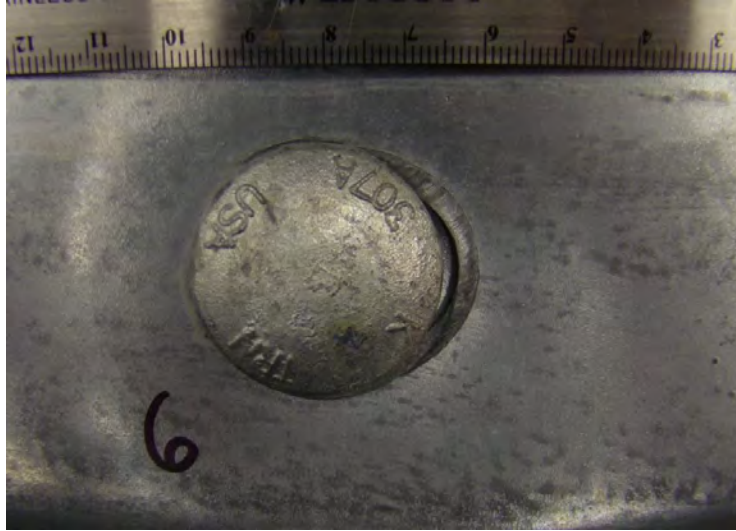
Figure 329. Splice bolt hole stretching – Stretching of the splice bolt hole is evidenced in this photo by the apparent longitudinal movement of the splice bolt relative to its original position.

4. *Condition of Splice Bolt Holes* – Each splice bolt hole was inspected for visible stretching and tearing. Figure 329 shows an example of a splice bolt hole with evident stretching (resulting from high tension loading in the rail during crash) which was measured by taking the longitudinal distance from the edge of the splice bolt to its apparent original position. In some cases the only visual cue to indicate that a bolt hole is “stretched” is when the edge of the bolt hole is visible beside the bolt head.

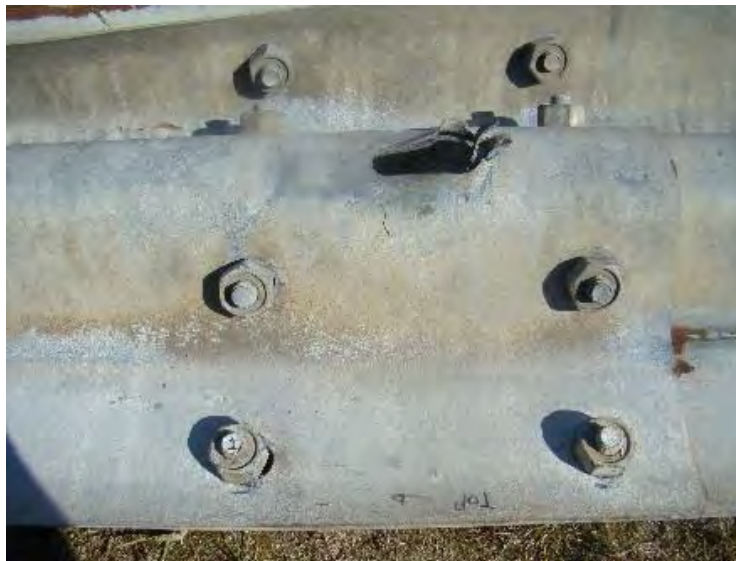
Figure 330. Horizontal tear in post bolt hole – This photo shows evidence of both stretching and a horizontal tear in the post bolt hole.

5. *Condition of Post Bolt Holes* – Each post bolt hole was inspected for visible damages which included (listed in order of increasing severity) stretching, horizontal tears, and vertical tears. Figure 330 shows an example of a splice bolt hole with evident stretching and a horizontal tear. In this case, the worse condition was recorded, which was the horizontal tear.

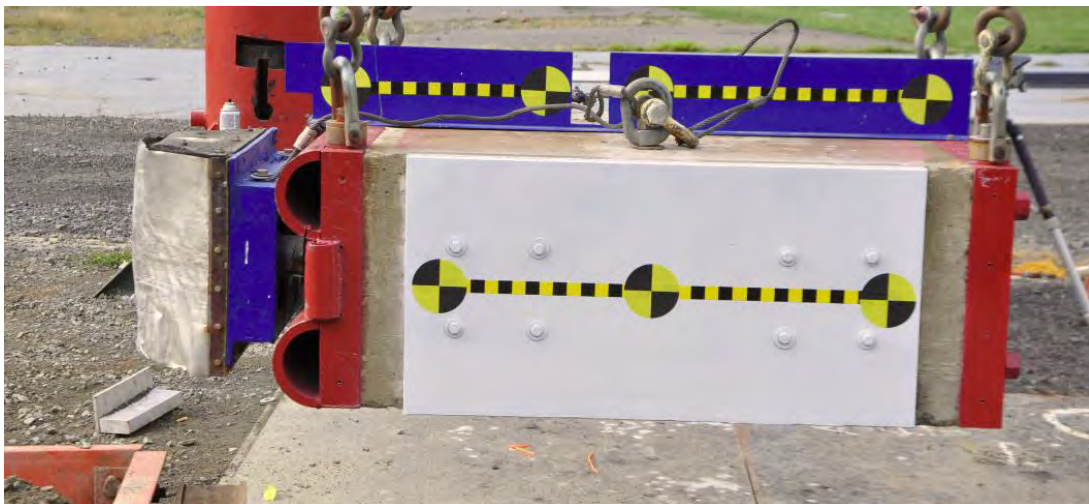
Figure 332. 4,360-lb pendulum device with semi-rigid nose.

The striker used in the tests was a 4,360-lb concrete pendulum with a semi-rigid nose, which is shown in Figure 332. The semi-rigid nose was developed by researchers from Virginia Tech during the first phase of this study and was fabricated from a wooden block and covered with sheet metal.[Gabler10] The radius of chamfer at the center of the impactor face was 6 inches, which was based on measurements of a 2006 Chevrolet 1500 pickup truck. [Gabler10]

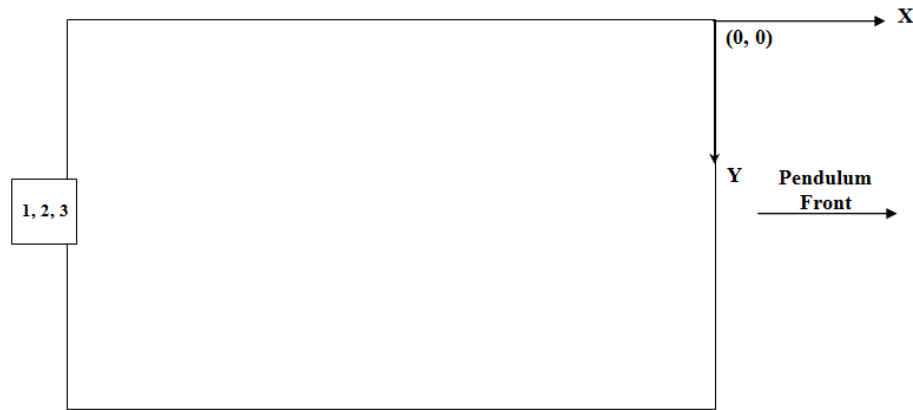
Pendulum top view with accelerometer blocks

CH.	LOCATION	X (cm) Guardrail	Y (cm) Center Pend. Nose	Z (cm) From ground	SERIAL NO.	AXIS
1	Rear Center of Pend.	-43.0	127.0	71.0	D12063	-X
2	Rear Center of Pend.	-43.0	127.0	71.0	D12130	-Z
3	Rear Center of Pend.	-43.0	127.0	71.0	D12899	-X

Figure 333. Schematic of the accelerometer instrumentation for the pendulum tests.

The pendulum was instrumented with three accelerometers mounted onto the backside of the pendulum mass. Accelerometers 1 and 3 recorded data in the x-direction (forward direction) and Accelerometer 2 recorded data in the z-direction (vertical direction). Figure 333 provides a schematic showing the locations of the accelerometers.

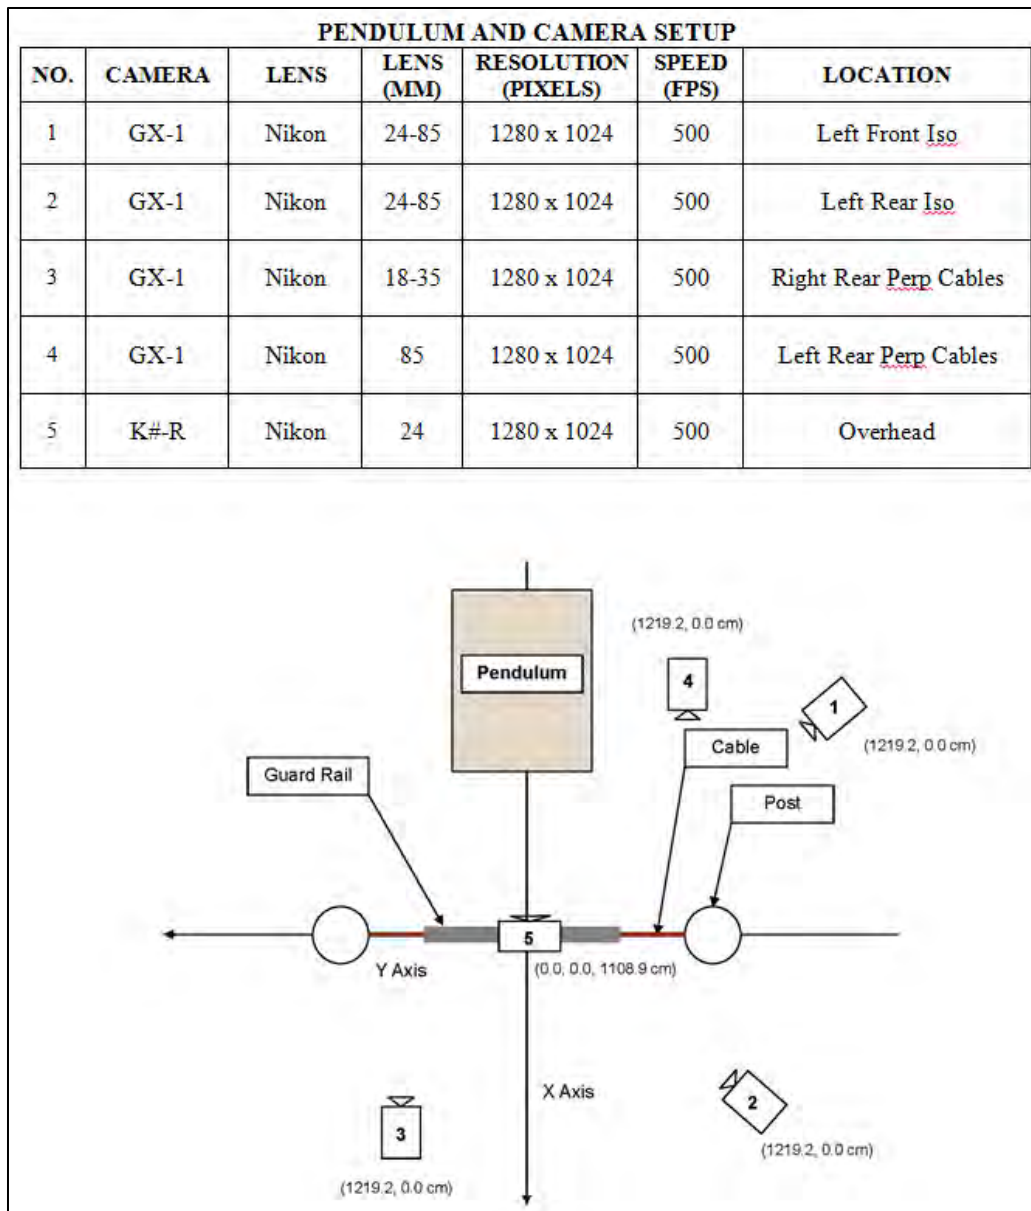
Figure 334. High-speed camera specifications and placement.

The tests were also recorded using five high-speed cameras with an operating speed of 500 frames per second and two digital video cameras (~60 fps). Figure 334 provides the specifications and the general placement of the high-speed cameras for the tests. The accelerometers and the high-speed video were triggered upon impact using pressure tape switches when the pendulum contacted the post. The test setup and results were also documented with pre- and post-test photographs.

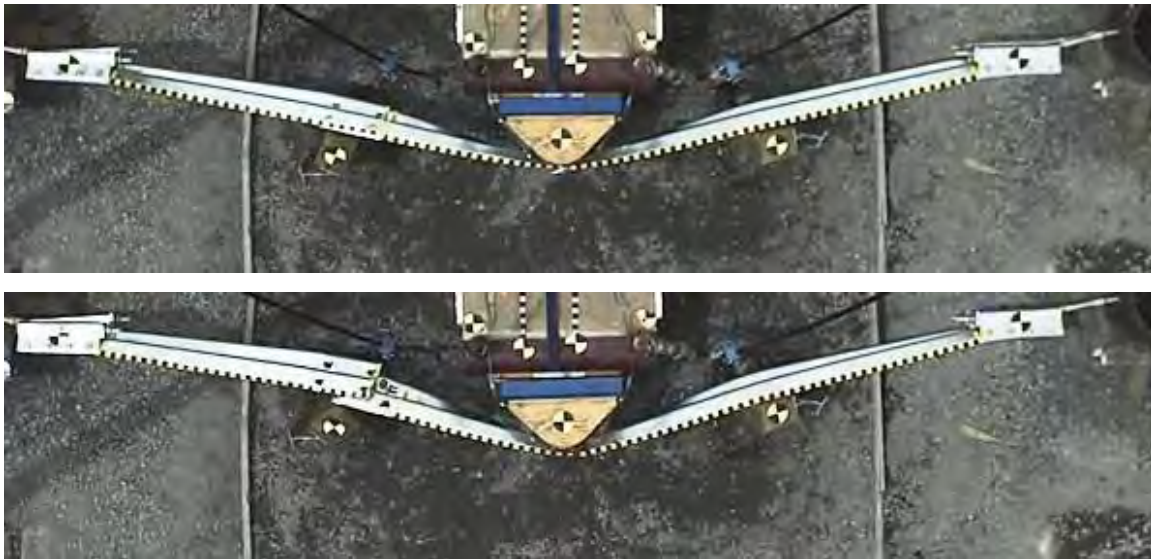
Figure 335. Sequential views of a pendulum test performed in Gabler's study.

The original plan was to use the same test setup that Gabler *et al* used for testing the damaged splice in Phase I.[*Gabler10*] After critical review of the test videos from Gabler's study, it was determined that the test setup tended to result in a tensile rupture of the splice, which is not generally the mode of failure mode witnessed in full-scale tests. Because of the short length of rail and the "rigid" constraint on the boundaries in Gabler's study, the rail developed very high tensile forces at relatively low rail deflections. Figure 335 shows sequential views extracted from the high-speed video in one of Gabler's tests. The upper image shows the test article immediately before splice rupture and the lower image is the test article shortly after rupture.

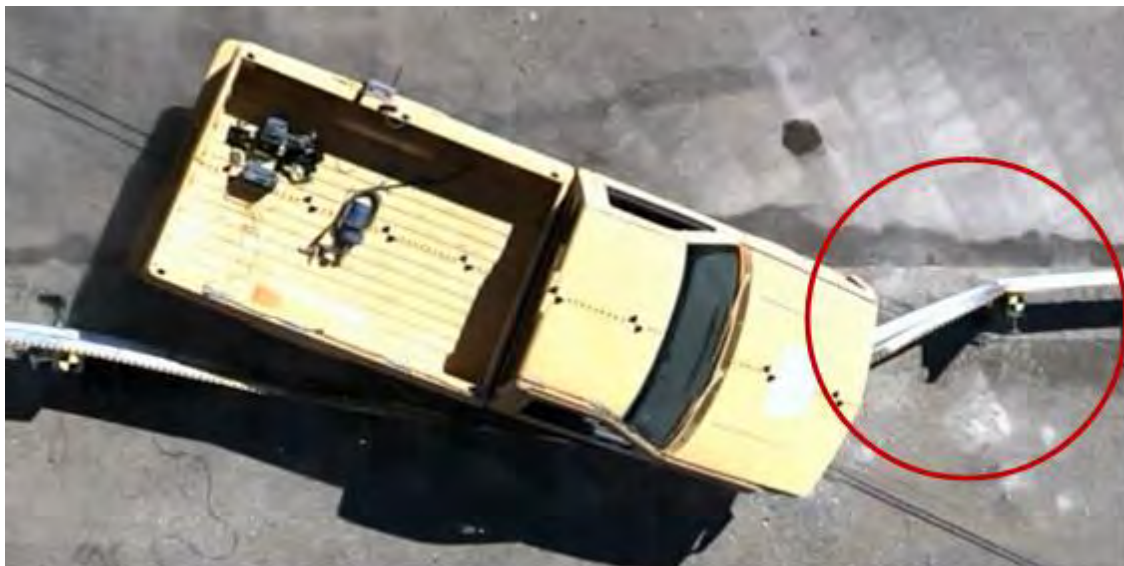
Figure 336. Pocketing during full-scale crash test C08C3-27.2.[Fleck08b]

Unfortunately, the length of rail could not be extended beyond these limits due to the limited space at the test site. One alternative would be to design the boundary conditions to mimic the longitudinal and lateral stiffness behavior of an extended guardrail, but such an effort was beyond the scope of this study. It was therefore decided to modify the test setup such that the rail would bend at the post (typical of a normal pocket that develops in a crash event), as illustrated in Figure 336.

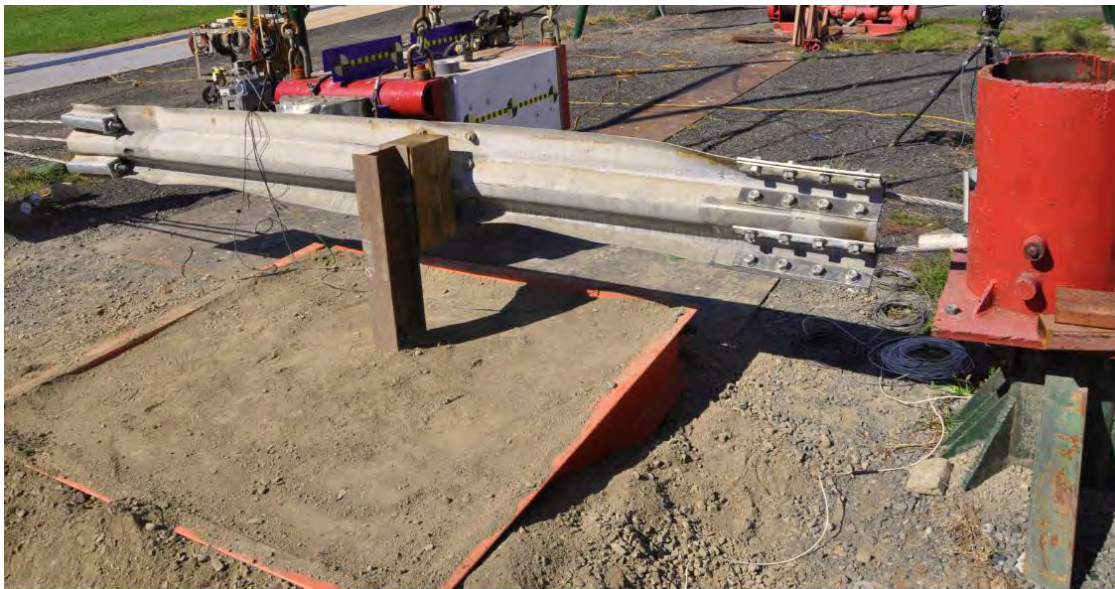
Figure 337. Test set-up for Test Series 14004.

The test set up is shown in Figure 337. The test article was a 13-ft long section of w-beam rail with a w-beam splice located at 65 inches from the downstream end. Each end of the rail was constrained from longitudinal displacement using two 0.75-inch diameter cables (i.e., AASHTO-AGC-ARTBA FCA01) fastened onto the ends of the rail. On the downstream end, the cables were fastened to two standard cable anchor brackets (i.e., AASHTO-AGC-ARTBA

The test setup involved a single W6x16 structural steel post with wood blackout installed downstream of the impact location at the splice connection. There was no post installed upstream of the impact point in order to permit the maximum amount of deflection prior to developing full tension in the rail. The rigid W6x16 post was used to limit the amount of deflection of the post and force the bending mode of the splice around the post. The post was 72 inches long and was embedded 44 inches in the soil. The 6x8x12 inch routed wood blackout was used to separate the w-beam rail from the post, and a standard 10-inch long 5/8-inch diameter bolt and nut (i.e., AASHTO-AGC-ARTBA FBB03) was used to fasten the rail to the blackout and post. The post-bolt was positioned at the downstream end of the slotted hole in the w-beam to emulate the typical position of the bolt resulting from an impact upstream of the splice, as shown in Figure 340. The rail height was 28 inches measured from the ground to the top of the rail.

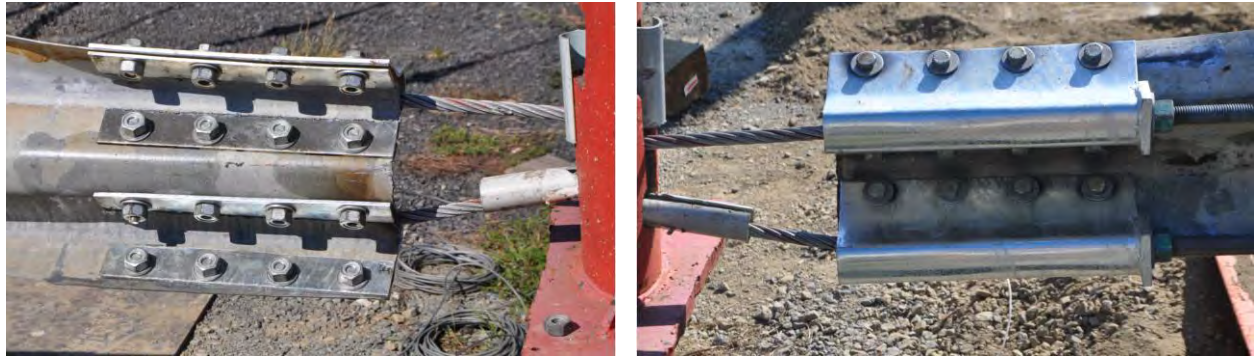
Figure 338. Anchoring of the downstream end of the rail for Test Series 14004.

FPA01). Each bracket was bolted onto the rail using eight ½-inch bolts and nuts with 1-1/16 inch diameter washers under the bolt heads and two 2.5 x 15 x ¼-inch steel bearing plates under the nuts, as shown in Figure 338. On the upstream end, the cables were fastened to the rail by welding three modified anchor cable brackets directly to the end of the w-beam, as shown in Figure 339. The two legs of each of the cable anchor brackets were removed and a continuous weld along the top and bottom side of each bracket was used to fasten the bracket to the rail.

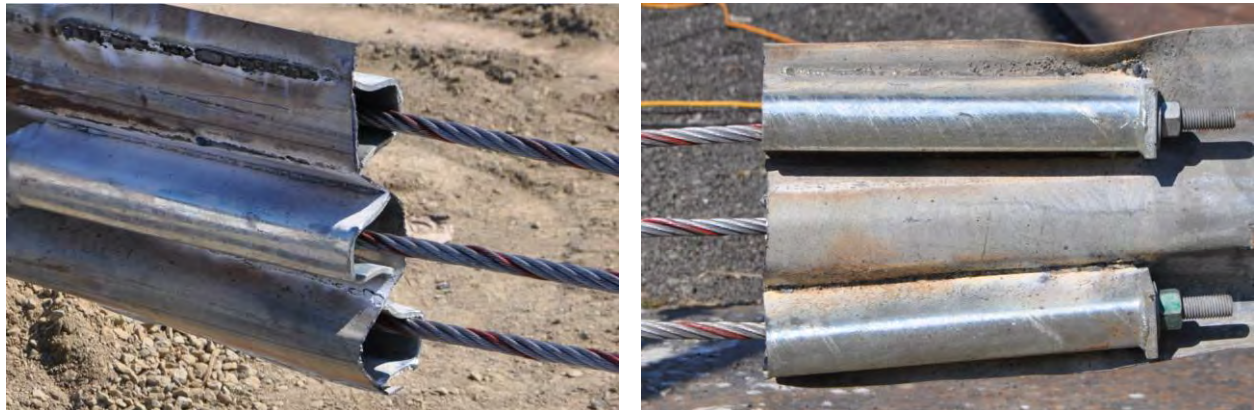
Figure 339. Anchoring of the upstream end of the rail for Test Series 14004.

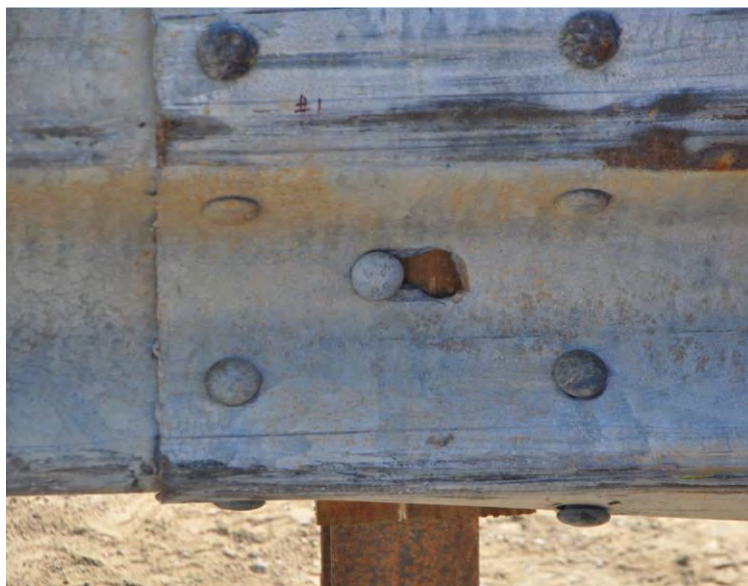
Figure 340. Typical mounting position for post-bolt was on the downstream side of the slotted hole on the rail.

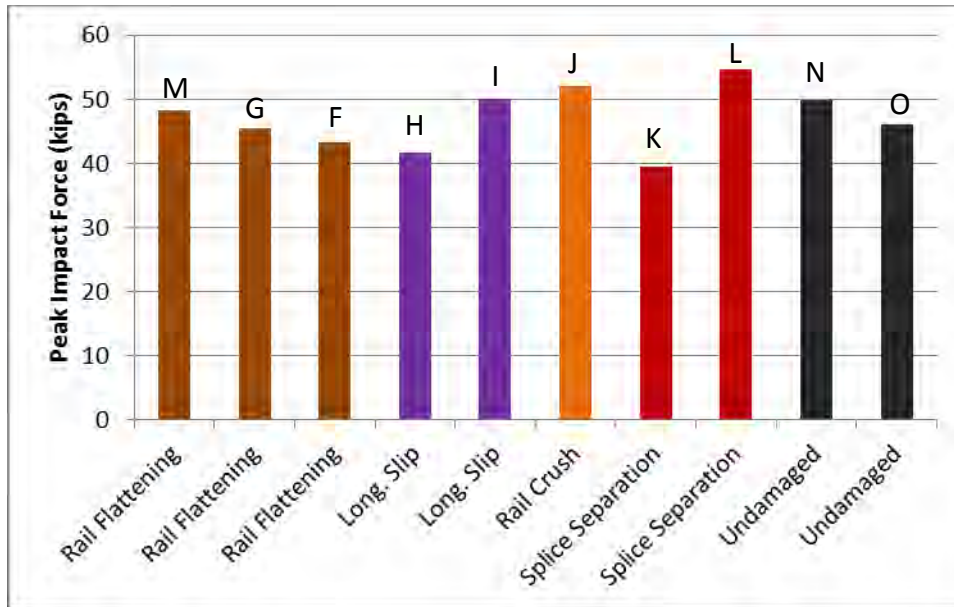
Figure 341. Peak impact force for each damage mode case investigated in test series 14004F-O.

A summary of the test results for Test Series 14004 are shown in Table 87, including damage mode case, damage level, impact velocity, failure mode, peak force during the impact, and the maximum energy absorbed by the guardrail system up to the point of rail rupture. The resulting peak impact force and peak energy for each case is also shown graphically in Figures 341 and 342. The impact force and energy vs. rail deflection for the various damage mode cases is compared to the results for the undamaged rail in Figures 343 through 346. Sequential views of the tests are shown in Figures 347 through 351. The individual test-summary sheets are included in Appendix S.

The force, energy and displacement values were back-calculated using the accelerometer data from the impacting mass, and thus relate indirectly to the lateral motion of the rail at the point of impact. The force values reported herein should not be interpreted as tensile forces in the splice. Also, the reported energy values are a function of deformations within the overall guardrail test section, which include not only the deformations of the rail and splice, but also the energy dissipated through deformations of the post and soil.

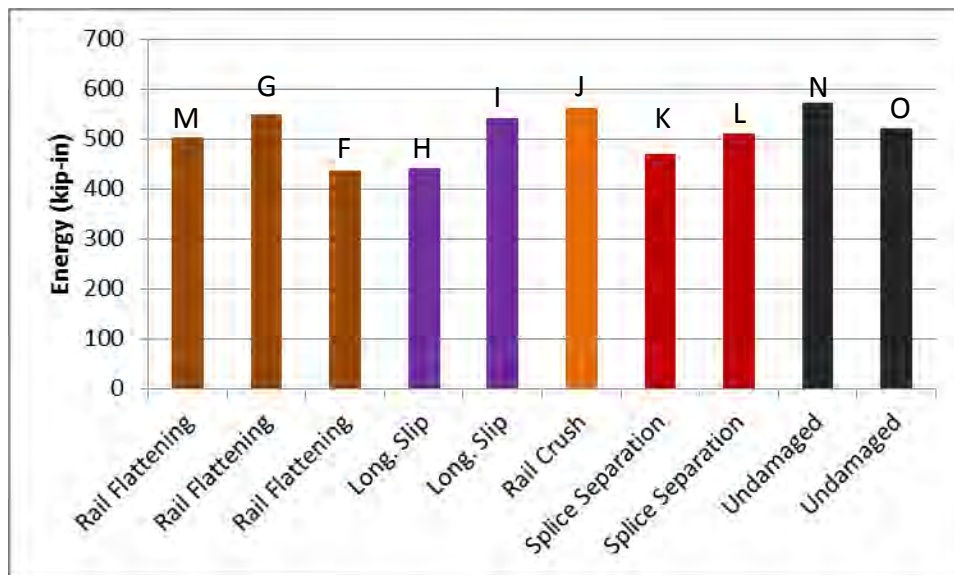
Figure 342. Peak impact energy for each damage mode case investigated in test series 14004F-O.

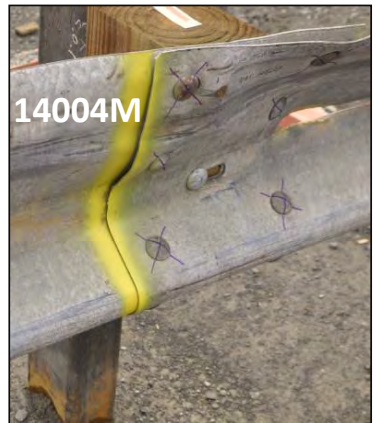
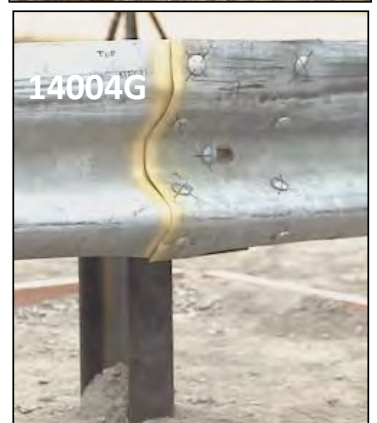
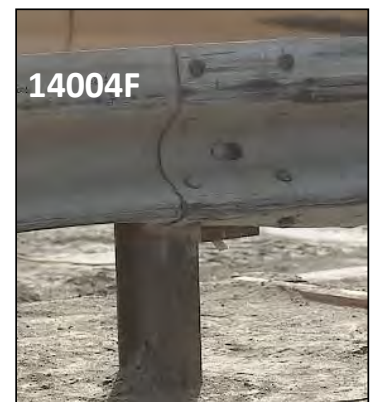
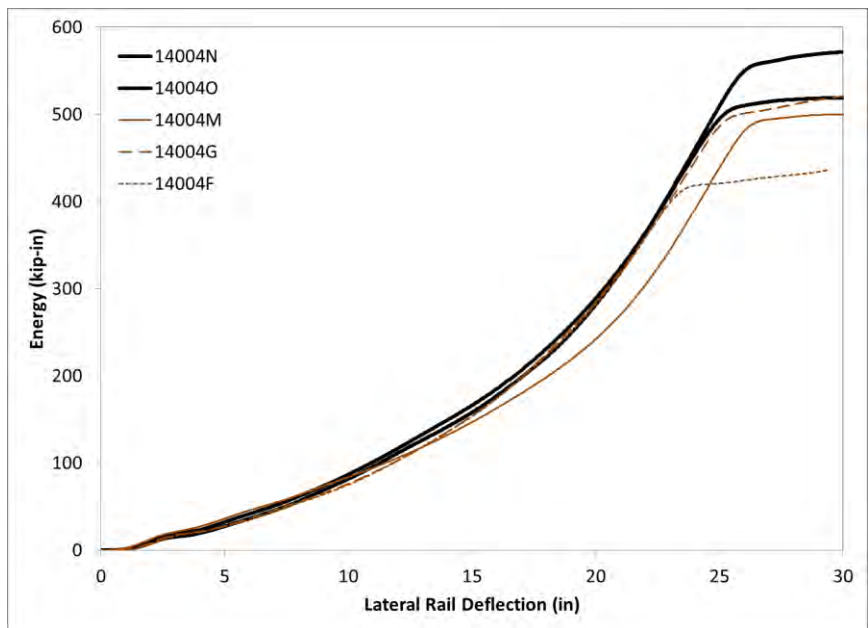
Figure 343. (a) Force vs. Deflection and (b) Energy vs. Deflection curves for damaged splices with flattened cross-section compared to undamaged cases.

section of the rail splice. The force and energy curves shown in Figure 343 indicate that this test article resulted in essentially the same capacity as the undamaged test article in Test 14004O. Test 14004M had the highest degree of rail flattening (i.e., 94%) but resulted in no reduction in load capacity and negligible reduction in energy capacity compared to the undamaged cases. Test 14004F, on the other hand, had only 68% flattening but resulted in a 6 percent decrease in load capacity and a 16 percent decrease in energy capacity. Test articles 14004M and 14004F both had the same amount of longitudinal slip in the splice (i.e., 0.2 inches); but 14004F, which resulted in the highest capacity, had greater lateral separation between the rail elements (i.e., 0.35 inches vs. 0.13 inches). The most notable outlier in Test 14004M was the fact that three of the splice-bolts were loose. It is possible that the loose bolts caused higher forces at one or more of the neighboring splice bolt connections which lead to the premature rupture of the splice. Recall that 14004F was the only test article that failed by tearing the rail through the cross-section, with the tear passing through all the downstream splice bolt holes, as shown in Figure 353.

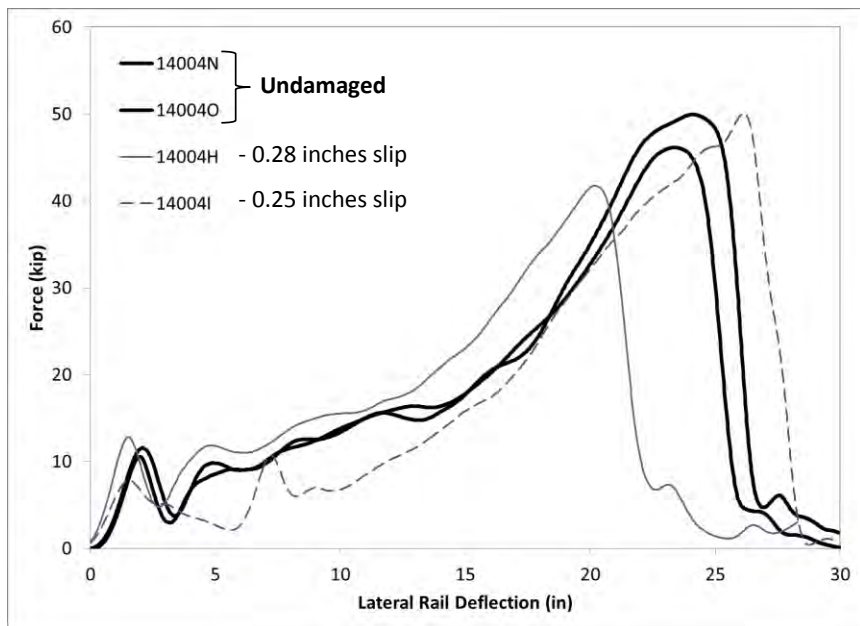
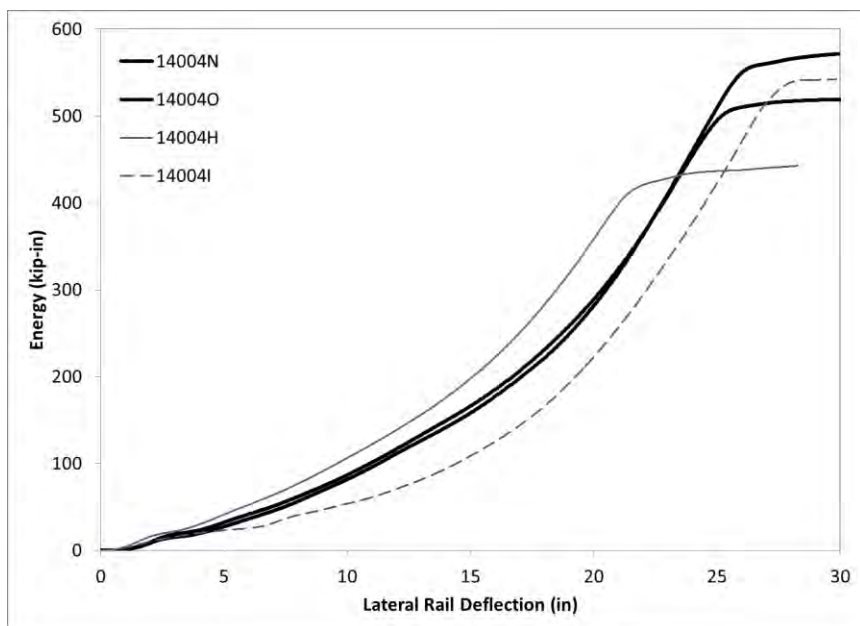
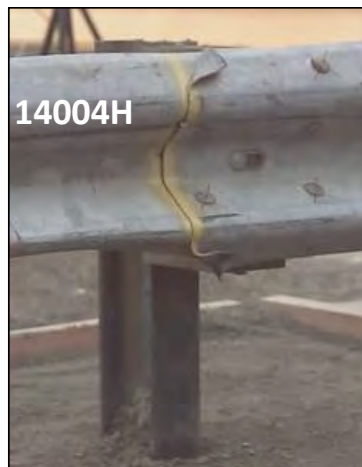
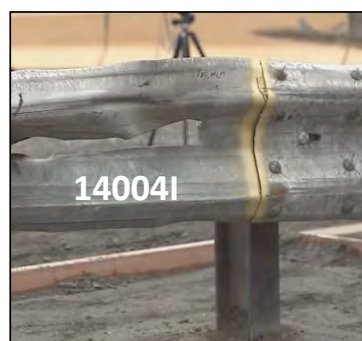
Figure 344. (a) Force vs. Deflection and (b) Energy vs. Deflection curves for damaged splices with longitudinal slip compared to undamaged cases.

The test articles for Tests 14004H and 14004I included the highest levels of lateral separation between rail elements at the downstream edge of the splice connection. The results from these tests yielded mixed results regarding the effects of longitudinal slip on the capacity of the splice, as shown in Table 87 and Figure 344. Test 14004H which had 0.28 inches of longitudinal slip in the splice resulted in 9.5 percent decrease in load capacity and 15 percent decrease in energy capacity. This test specimen also included a 25 percent flattened rail and one loose splice-bolt. Test 14004I, which included 0.25 inches of longitudinal slip, showed no decrease in capacity. This test article also included a 68 percent flattened rail, 0.25 inches of lateral separation between the two rails at the downstream edge of the splice and a large

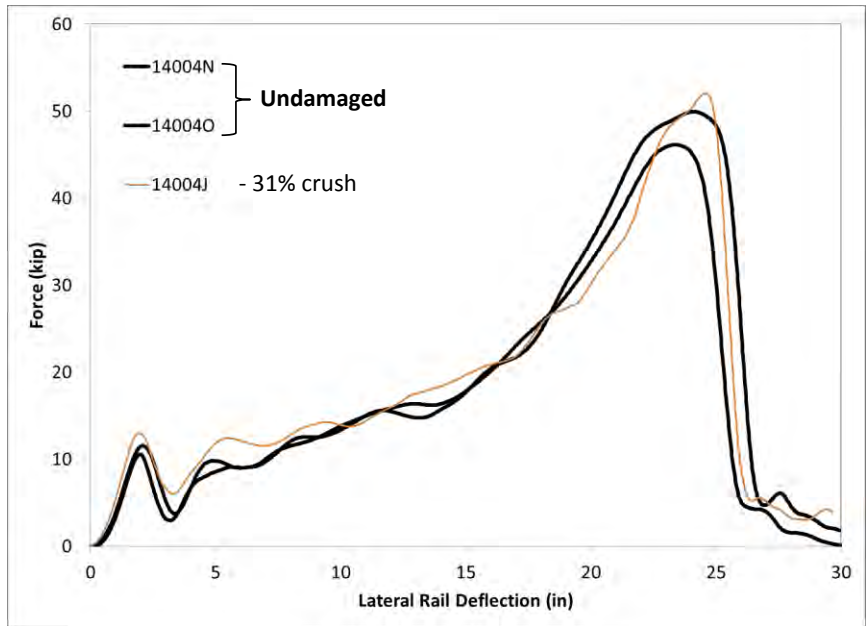
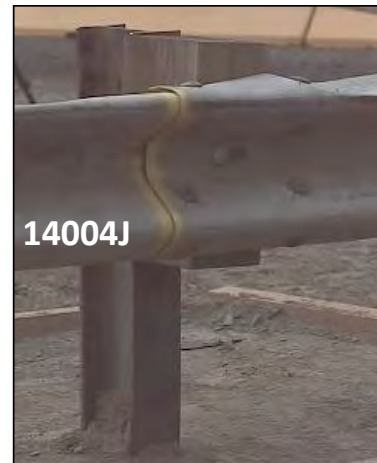
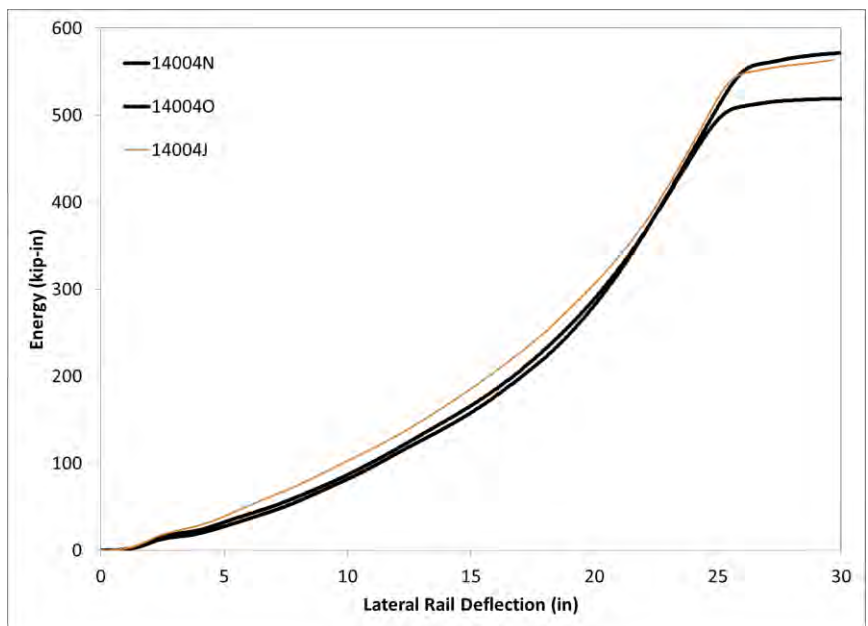
Figure 345. (a) Force vs. Deflection and (b) Energy vs. Deflection curves for damaged splice with vertical crush compared to undamaged cases.

There was only one test specimen available that had significant vertical crush of the splice. The damages for Test Article 14004J included 31 percent rail crush and 0.25 inches of lateral separation of the two rail sections at the downstream edge of the splice. The results from the test showed slightly higher load capacity for this damage mode than either of the undamaged cases, as shown in Table 87 and Figure 345. Although there was only a single test conducted for this damage mode, it was concluded that rail crush does not adversely affect rail capacity.
