Criteria for Restoration of Longitudinal Barriers, Phase II (2021)

Criteria for Restoration of Longitudinal Barriers, Phase II

Contractor's Final Report for NCHRP Project 22-28
Submitted June 2015

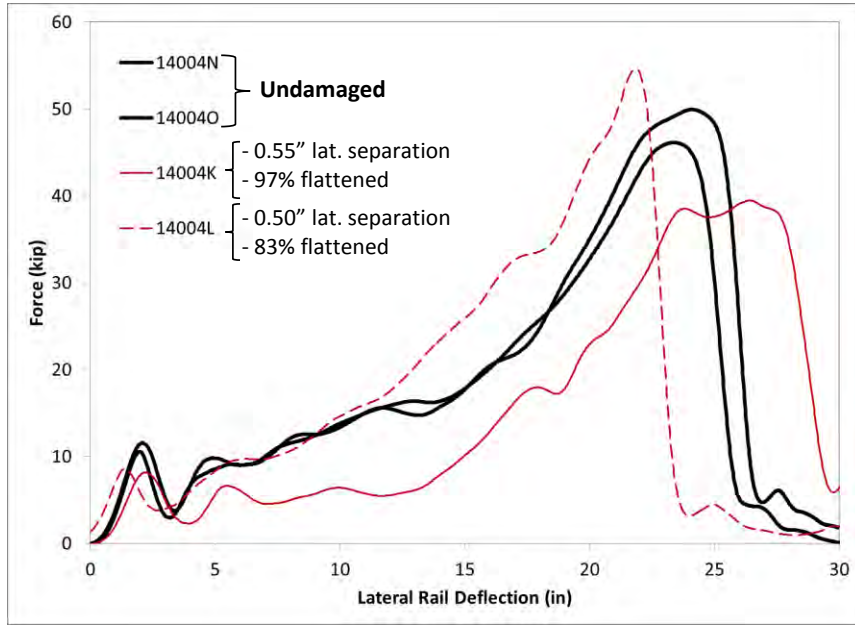
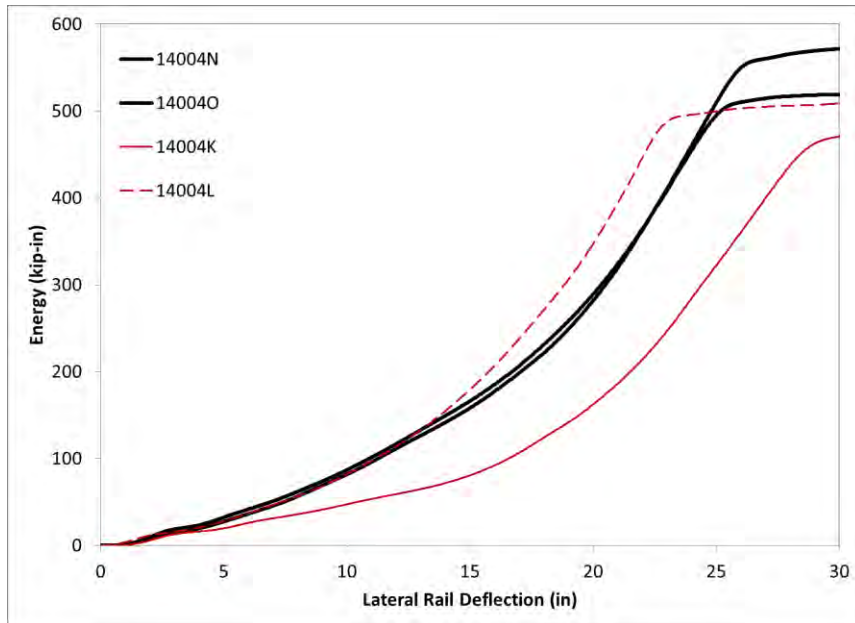
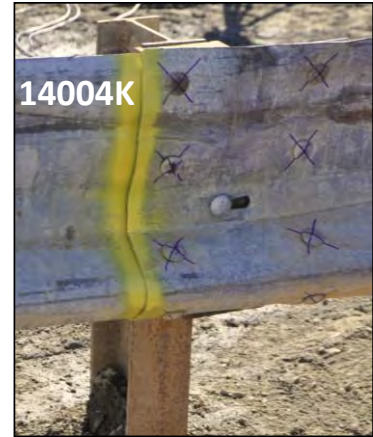
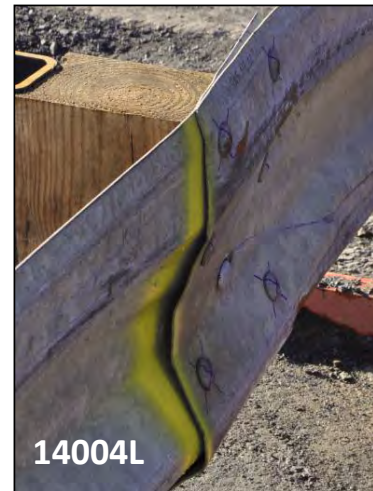
Figure 346. (a) Force vs. Deflection and (b) Energy vs. Deflection curves for damaged splice with combination of lateral rail separation and flattened rail compared to undamaged cases.

The results from these two tests were inconclusive. Test 14004L resulted in little or no decrease in capacity. Test 14004K, on the other hand, resulted in a 14 percent decrease in load capacity and a 4 percent decrease in energy capacity (refer to Table 87 and Figure 346). It was apparent, however, from the sudden drop in force shown in Figure 346 that the splice failed at approximately 30 inches of lateral rail displacement, which corresponded to approximately 470 kip-in of energy absorbed by the rail system (i.e., 10% less energy than the undamaged case). The additional energy absorbed in Test 14004K after splice rupture was due to the post-bolt tearing through the w-beam, based on review of the high-speed test video. It should be noted that the Test Article 14004K did include additional damage modes, but the level of damage was considered low to moderate for those cases. In fact the damages of Test Article 14004K are very similar to those of Test Article 14004M, with the exception of the lateral separation of the rails at the splice; but the results of Test 14004M showed no reduction of splice capacity for that case.

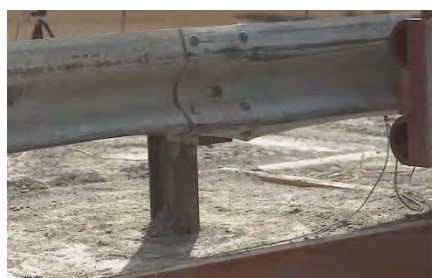
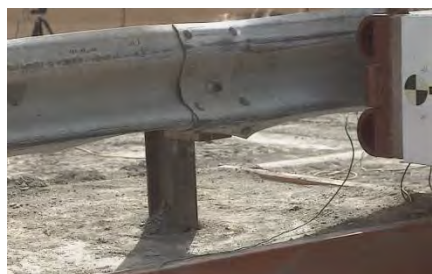
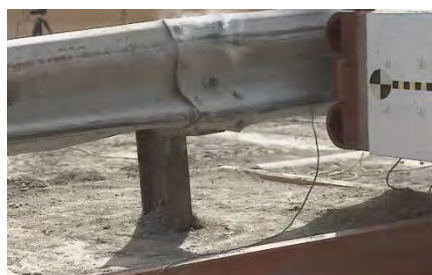
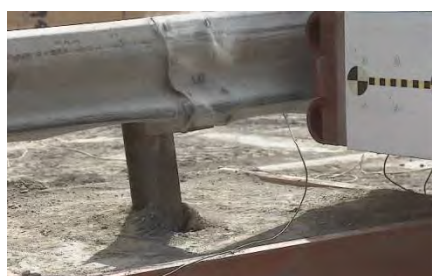
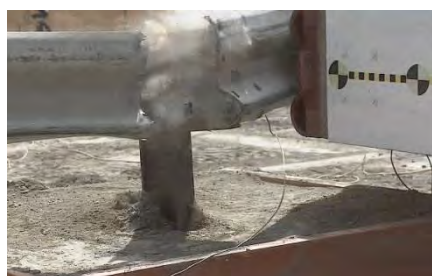
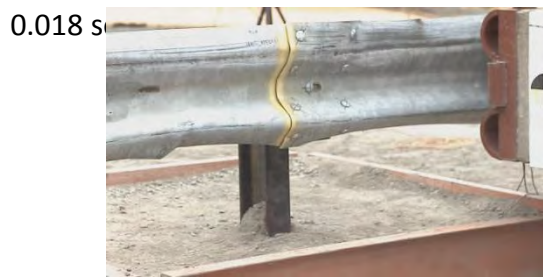
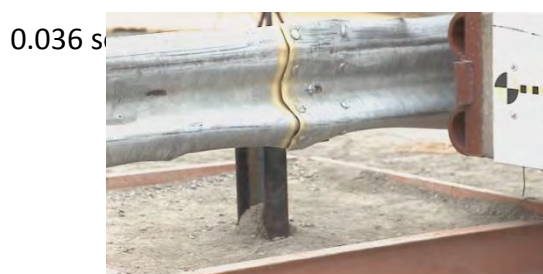
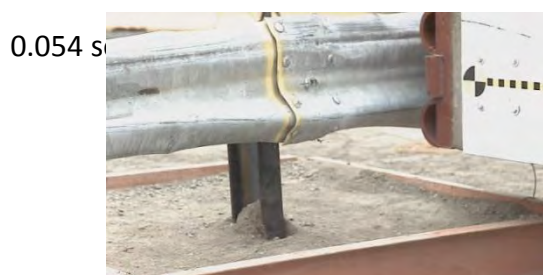
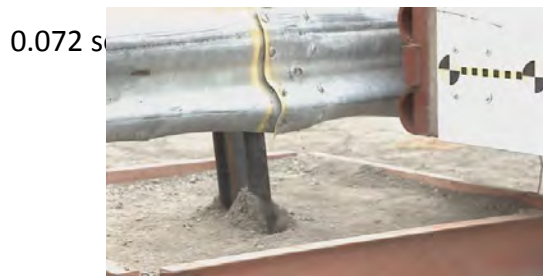
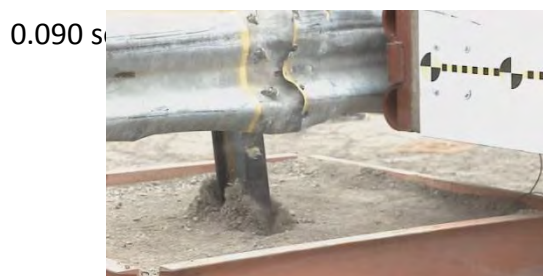
Figure 347. Sequential views of Tests 14004F and 14004G.

Test 14004F

Test 14004G

A summary of the test results for Test Series 14004 are shown in Table 87, including damage mode case, damage level, impact velocity, failure mode, peak force during the impact, and the maximum energy absorbed by the guardrail system up to the point of rail rupture. The resulting peak impact force and peak energy for each case is also shown graphically in Figures 341 and 342. The impact force and energy vs. rail deflection for the various damage mode cases is compared to the results for the undamaged rail in Figures 343 through 346. Sequential views of the tests are shown in Figures 347 through 351. The individual test-summary sheets are included in Appendix S.

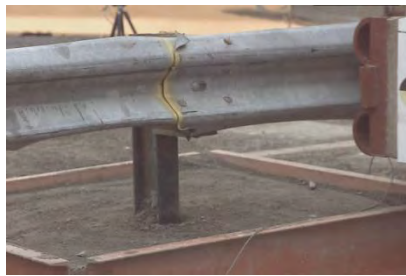
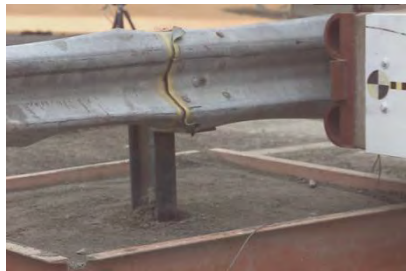
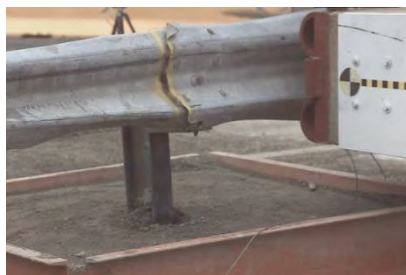
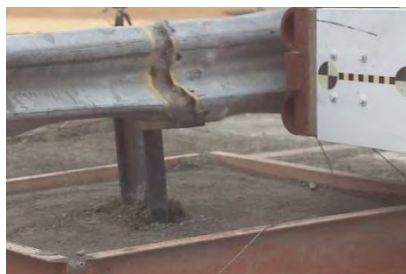
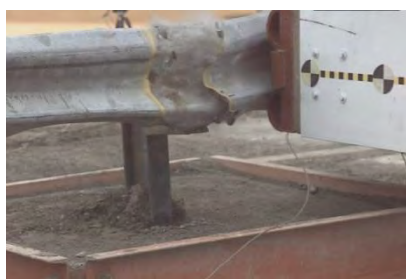
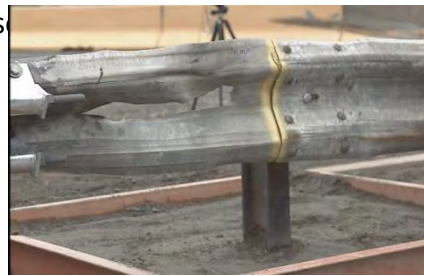
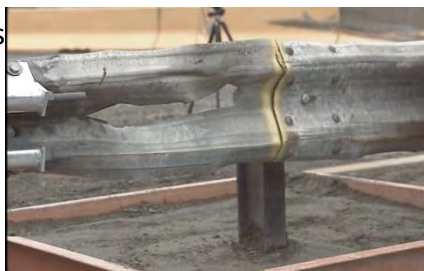
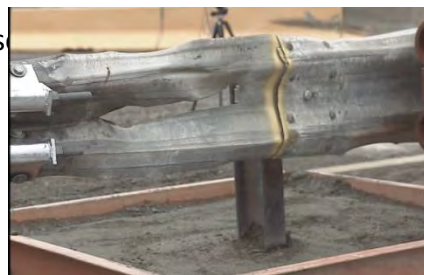
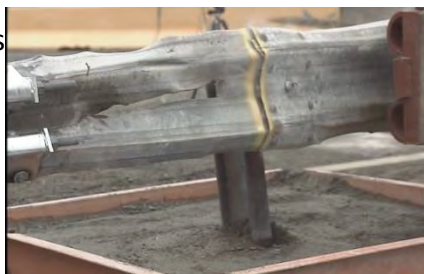
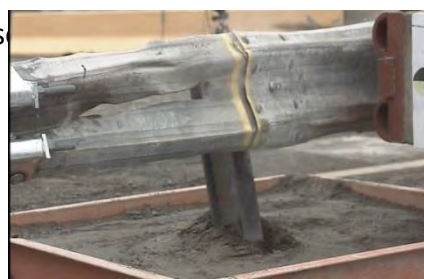
Figure 348. Sequential views of Tests 14004H and 14004I.

Test 14004H

Test 14004I
(rail tear at left boundary)

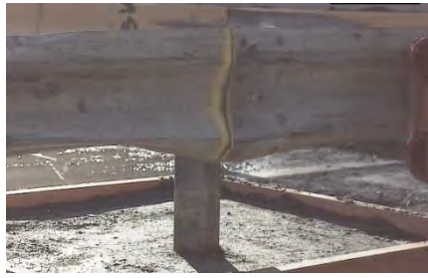
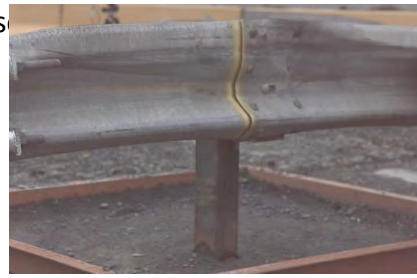
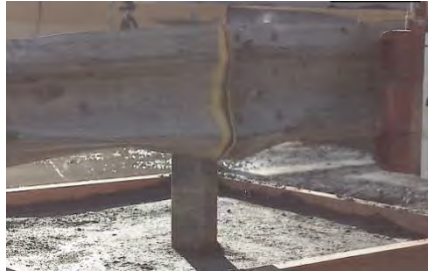
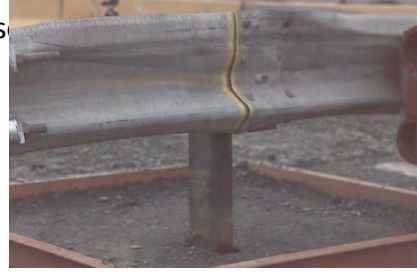
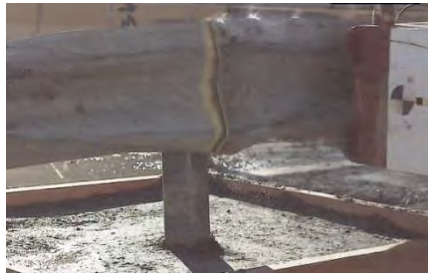
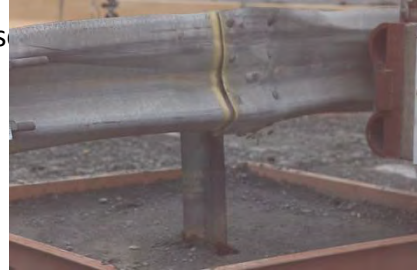
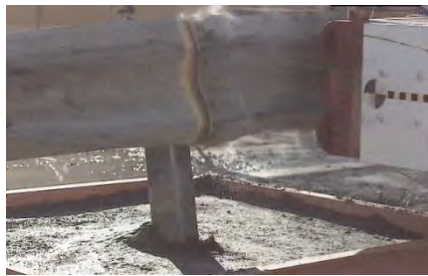
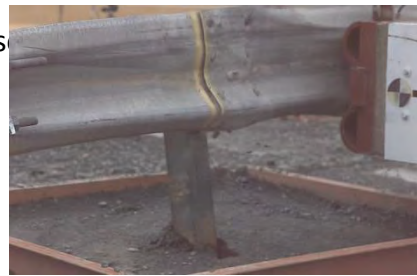
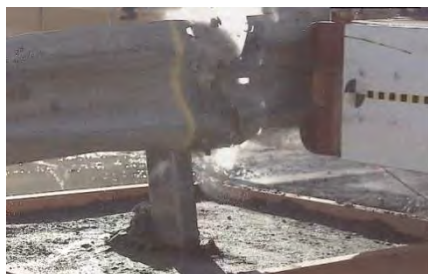
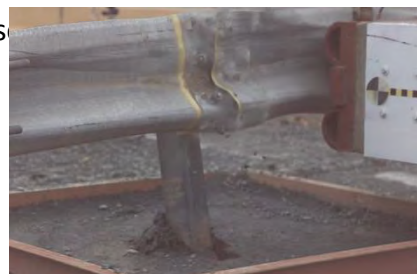
Figure 349. Sequential views of Tests 14004J and 14004K.

Test 14004J
(cable rupture at left
boundary)

Test 14004K

There was only one test specimen available that had significant vertical crush of the splice. The damages for Test Article 14004J included 31 percent rail crush and 0.25 inches of lateral separation of the two rail sections at the downstream edge of the splice. The results from the test showed slightly higher load capacity for this damage mode than either of the undamaged cases, as shown in Table 87 and Figure 345. Although there was only a single test conducted for this damage mode, it was concluded that rail crush does not adversely affect rail capacity.

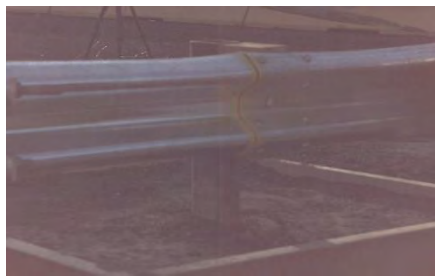
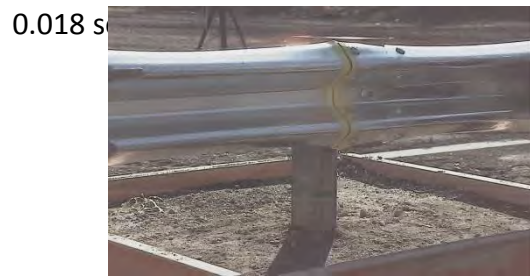
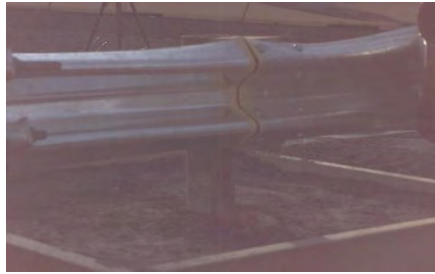
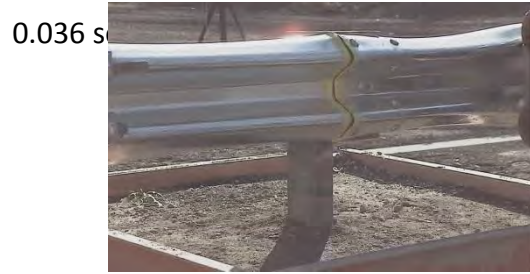
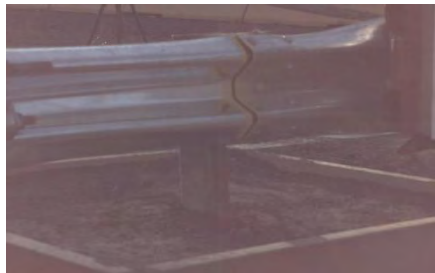
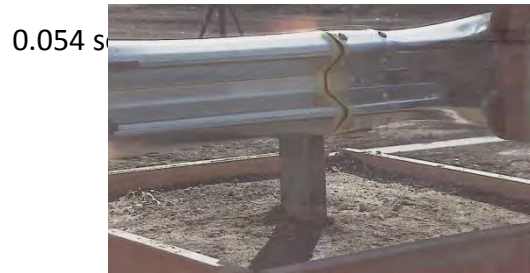
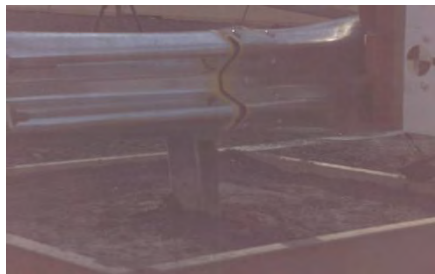
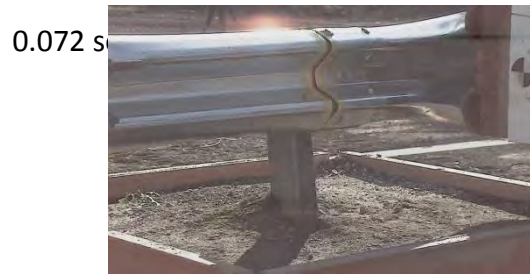
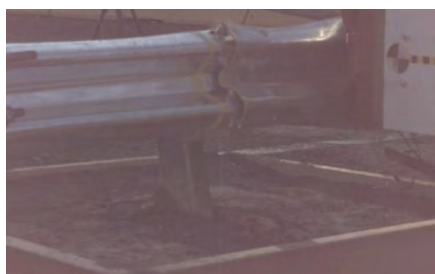
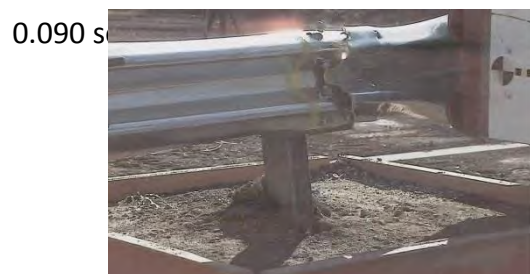
Figure 350. Sequential views of Tests 14004L and 14004M.

Test 14004L

Test 14004M

section of the rail splice. The force and energy curves shown in Figure 343 indicate that this test article resulted in essentially the same capacity as the undamaged test article in Test 14004O. Test 14004M had the highest degree of rail flattening (i.e., 94%) but resulted in no reduction in load capacity and negligible reduction in energy capacity compared to the undamaged cases. Test 14004F, on the other hand, had only 68% flattening but resulted in a 6 percent decrease in load capacity and a 16 percent decrease in energy capacity. Test articles 14004M and 14004F both had the same amount of longitudinal slip in the splice (i.e., 0.2 inches); but 14004F, which resulted in the highest capacity, had greater lateral separation between the rail elements (i.e., 0.35 inches vs. 0.13 inches). The most notable outlier in Test 14004M was the fact that three of the splice-bolts were loose. It is possible that the loose bolts caused higher forces at one or more of the neighboring splice bolt connections which lead to the premature rupture of the splice. Recall that 14004F was the only test article that failed by tearing the rail through the cross-section, with the tear passing through all the downstream splice bolt holes, as shown in Figure 353.

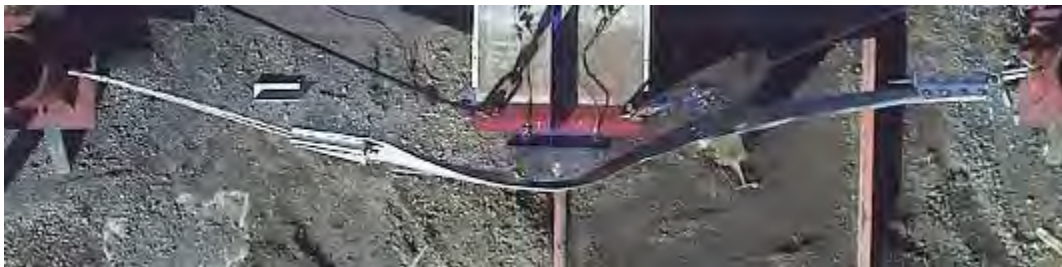
Figure 352. Overhead view of Test 14004K from high-speed video camera.

The pendulum tests performed in this study were designed to create “pocketing” of the rail immediately upstream of a splice connection at the guardrail post in an attempt to emulate typical real-world conditions that lead to splice ruptures. Unfortunately, the tests were not able to accurately duplicate these conditions. Figure 352 shows an overhead view from Test 14004K demonstrating the typical pocketing behavior that occurred in the tests. The image was taken from one of the high-speed cameras at 0.002 seconds before rupture. The degree of pocketing was moderate and may have been sufficient for this study had the tension in the rail not developed so abruptly and so severely. Only one test (i.e., Test 14004F) resulted in rail rupture due to tearing the rail through its cross-section. In all other tests the rupture was due to the splice-bolts tearing through the splice-bolts holes or due to boundary failure.

This was basically the same issue that Gabler faced in Phase I, i.e., having a relatively short length of rail with a fixed longitudinal constraint at each end.[*Gabler10*] As a result very high tensile forces developed in the rail at relatively low rail deflections during the impact tests. As discussed earlier, the test setup did not permit a longer length of rail because of the limited space within the pendulum test area. So, future pendulum impact studies on rail splices should consider designing boundary conditions to more accurately emulate the longitudinal and lateral stiffness behavior of an extended guardrail.

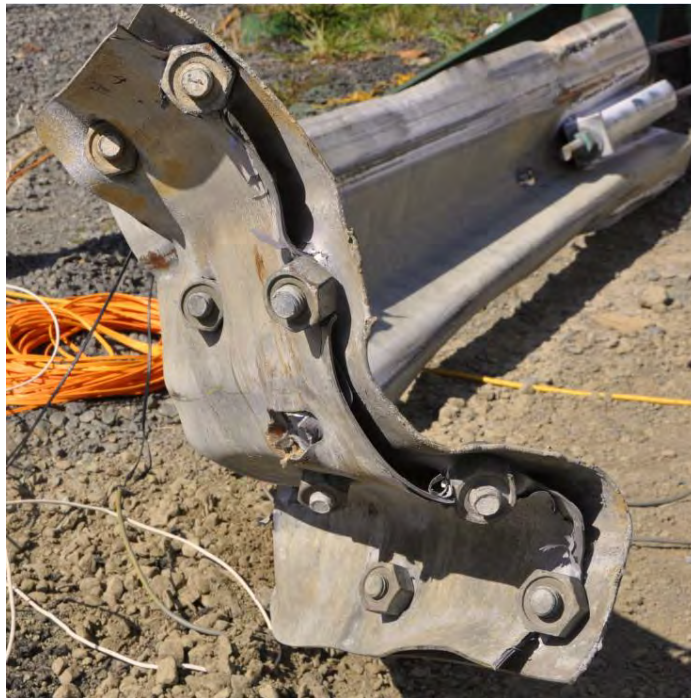
Figure 353. Results of Test 14004F with rail tear passing through all four downstream splice-bolt holes.

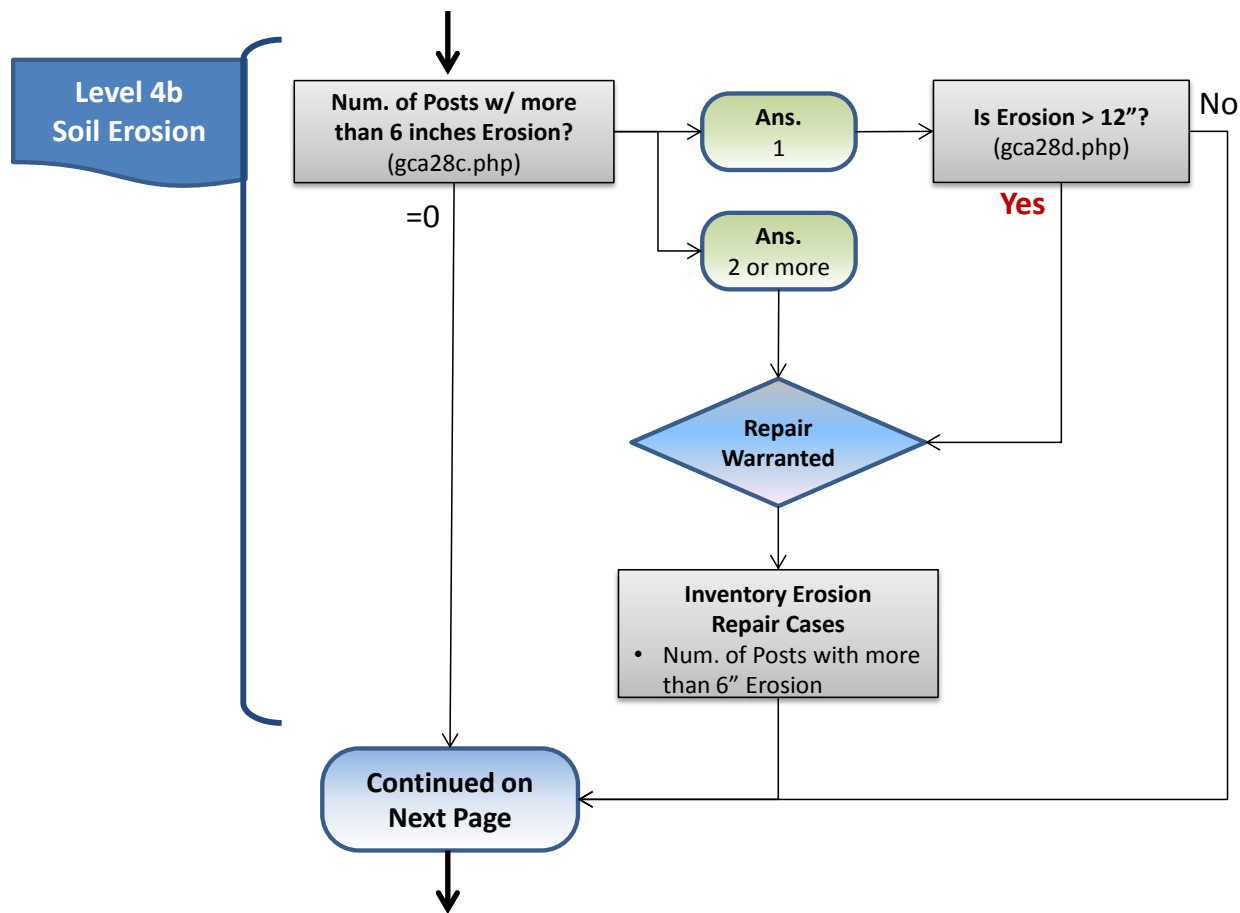
Figure 354. Flow chart for the online guide's guardrail assessment.

The number of damage modes included in *NCHRP Report 656* was relatively small and thus manageable for use in routine inspections. However, as additional damage modes and additional guardrail types were included, the evaluation process became more complex and time consuming. To make the assessment process as accurate and efficient as possible, an on-line, context sensitive version of the field guide was developed using standard web development language. HTML and PHP were used to create a user interface and to store users’ answers to questions as variables. At the end of the automated assessment, the results were: 1) displayed directly on the screen of the device being used, 2) sent in an email to the address provided by the user at the beginning of the assessment, and 3) stored in a central MySQL database maintained by the research team. The online guide was coded such that the time required to perform assessments are minimized by avoiding unnecessary questions based on user inputs. The flow chart for the online guide is show in Figure 354. Example field assessments are provided in the next chapter to illustrate the use of the on-line field guide.

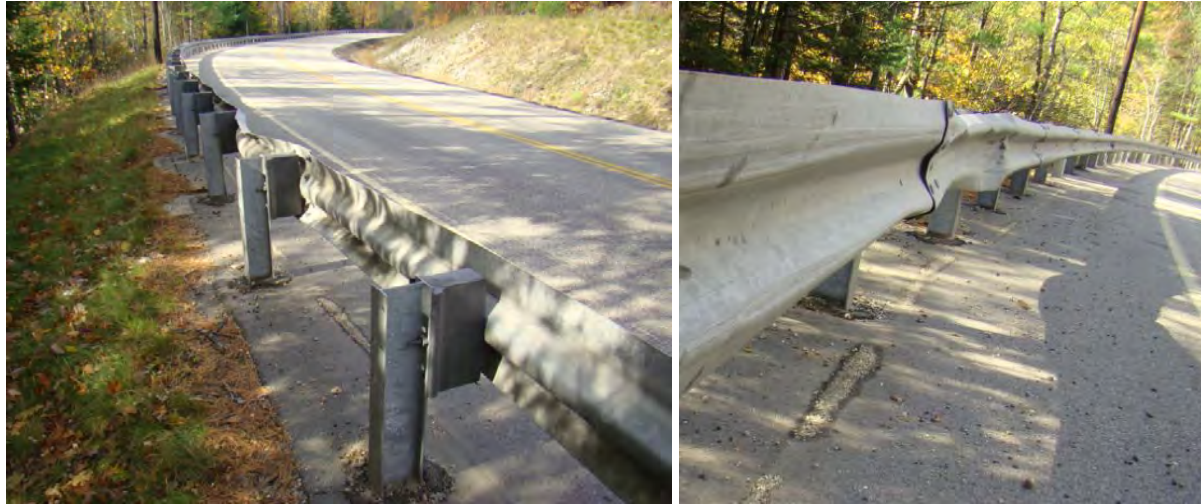
Figure 355. Photos of the crash site for Example 1.

This example involves a modified G4(1S) guardrail with crash damage extending over two rail panels, including the w-beam splice, as shown in Figure 355. The following images show the step-by-step evaluation procedure using the on-line *Guardrail Condition Assessment* (GCA) program developed in Chapter 15.

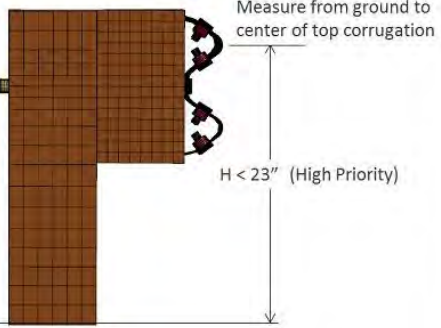
System Damage - Rail Height

Is the height measured from the ground to the center of the top corrugation of the w-beam less than 23 inches?

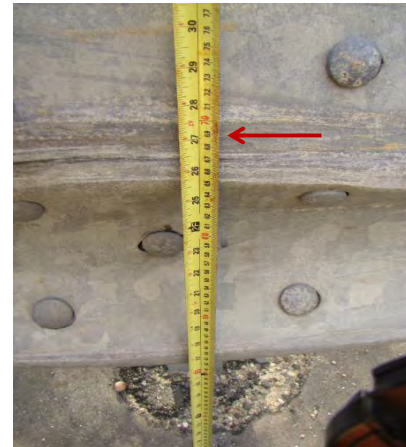
User Input for Question 5:

The rail height was 26.5 inches measured from the ground to the middle-point of the top w-beam corrugation, so the “No” response was selected.

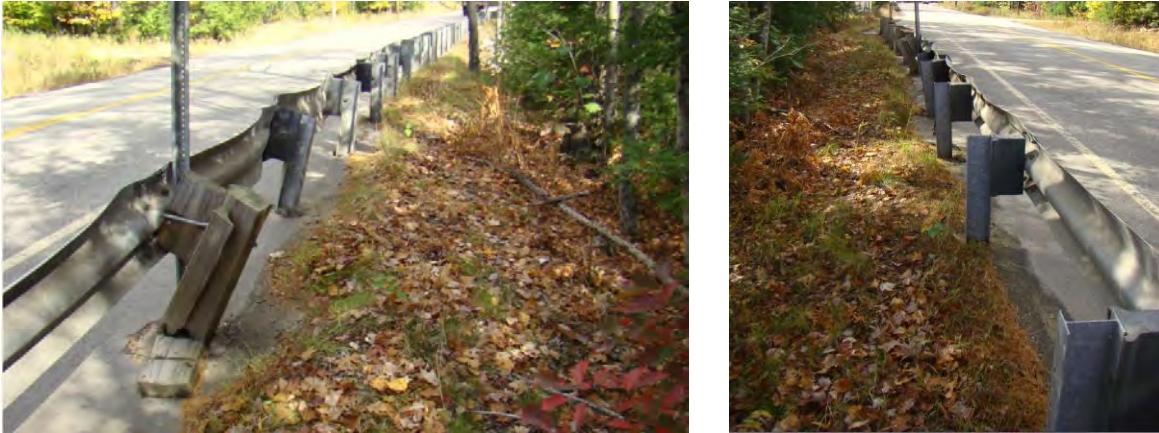
Figure 356. Photos of the crash site for Example 2.

This example also involves a modified G4(1S) guardrail with crash damage extending over two rail panels on the length-of-need section of the guardrail, as well as a portion of the end-terminal, as shown in Figure 356. The following images show the step-by-step evaluation procedure using the on-line GCA program.

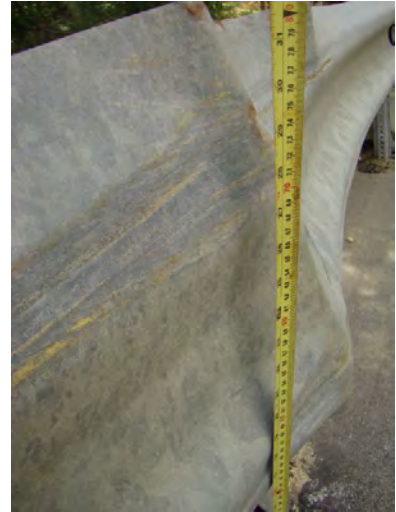
Is the height measured from the ground to the center of the top corrugation of the w-beam less than 23 inches?

User Input for Question 5:

The rail height was 28 inches measured from the ground to the middle-point of the top w-beam corrugation, so the answer was “No”.

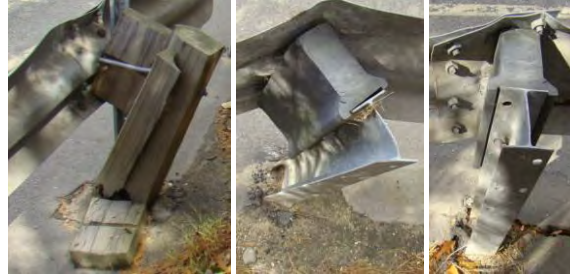
User Input for Question 11:

There are a total of 3 posts that need replacement. Two line posts were damaged and one CRT post.

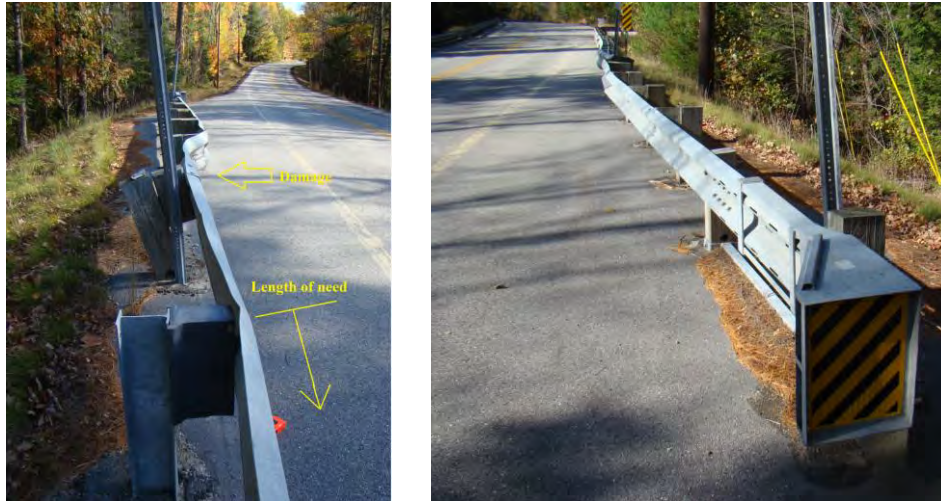
Figure 357. Photos of the crash site for Example 3.

This example also involves damages to a FLEAT guardrail end-terminal section, as shown in Figure 357. The following images show the step-by-step evaluation procedure using the on-line GCA program.

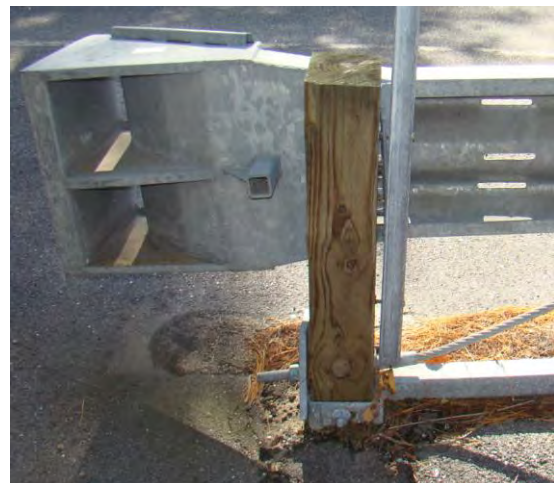
User Input for Question 4:

The lag screws fastening the terminal head to the end-post were pulled out of the post.
